# Quaife Woodlands

Our Ref: AR/2477/jq

## Arboricultural Statement at Shangri-La Cattery, Lower Road, Hockley, Essex

Site Plans - Existing and Proposed Layouts  
with subject trees and photographs

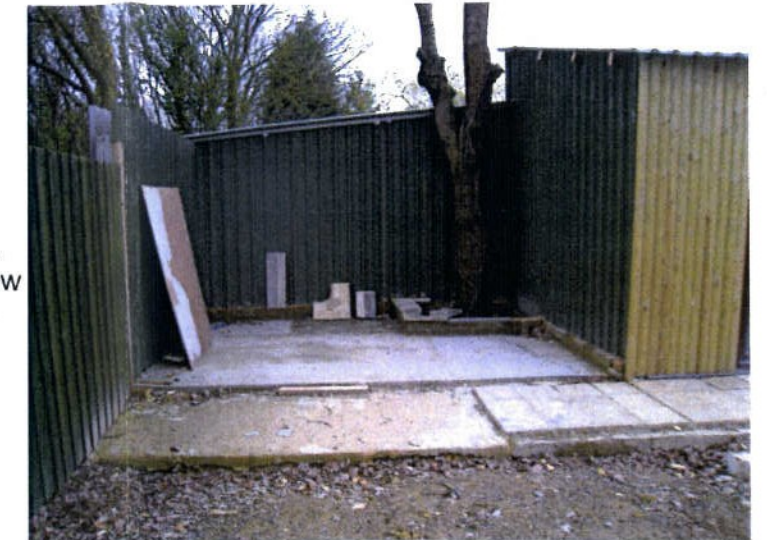
The two plans at Appendix A show the existing and proposed layouts area extracts from New World Designers drawing number 2219/3/31 (sheet 6 of 7) dated February 2011. The existing layout shows the Oak 1 within the building, but this part has now changed. In the proposed layout the existing building footprint has actually remained the same and the only difference is in respect of the Oak 1. Previously this was (unusually) enclosed within the building with a cut-out in the roof for the stem to protrude through. The roof and outer walls have now been removed and the tree is now "external" to the building as shown in Photograph 1 at Appendix A. The concrete floor remains and the tree is within a small raised bed with a brick retaining wall of just two courses and the tree is in satisfactory condition.

**Photograph 1.**  
View of Oak now  
external to the  
building

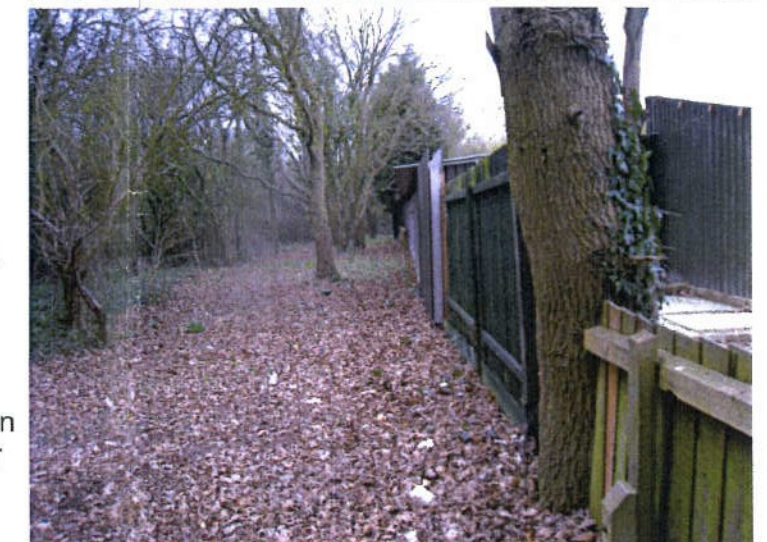
The western flank wall of the building is along the boundary and I understand that it will not be altered. The trees on the neighbouring ground to the west are shown in Photograph 2 at Appendix A and they may well have been adversely affected by the original construction, but with the passage of 3 or 4 years they have clearly adapted. They appear to be in satisfactory condition and the proposed changes to the building will not affect them.

However, severe effects of root damage can take several years to manifest themselves, and although the trees appear to have adapted, should their condition decline in respect of the building (as opposed to disease or other effects) then remedial action may be necessary. The ground was clean of low vegetation at my visit, but as it was in the first half of March this is not unexpected, however the only effective restorative action would be to cover the ground under the crowns of the ailing trees with woodchip mulch. This should be laid at a depth not exceeding 100 millimetres. Whereas one might also consider ground decompaction in these circumstances, with reference to the Geological Survey Drift Map, Sheet 258/259, Southend and Foulness, the site is situated on London Clay. Decompaction of this soil type is rarely effective and should it be necessary best results would be achieved with mulching.

The Oak 3 on the western boundary (foreground of Photograph 2 and left in Photograph 3 at Appendix A) has had the paving taken up to the north-east and this is to be kept open as an herbaceous bed. The tree does have some dead wood, but shoot extension is normal and it appears to have adapted. As with the trees on neighbouring ground, if the condition of this tree should decline then mulching would be beneficial. The mulching would need to be on the neighbouring ground but I would anticipate agreement by the owner because it would be beneficial to the adjacent Oak to the south-west.

**Photograph 2.**  
View looking  
northwards  
along the  
western  
boundary (taken  
by leaning over  
the fence)

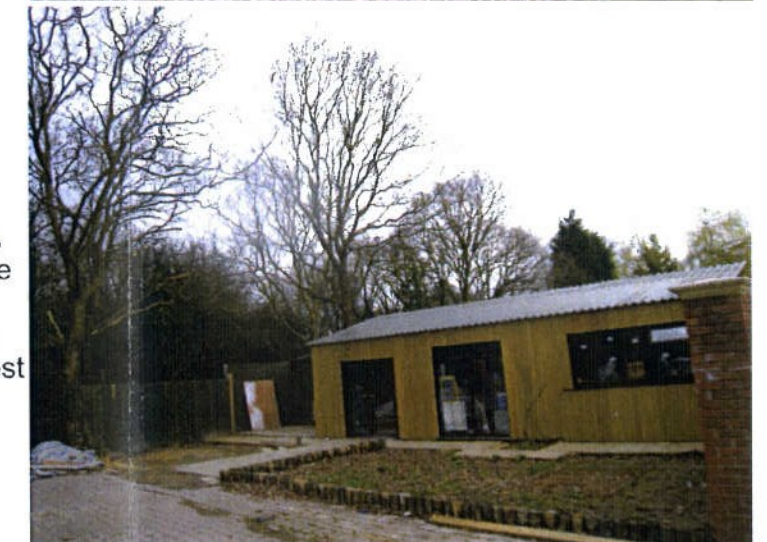
**Photograph 3.**  
View across the  
front of the  
cattery looking  
to the north-west
