ARBORICULTURAL REPORT

89 DOWNHILL ROAD
RAYLEIGH
ESSEX

The purpose of this report is to provide Arboricultural advice as to the current condition and future management of two semi mature trees located at the front of 89 Downhill Road, and comment on how the proposed development may affect them. This report is aimed at assessing the trees in terms of their current health and future management. This report is in accordance with BS5837 'Trees in relation to construction' 2005.

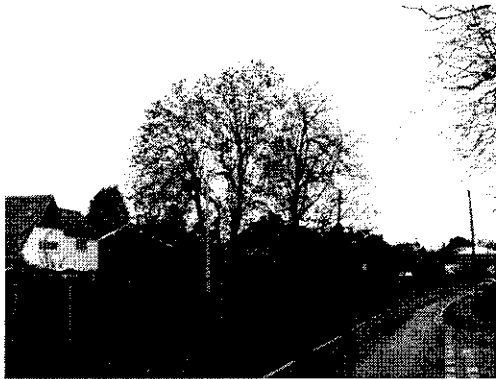
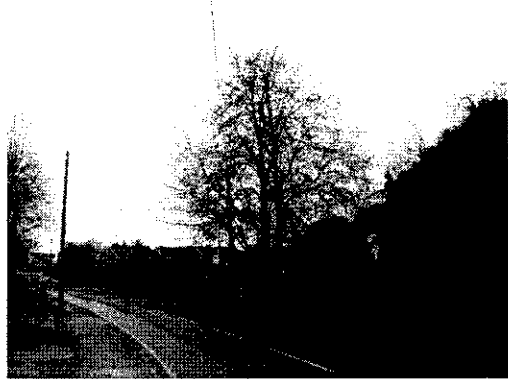
At present the trees would appear to be in good health with no signs of noteworthy decay or disease. The Ash tree (T1) appears to have received prior crown reduction works, and has recovered well. The Horse Chestnut tree (T2) does not appear to have had any prior management, but due to its proximity to the adjacent power lines, may require some reduction work to provide clearance. Some cavities are present but appear to have occluded well; these should be monitored to ensure that significant decay pockets do not develop. Due to their proximity to each other it is likely that the crowns will be suppressed on one side of each tree, and will have to be managed as a pair so as not to detract from their visual prominence in the street scene. Although no signs of pests or diseases was noted at the time of inspection, it should be noted that Horse Chestnut trees are becoming susceptible to a leaf mining moth called *Cameraria ohridella*. The larvae of this moth affect the photosynthetic efficiency of the leaves and can result in premature leaf drop and distort its amenity value. Although no tree deaths have been solely attributed to infestation of this moth, it is reasonable to suggest that such damage to the leaf area could stress the tree and make it more susceptible to attack from pathogenic organisms.

Looking West along Down Hall Road at T1 and T2

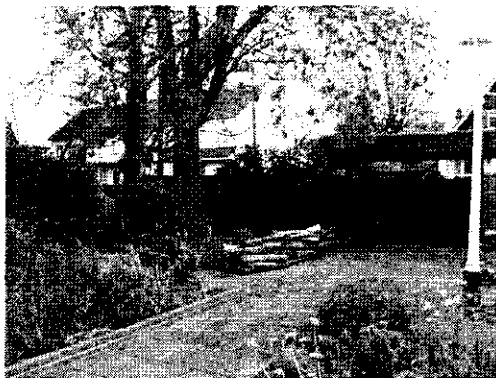
- 4.4 It is possible that significant roots will be present in the areas where excavation works will be required to implement the development. However, this may depend on the history relating to the garden path and its construction method. It is possible that the construction of this path could have already resulted in damage or severance to significant roots.

View of garden path at base of T1

- 4.5 It may be advantageous to undertake investigations to determine if significant roots are extending into the areas that might be affected by development

- 4.6 If significant roots are encountered a qualified arborist should assess if they can be pruned and appointed to administer the works required. If the roots can not be cut due to the likely hood of it affecting the trees health and stability, alternative design proposals should be considered.

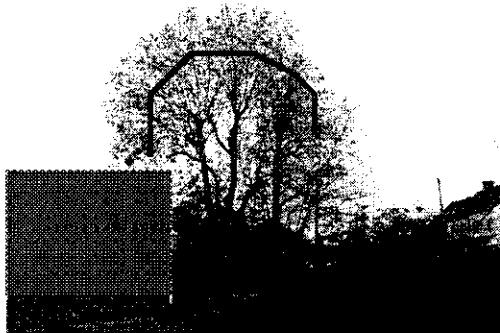
From viewing the drawing labelled P01 it shows the proposed building to be located within 2m of T1 (Ash) and T2 (Horse Chestnut) within 6m. T2 would appear to be of sufficient distance from the proposed property as to be of moderate risk of damage from construction pressures; with adequate protection any damage risk could be reduced. However, at this proximity to T1 (Ash); it is possible that roots could be affected that could have detrimental effects on the trees health and longevity. Roots deemed to be of significance to the trees health and future vitality are those of 25mm in diameter or over, or roots that form bundles but are smaller than 25mm should also be considered as significant. No detail pertaining to the foundation design has been provided, but it is assumed that excavation works are likely to be involved that could damage any roots that may be present. At this distance it will not be possible to provide protection in accordance with BS5837 2005 'Trees in relation to construction'. Currently in close proximity to the tree there is a garden path that would appear to be relatively recent in construction, and could have resulted in severance or damage to roots already. Without investigation involving careful excavation of the area likely to be disturbed during the construction process, it can only be speculated as to the extent and significance of root activity present. Although given the size and proximity of the tree it is likely that if roots have not already been cut or damaged by the path construction, then there will be significant root material present. As well as the rooting area the crown spread may also be affected and require reduction to accommodate the building. This is unlikely to be a major issue in terms of the trees health, as it would appear that reduction works to the crown have taken place in the past, and will likely be required again in accordance with good Arboricultural management. Should construction works be allowed and roots are encountered, it is suggested that a qualified arborist is consulted to provide advice and undertake any root pruning works that may be required in accordance with the method statement provided. If allowed to proceed care should also be taken in the demolition process of the existing property, and adequate protection for the trees provided.

Approximate position of proposed building to T1
And suggested crown reduction line

It would seem that the proximity of the new building to T1 (Ash) is the factor that presents the most risk of damage to the tree. If possible the manipulation of the foot print to afford the tree greater protection area would help to assist in protecting the tree from the development pressures likely to occur if the development were permitted. An alternative could be to place the parking in the area closer to the trees with the access road running along the boundary of the neighbouring property. This way a construction technique such as 'No dig' could be implemented for the parking area and take into account other factors such as permeability to allow rain fall to percolate to the rooting zone unobstructed. This is likely to have less of an affect on the trees in terms of root and crown interference, and allow the development to progress in harmony with the established trees as a feature. The increased distance from the trees could also lessen the problems that might be associated with light to dwellings or leaf litter deposit in gutters, as well as distancing the property from the neighbouring property and Down Hall Road itself. To further enhance the property and provide pleasant screening from Down Hall Road, the placement of a row of trees of native origin could be located along the front boundary. Species such as Hornbeam, Hawthorn, Field Maple and Silver Birch, would offer seasonal variety and provide a diverse habitat for local wildlife.

- 4.7 Alternatively the foot print for the development is revised to provide the parking area closer to the trees and the use of 'no dig' techniques implemented to reduce the likelihood of detrimental disturbance to the trees. This could also be an adventitious solution to reduce other problems associated with trees such as light and litter.
