ARBORICULTURAL REPORT
(BS5837:2005 'Trees in relation to construction – Recommendations' Tree Report)

Rayleigh House
High Street
Rayleigh

On Behalf of
Autosecond Ltd

26th July 2007

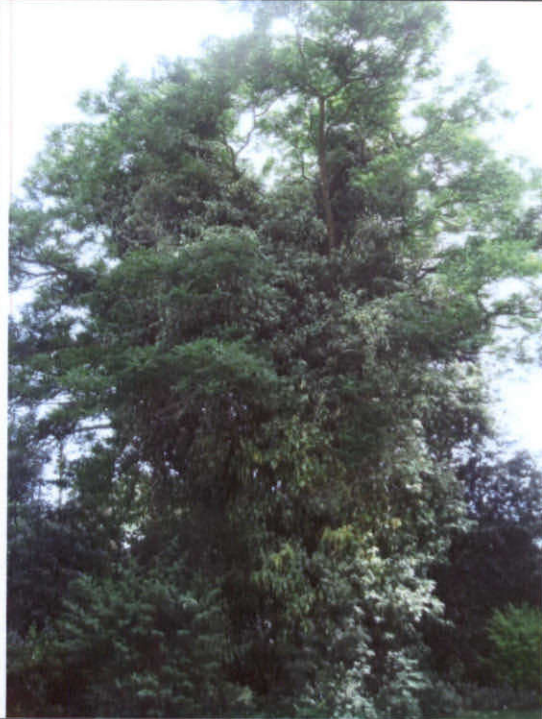
T3 False Acacia (Robinia) B2	Mature tree swamped with an ornamental ivy. RPA 12m, difficult to plot likely rooting area due to change in levels. This species has brittle branches.	Retention desirable, subject to ivy removal and inspection. Remove dead wood
T4 Copper Beech A1 and 2	A mature tree in good health growing on a raised bank next to the entrance. RPA is shown as a circle with a radius of 13.2m.	Retention essential Minor tree surgery recommended May be prudent to retain banking and entrance as it is as Beech roots are sensitive to change
T5 Red Oak B2	Off site tree, unable to examine base. RPA estimate 452 square metres. Forms part of a high canopy with adjacent trees.	Outside of control of site, apart from pruning overhanging branches (subject to TPO consent)
T6 Sycamore C2	Tall drawn up tree with a narrow crown which has been heavily crown lifted in the past. RPA 222 square metres.	Retain in the short term. As with all trees to be retained, I recommend annual monitoring.

T3 False Acacia – note dense ivy growth

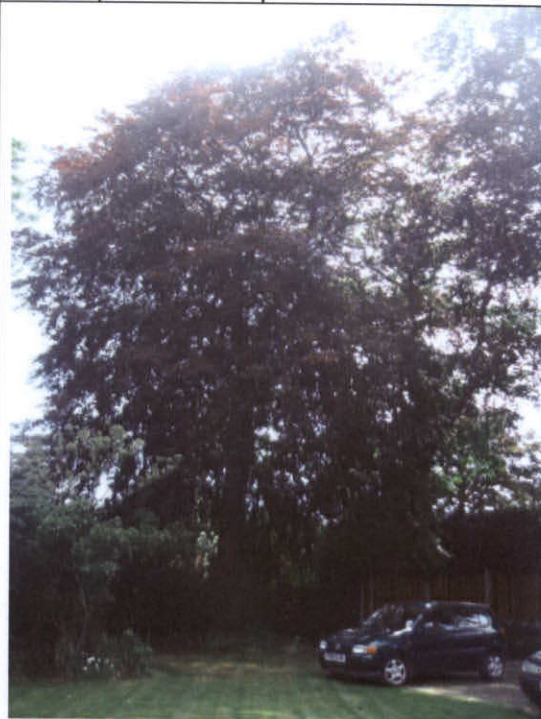
T4 Copper Beech looking south

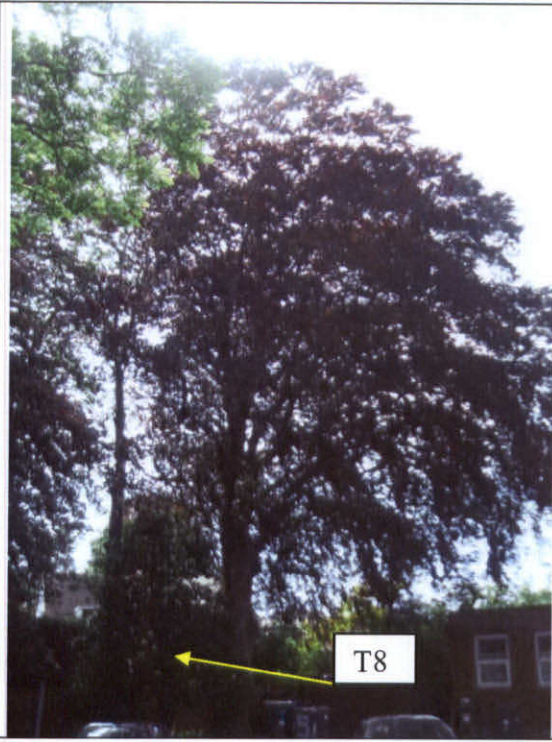
T8	Holly <i>Ilex aquifolium</i>	7	300 41m ² / 3.6	Average 2	Ma	fair vigour, minor insect pest <i>Phytophthora ilicis</i> present	20-40	C2	Branches at 2m Tips 0.5m		-Annual monitoring -Sever light ivy growth
T9	Lime <i>Tilia x europea</i>	8	Estimate 600 163m ² / 7.2m	0	Ma	Good vigour Epicormic growth	20	C2	-	Has been very recently pollarded at 8m, this tree is off site and the base could not be inspected	-Annual monitoring
T10	Golden Lawson Cypress <i>Chamaecyparis lawsoniana</i>	9	Estimate 150 10m ² / 1.8m	Average 1	Y/Ma	Good vigour	20-40	C2	2m	Typical for species 300mm overhang <i>Rooting area not known</i>	-Annual monitoring
T11	Horse Chestnut <i>Aesculus hippocastanum</i>	4	M/S	Average 2	Y	Good vigour	-	R	2m	Immediately adjacent to garage - self sown	-Advise to fell due to close proximity
T12	Norway Maple <i>Acer platanoides</i>	4	M/S	Average 2	Y	Good vigour	-	R	2m	Leans north -Numerous shoots -Moderate dead wood <i>Rooting area: lawn</i>	Annual monitoring

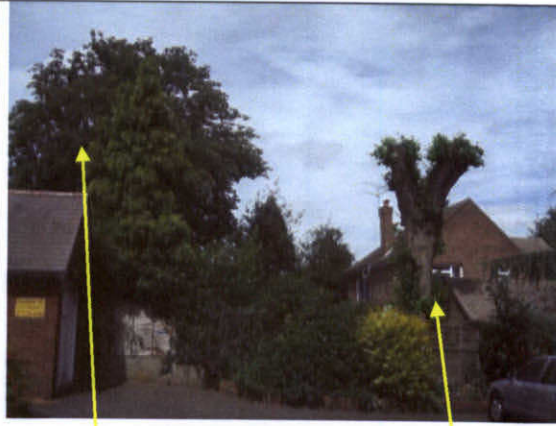
T18	Horse Chestnut Aesculus hippocastanum	17	Estimate 700 222m ² 8.4m	Average 5 S - 5	Ma	Good vigour Horse Chestnut leaf miner (Cameraria ohridella)	20-40	B2	Tips 3m	Typical for species although unable to fully examine as off site -Has been crown lifted on site side in the past Rooting area - Lawn on off site and on site, around road, covered by a base, lowest 2m managed as an oval topiary Rooting area: lawn	-Annual monitoring
T19	Yew Taxus baccata	7	-	Average 2 Average 2 Average 2 Average 2	Ma	Good Vigour	>40	C2	2m		-Annual monitoring
T20	Silver Birch Betula pendula	7	2 stems both 200 18m ² 2.4m	Average 3 Average 3 Average 3 Average 3	Ma	Low vigour	-	R	2m	Significant amount of moderately sized crown dead wood overhangs road Rooting area: raised border adjacent to pavement	-Fell
T21	Holly Weeping Ilex aquifolium	5	200 18m ² 2.4m	Average 1.5 Average 1.5 Average 1.5 Average 1.5	Ma	Good vigour	20	C2	0.5m	Typical for species Rooting area: lawn	-Annual monitoring

T18
Horse
Chestnut

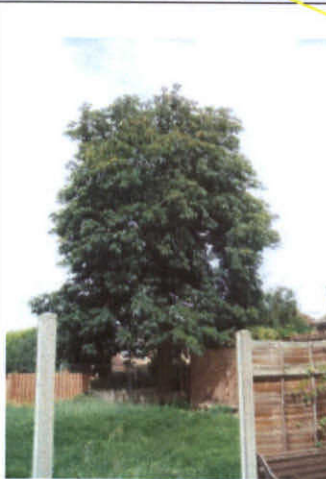
The trees in the rear garden are of a low visual amenity and are all young, and therefore could be replaced as part of a landscaping scheme for a new development. The most important trees off site are a Red Oak (T5) and a Horse Chestnut (T18).

Low quality
trees in rear
garden
