**OUR LADY OF RANSOM
CATHOLIC PRIMARY SCHOOL
RAYLEIGH**

TREE SURVEY,
ARBORICULTURAL IMPLICATION
ASSESSMENT &
METHOD STATEMENT

Project No: **2395**

Our Lady of Ransom
Rayleigh
Essex
SS6 9EH

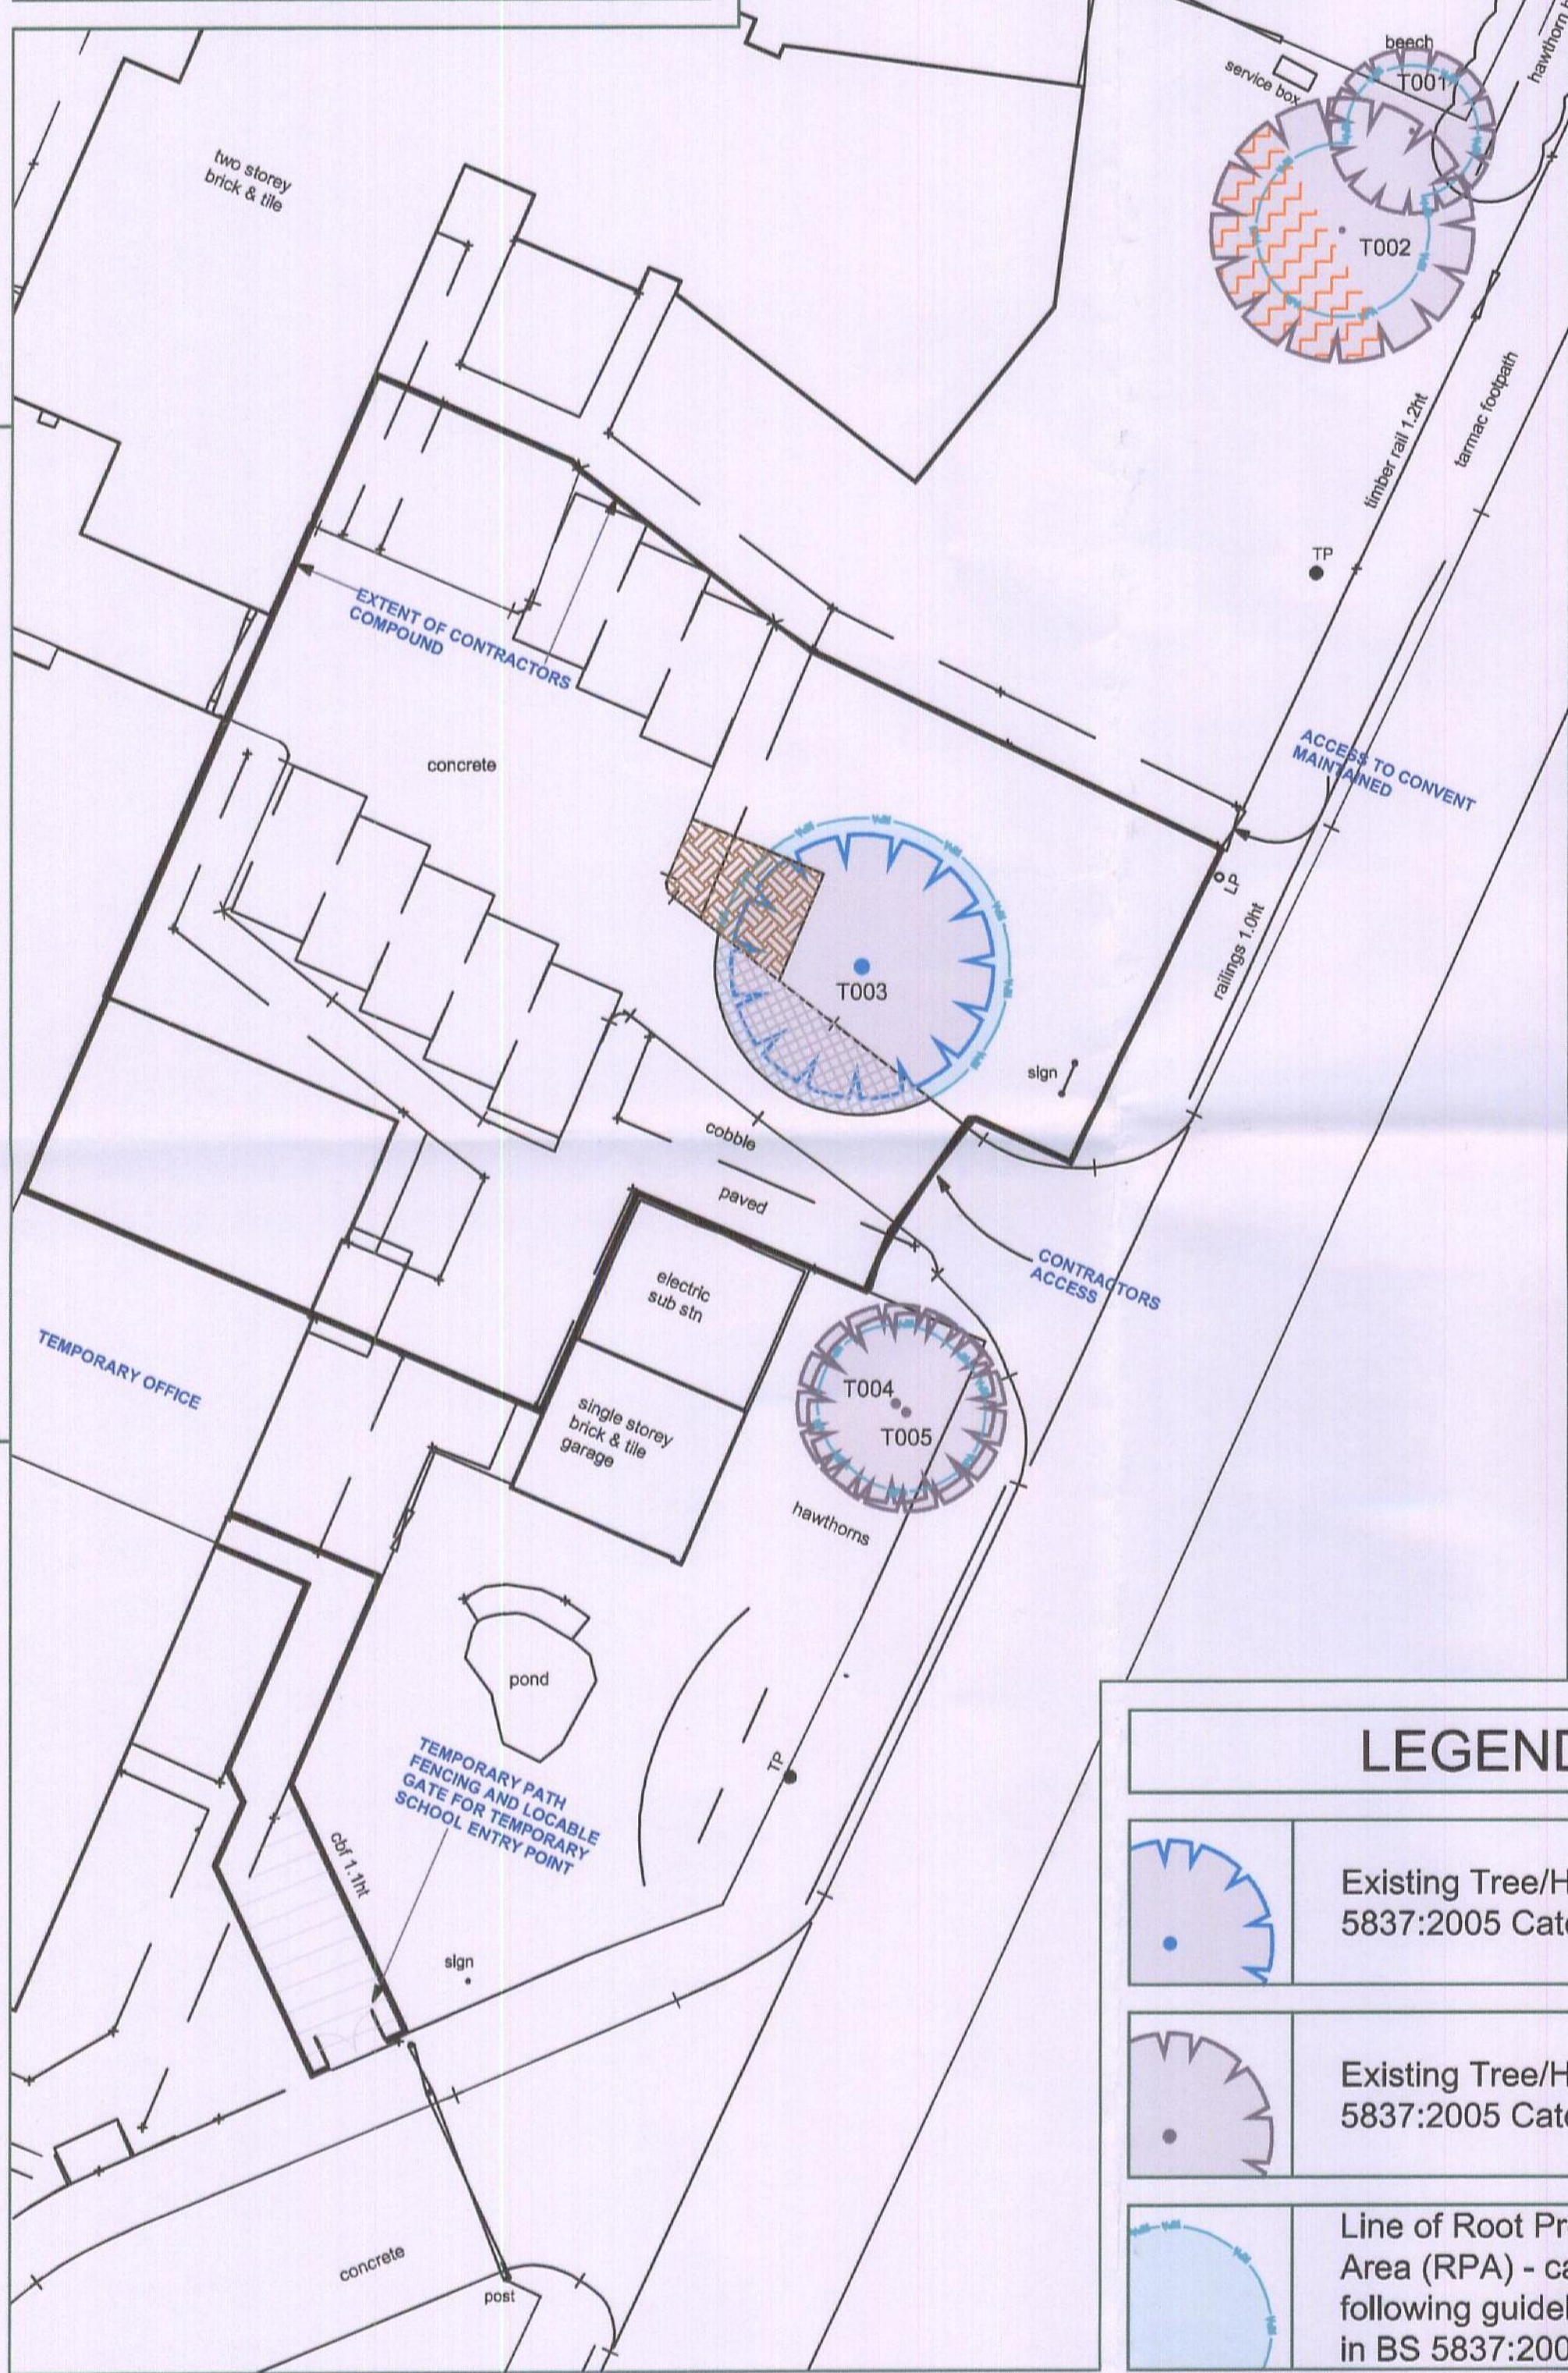
- 4.1.3 A proposed parking bay/hard surface encroaches within a small portion of the Root Protection Area (RPA) of one tree to be retained – T003. Given the minor extent of the intrusion at this location and the changes in levels it is considered appropriate to undertake linear root pruning (see item 4.2.1, below). This operation will obviate the need for "no dig" construction methods in this situation.

- 4.1.4 The proposed pedestrian access to the south of T003 marginally infringes on the RPA of T003. This is currently an area covered with hard surface used for access. It is considered that tree roots from T003 will be present in this area and it is there not considered necessary to construct the path using no dig as described in item 12.0 of this report.

Option 1: Existing trees to be retained. Trees to be protected during development using temporary protective barriers, and root pruning to be undertaken to allow installation of one parking bay.

4.2.1 It is necessary to undertake linear root pruning to T003 as noted at item 4.1.3 above and as shown on drawing no. 2395.D Rev A. This must be carried out using an Air-spade and hand tools (secateurs and handsaw etc), and in accordance with item 12.2 below. This operation will not require repetition.

4.2.2 It is necessary to crown lift T002 to permit construction of adjacent parking bays. Given the amount of pruning necessary and the locations of the works, this is not considered likely to have a significant adverse effect on the tree concerned. It will be necessary to repeat this pruning on a cyclical basis maintain the appropriate clearances

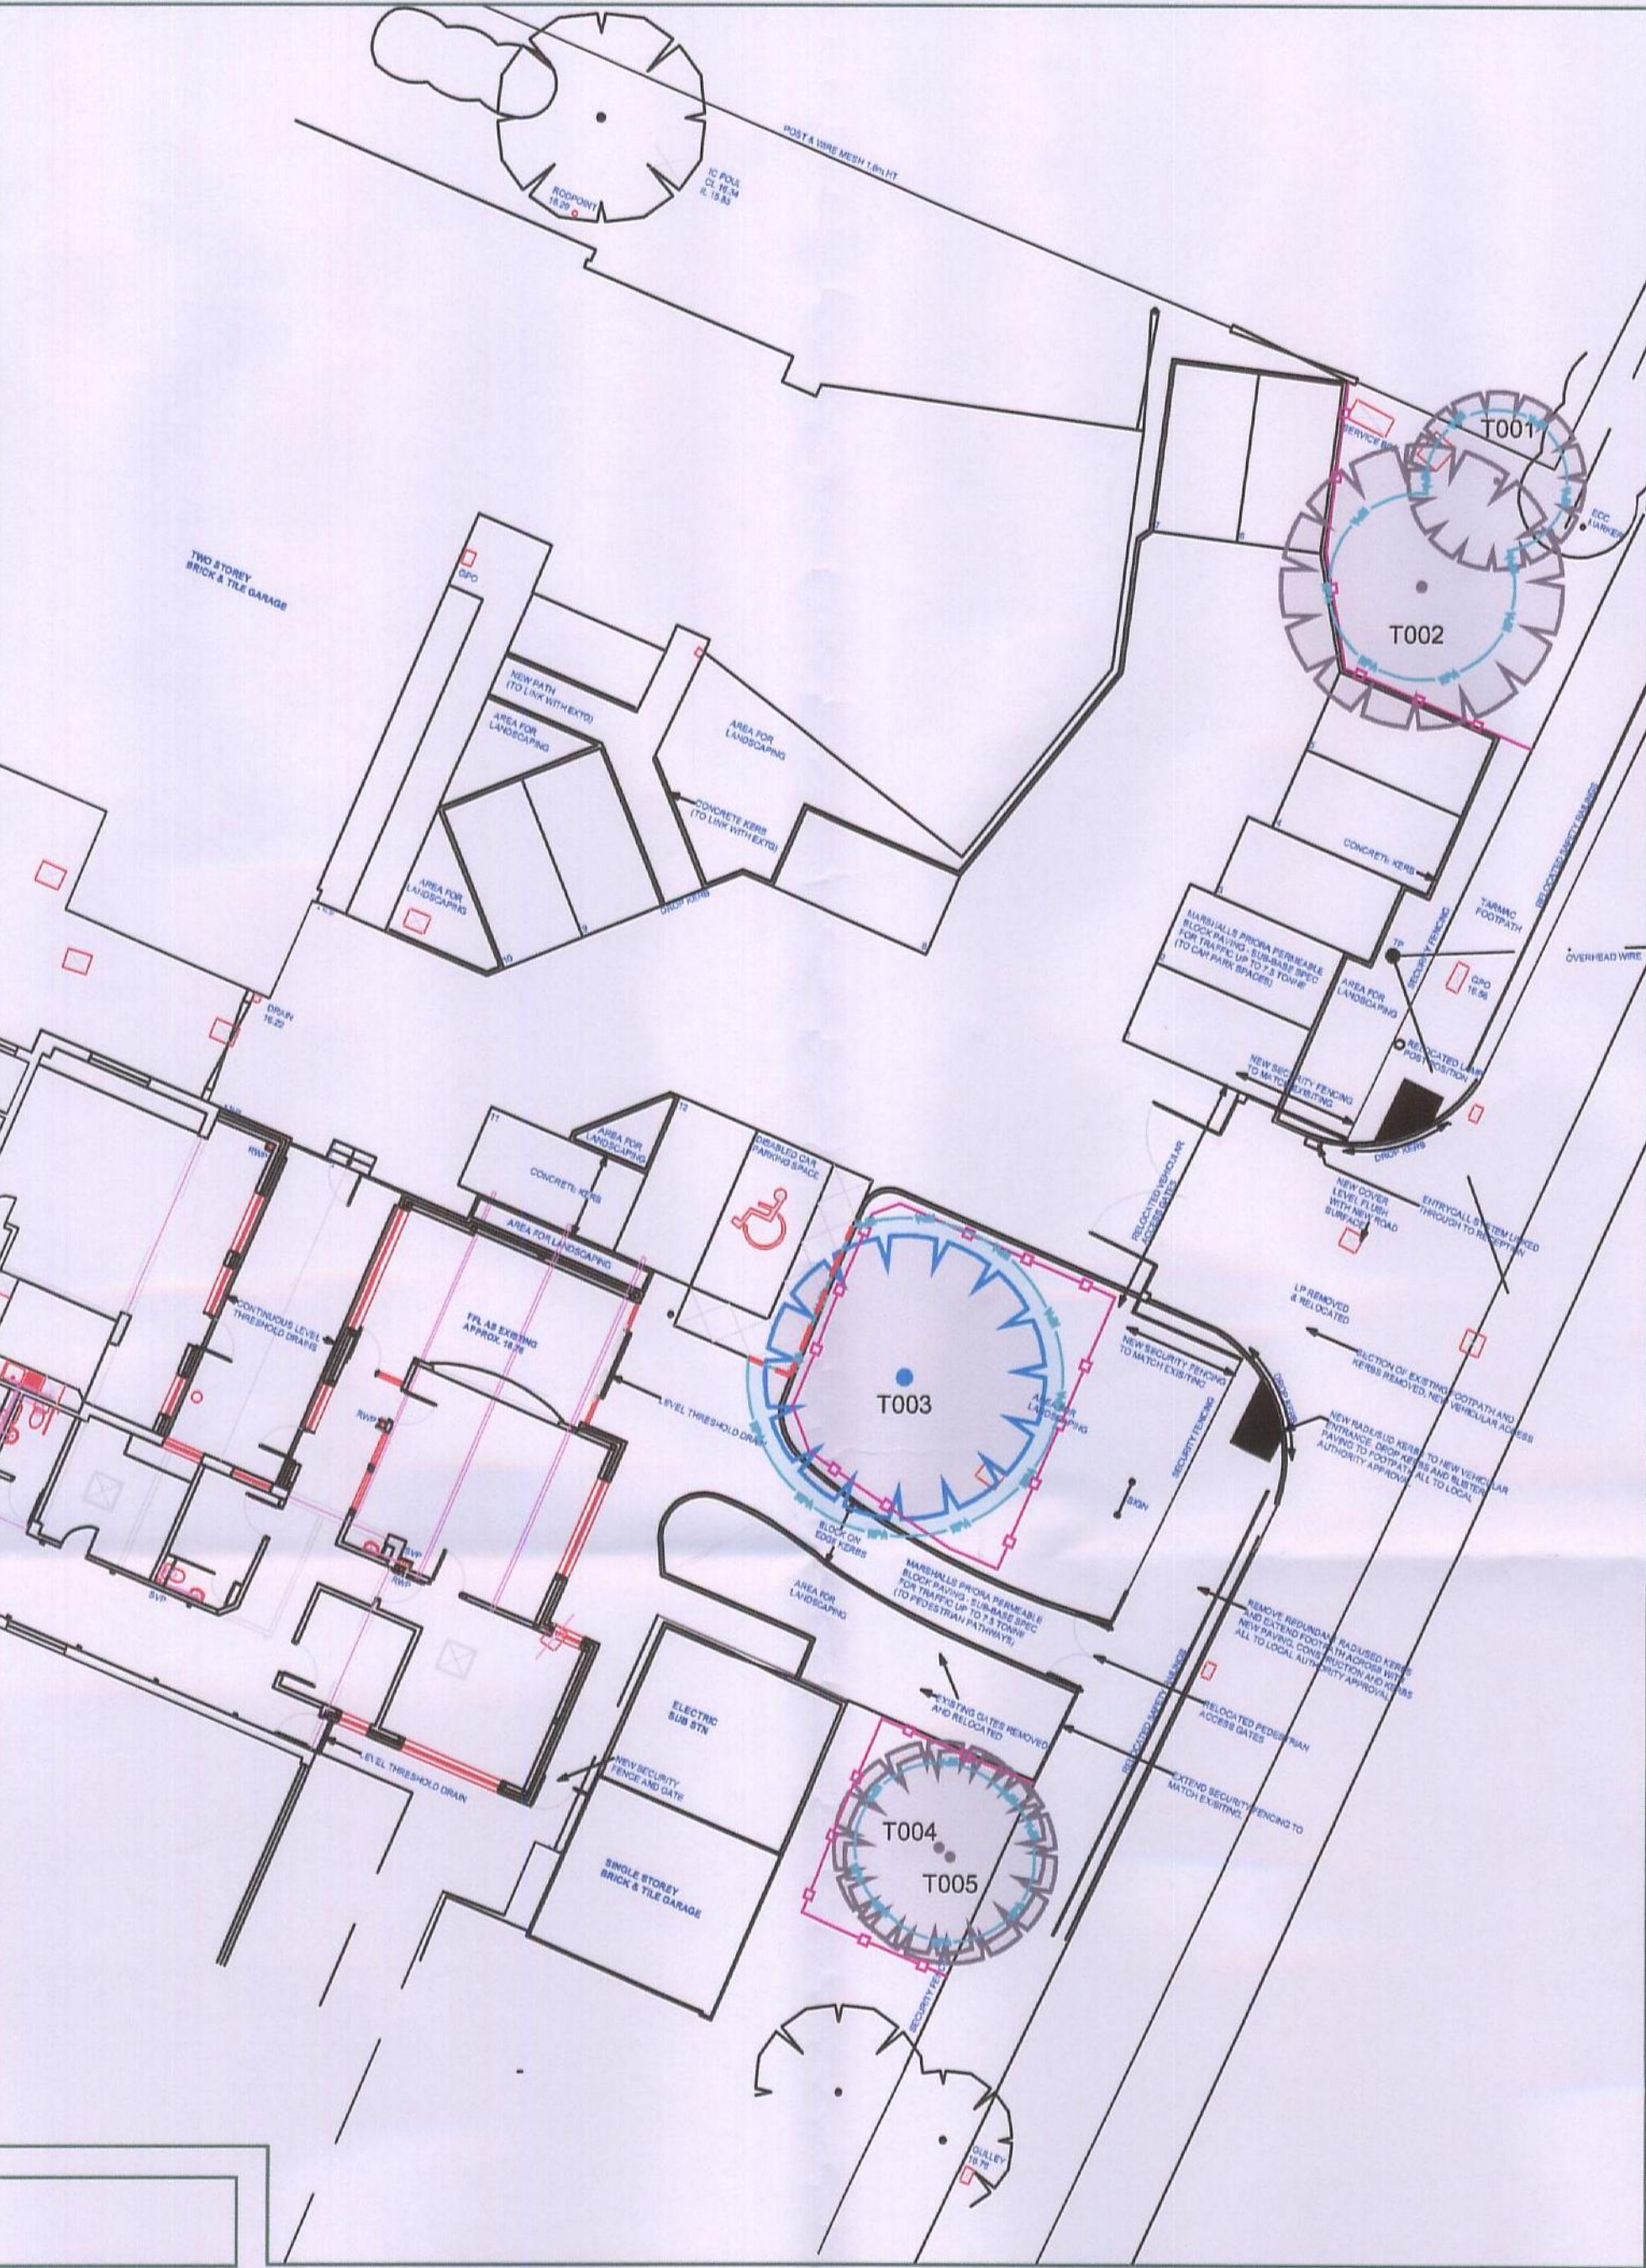
Option 2: T001, T002 and T003 to be removed to allow for new tree planting as part of improved landscaping theme. Haydens Arboricultural Consultants Ltd. consider this option to be preferable.

- 15.1 Whilst this report details protection for T002 and T003 and shows how they can be retained it is recommended that consideration is given to the removal and replacement of these trees as part of the proposed development. This would remove the requirement for root pruning and tree protection; it would also ensure that sustainable tree cover is maintained. Replacement trees are recommended to be *Acer campestre* (Field Maple) although this can be subject to negotiation with the local planning authority. Trees should be planted as container grown specimens with a 14 – 16cm girth. For positioning and planting pit specifications, see drawing no. 2395.D Rev A. T001, T002 and T003 shall be felled prior to commencement of development works, replacement planting shall be undertaken during the first planting season upon completion of development. Any trees which fail with five years of planting shall be replaced like for like.
