THE WHITEHOUSE RAYLEIGH
ARBORICULTURAL IMPACT ASSESSMENT

-August 2006-

The Executive Summary

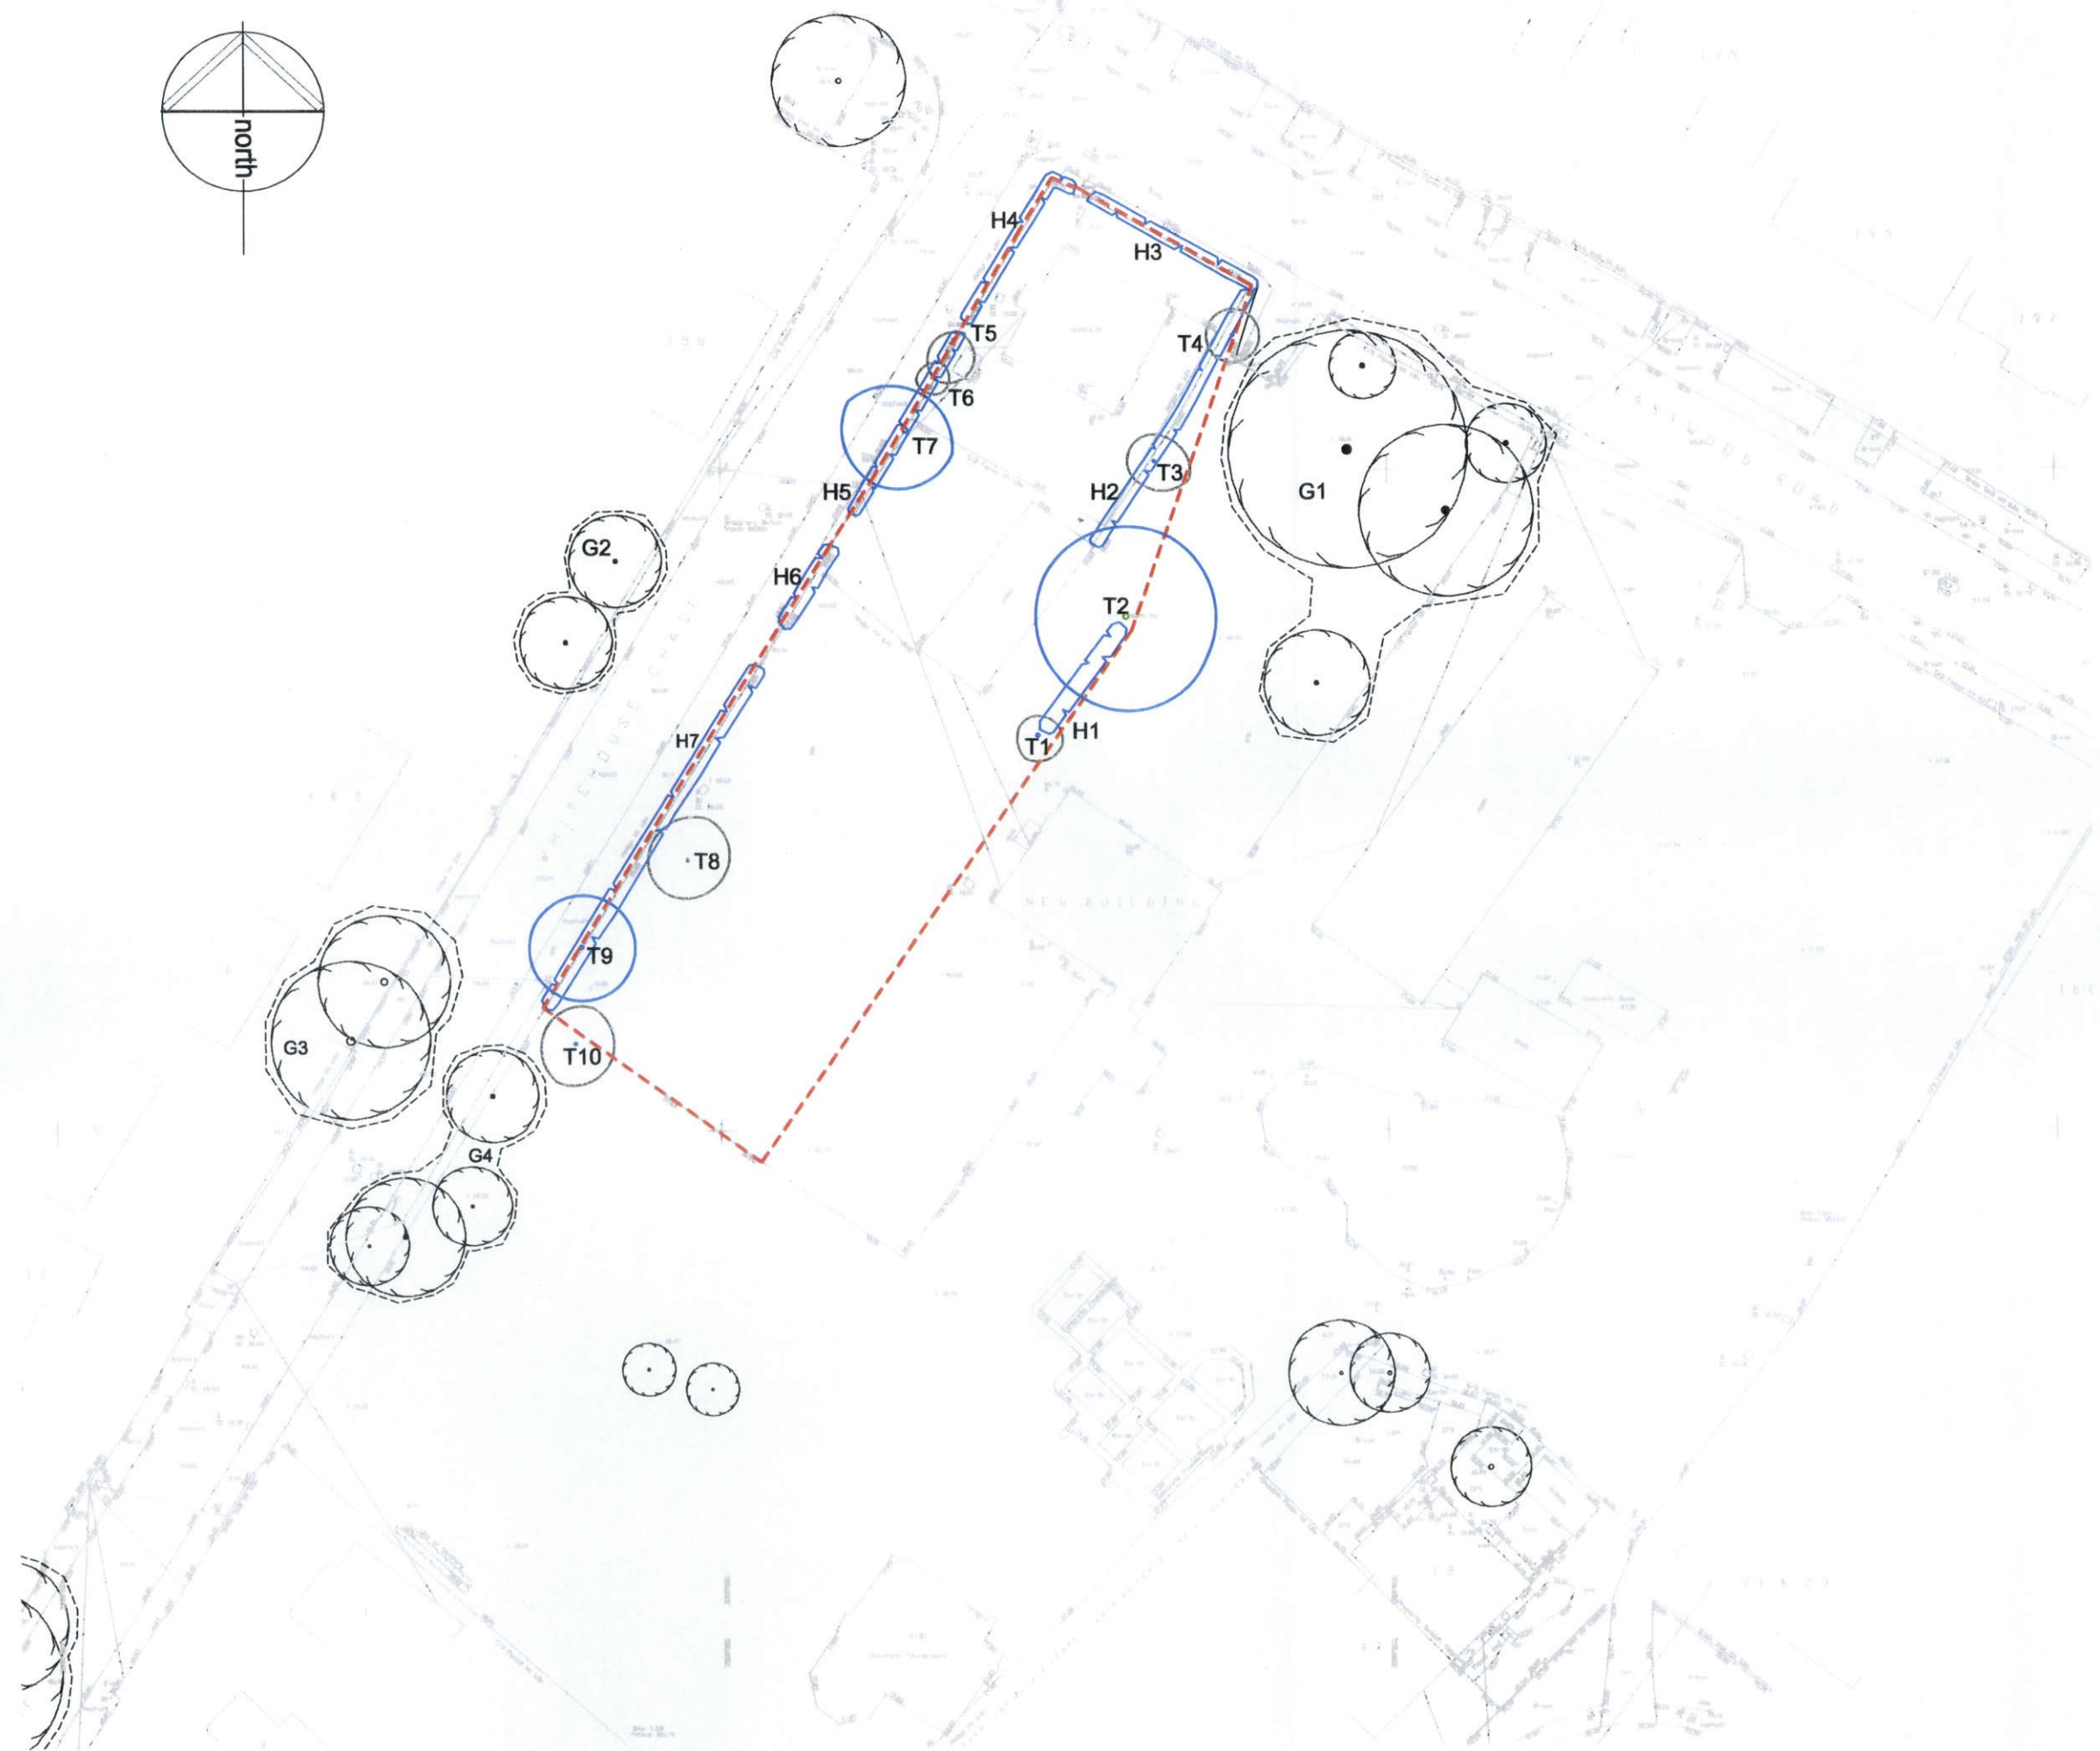
DRAWING TITLE:
PLAN BASE 2
TREE AND HEDGE SURVEY

Whilst some trees shall be removed to accommodate the proposed development, the most significant tree within the site, the large Sycamore tree, T2, situated on the south-eastern boundary, shall be retained. This tree makes a contribution to the setting of the Listed Building.

Whilst the Sycamore trees T7 and T9 are visible from Whitehouse Chase and also seen from Eastwood Road, they are only two of a number of trees within the front boundaries of Whitehouse Chase. The dominant species is Oak and these form an informal and irregular distribution along the road and not part of a formal avenue. Whilst there will be the loss of individual trees, general tree cover will still be retained along the south-western part of Whitehouse Chase.

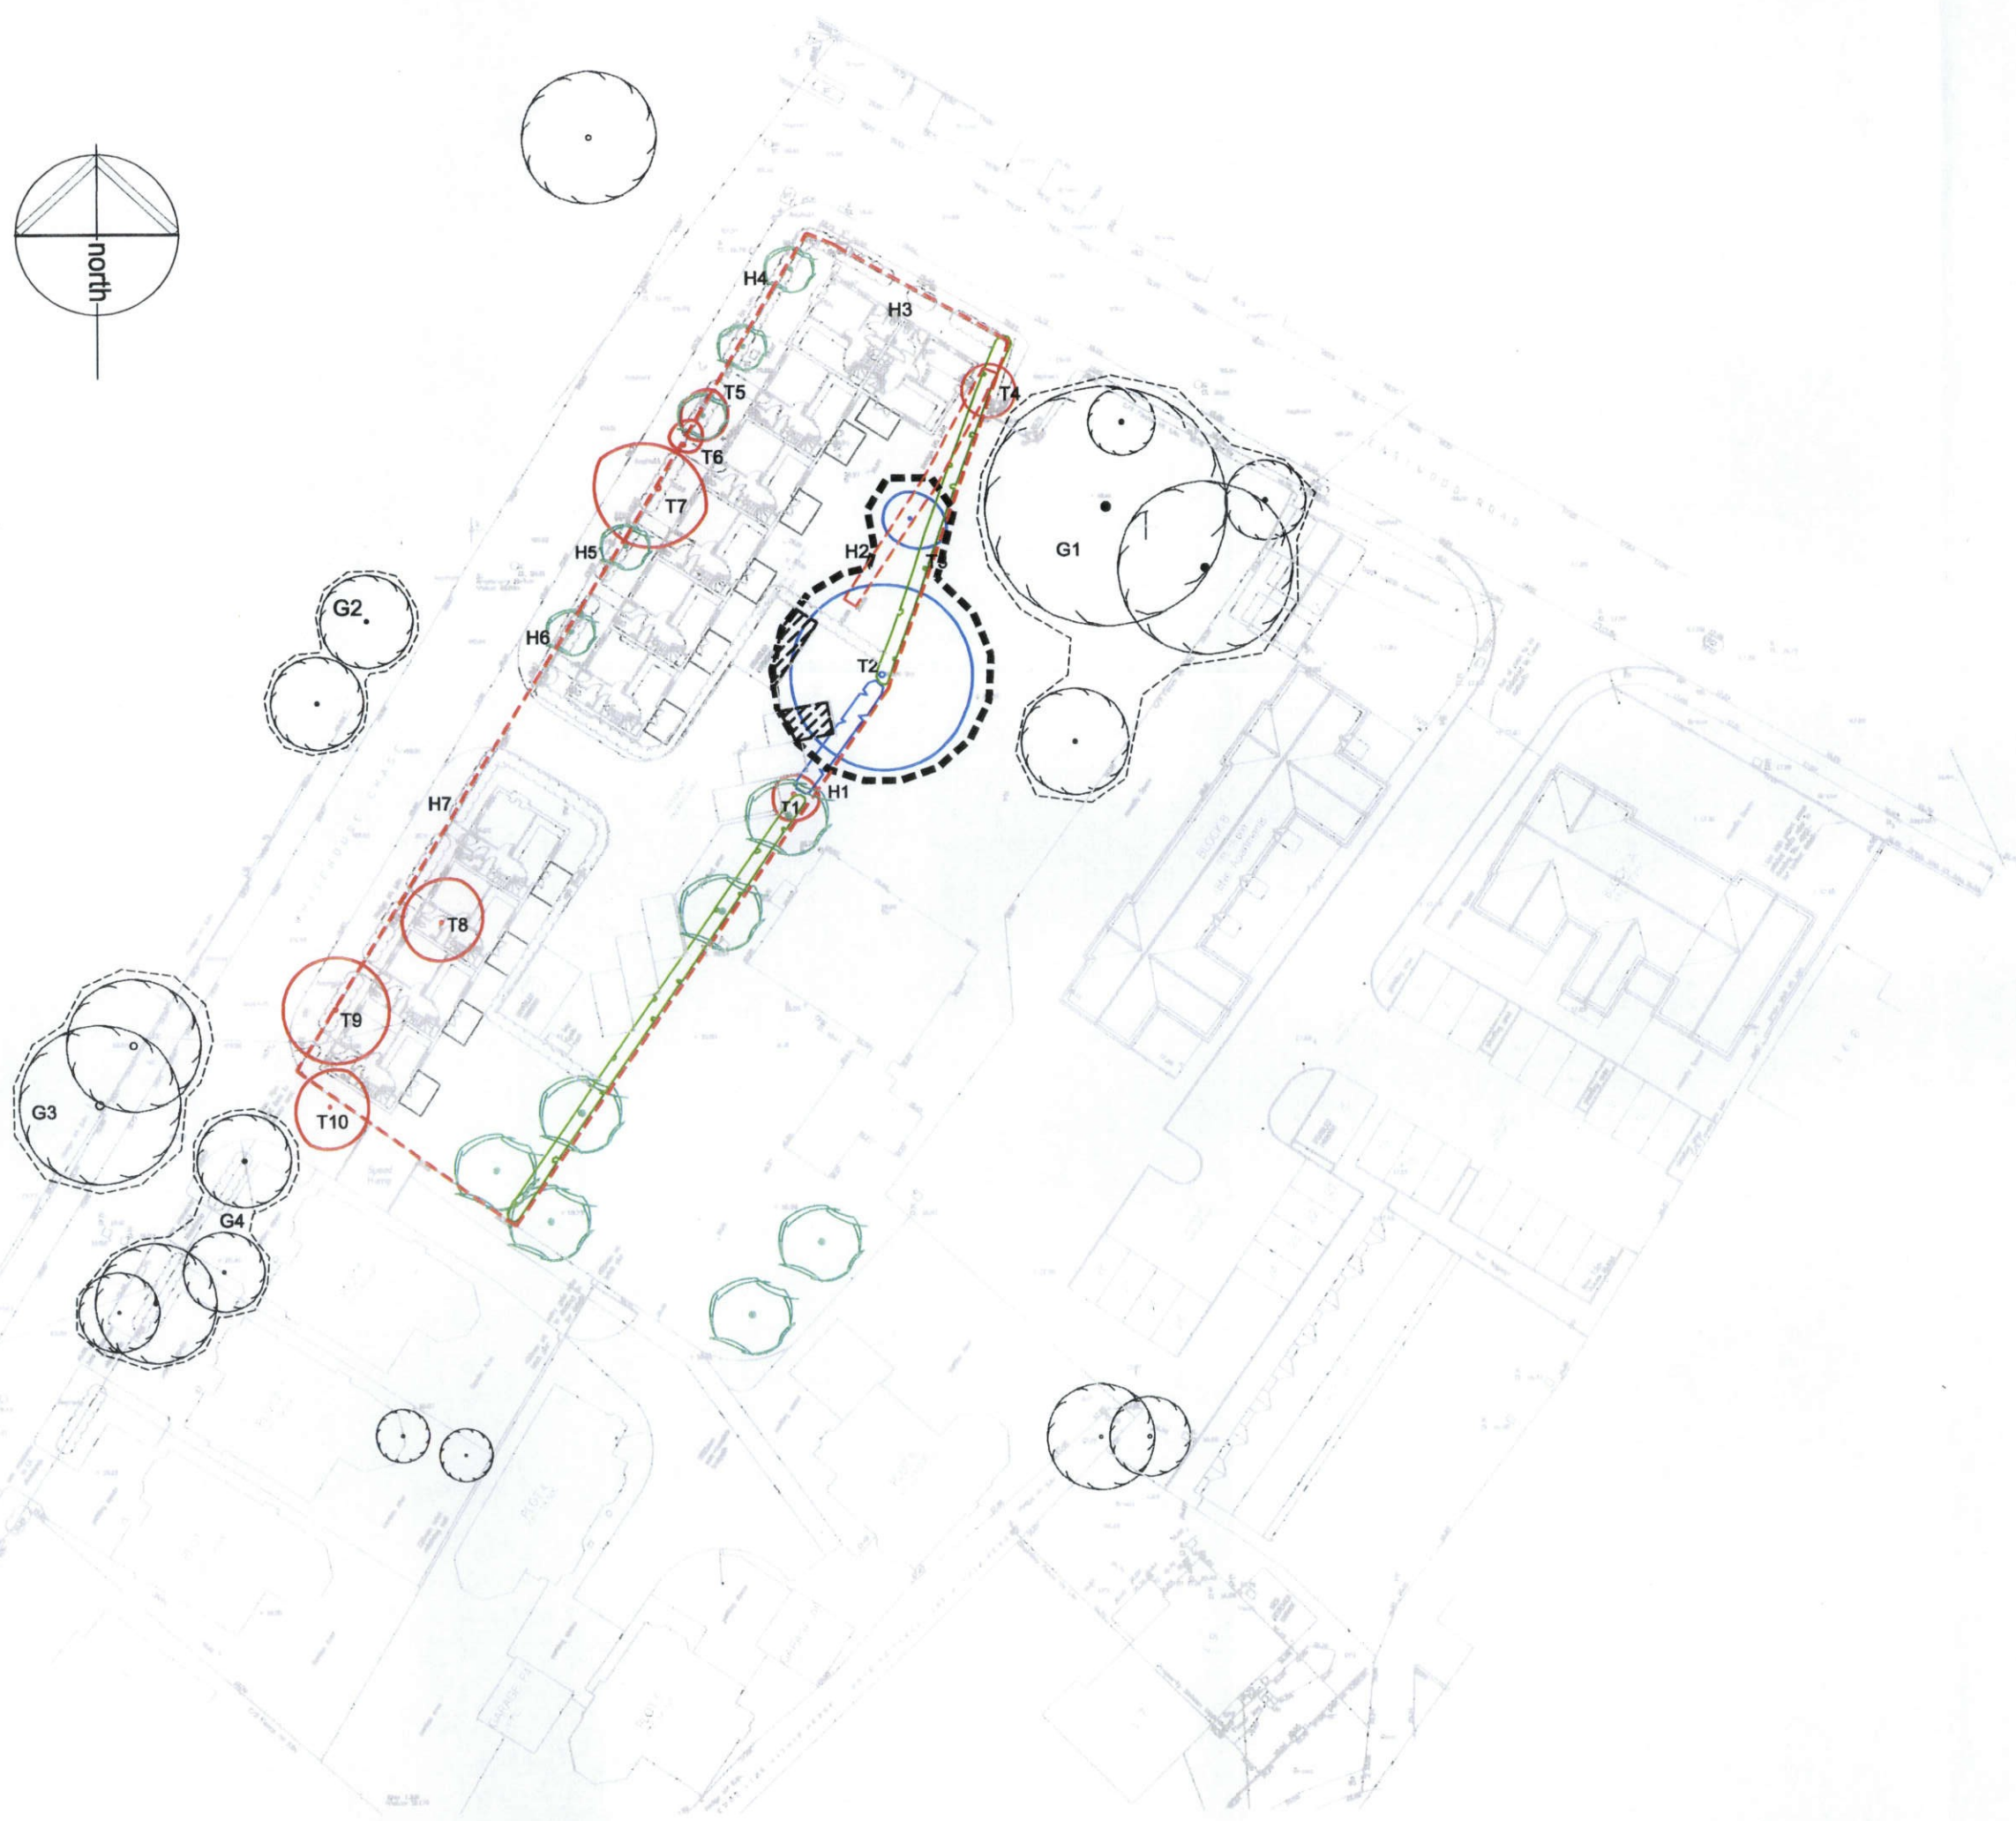
DRAWING TITLE:
PLAN BASE 3
TREE RETENTION, REPLACEMENT AND PROTECTION

Trees to be retained, removed and replaced have been identified, these as shown on Plan Base 3

The most significant tree within the site, T2, Sycamore has been retained. This tree makes a positive contribution to the setting of the Listed Building. Measures for the protection of trees during the construction process have been identified and include the construction and maintenance of protective fencing during the demolition and construction phase.

Trees to be retained will be protected by fencing during the course of the construction as shown on Plan 3 and Appendix 5. There shall be no access into the area of protective fencing apart from the installation of the cellular confinement system.

- Carry out due diligence, checks for nesting birds and bats prior to tree works in accordance with the relevant Wildlife and Countryside Legislation
- Undertake tree works in accordance with the Tree Works Recommendations.
- Erect protective fencing in accordance with Plan Base 3 and specification in Appendix 5
- Do not breach the tree protective fencing during the course of the development or contaminate the RPA
- Place services outside the RPA
- Install cellular confinement system in areas where parking areas are within the RPA of T2 Sycamore
- Site supervision by a competent Arboriculturist may be required in accordance with recommendations in the AMS.
