#### ARBORICULTURAL REPORT

Badgers
53 Rayleigh Avenue
Eastwood
Essex

9th February 2015

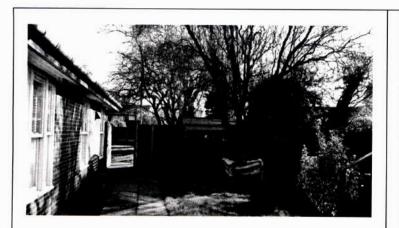
Showing T1 & T2

Showing T2- T5

To implement the planning permission being sought, T1 & T2 will need to be removed. These are low quality trees that do not have an amenity merit in terms of the surrounding landscape or site.

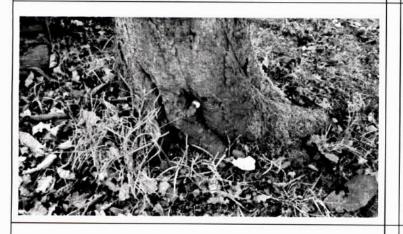
The trees appear to be generally in a healthy condition with no signs of pests or diseases normally associated with the species, apart from T3 that has a small fungal bracket at the base of the stem, which I suspect to be a young Ganoderma Spp bracket. This type of fungus develops to cause internal decay that could compromise the trees structural integrity and longevity.

Showing fungal bracket at the base of T3

In my opinion the trees are fairly suited to the site, but not noteworthy amenity trees within the landscape or site. No management is required at present, but consideration should be given to removing T3 before decay establishes making the tree a liability.

T3 could be retained, but because of the decay fungus developing on the main stem and to provide more space for the development works, I think it would be better off to remove this tree.
