Arboricultural Report

BS 5837 Tree Survey.

33 & 31 White Hart Lane
Hockley
Essex

Prepared For; Frost Construction

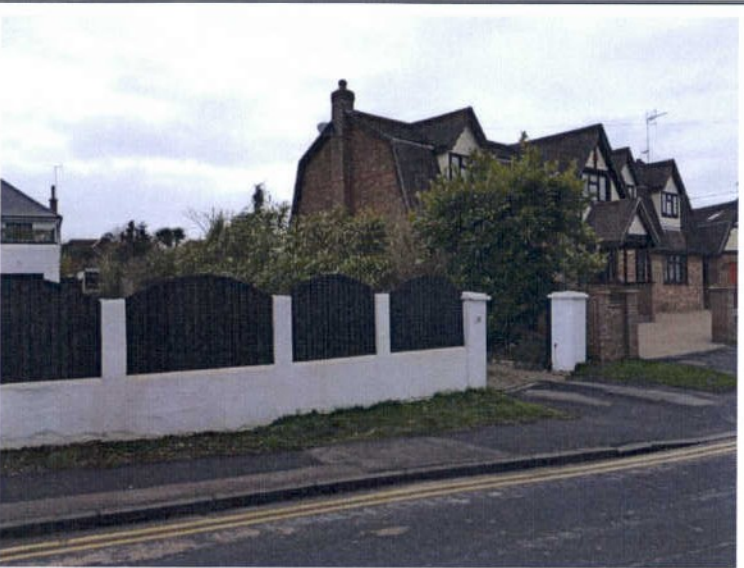
2.4.2 The other 3 hedges, are young and of poor quality. Their value is limited.

Pic 1; Laurel Hedge between 33&35

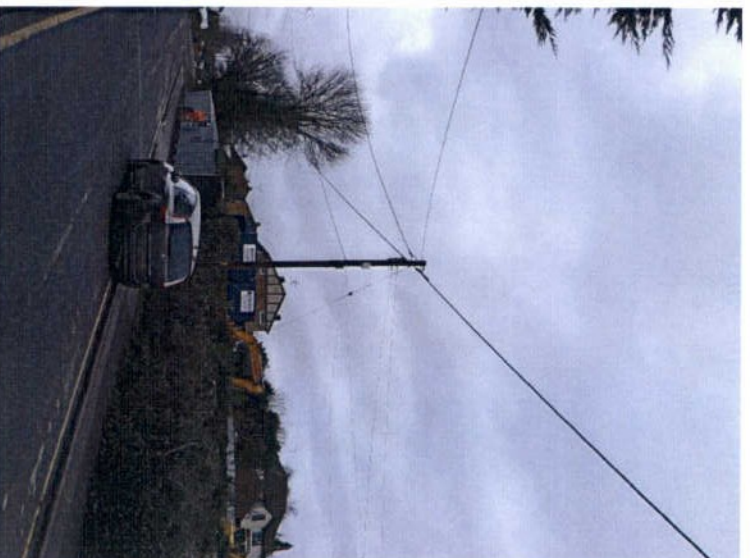
2.3.4 There are four planted, landscape hedges, of limited amenity value. The most visible is the front hedge. Close inspection revealed that this is mostly ivy and a number of the tree stems were actually dead.

2.4.1 The hedge to the front of the site is old but the main woody plants are now mainly moribund.

Pic 2; Remnant Hedge Front Boundary.

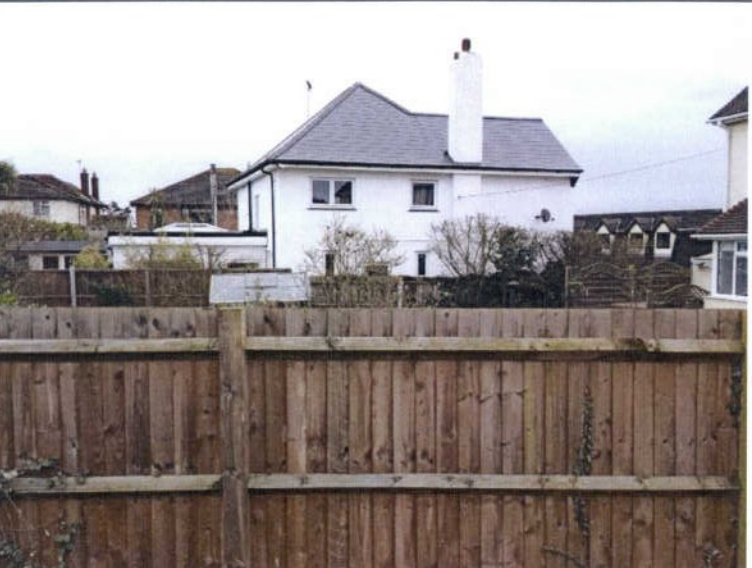
Pic 3: Hedge Between rear garden 31&35.

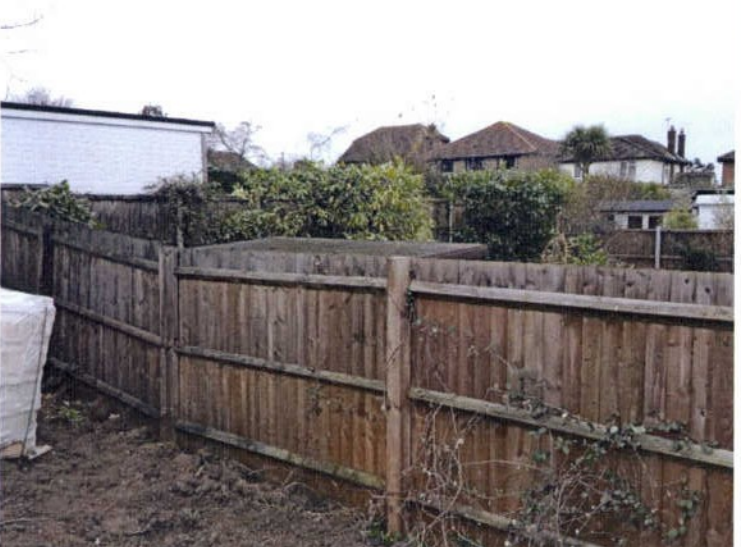
Pic 4; Hedge at rear of 31
