Arboricultural Report BS5837

**16 Eastern Road
Rayleigh
Essex**

**Planning Application For Building Works
Following;**

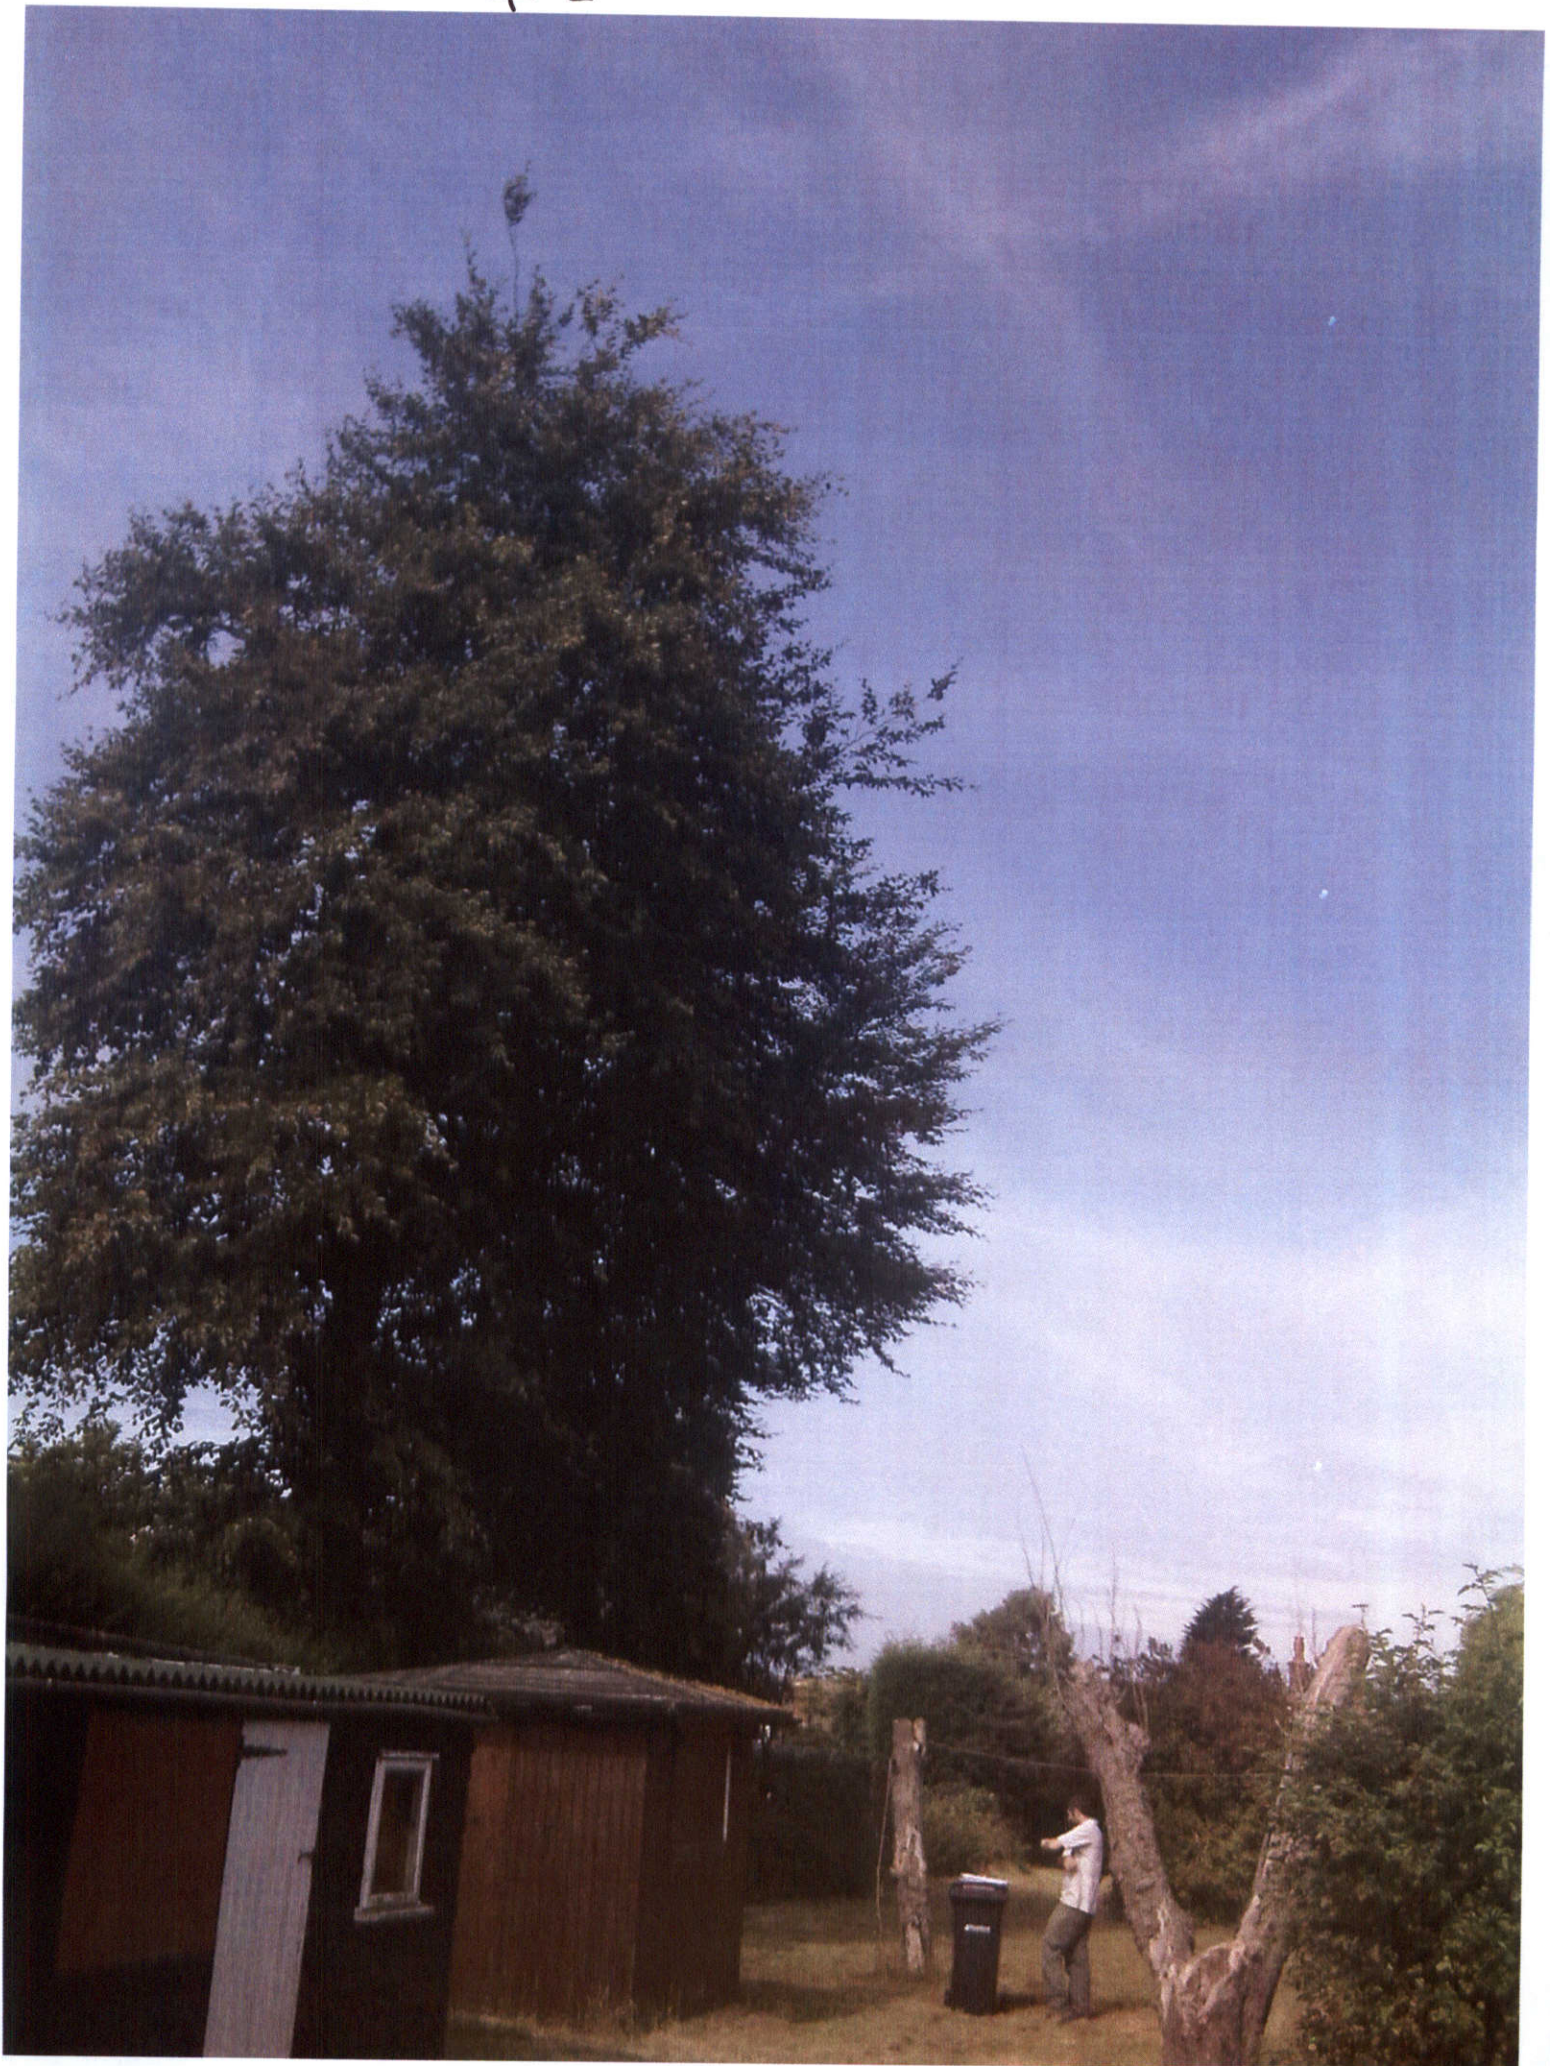
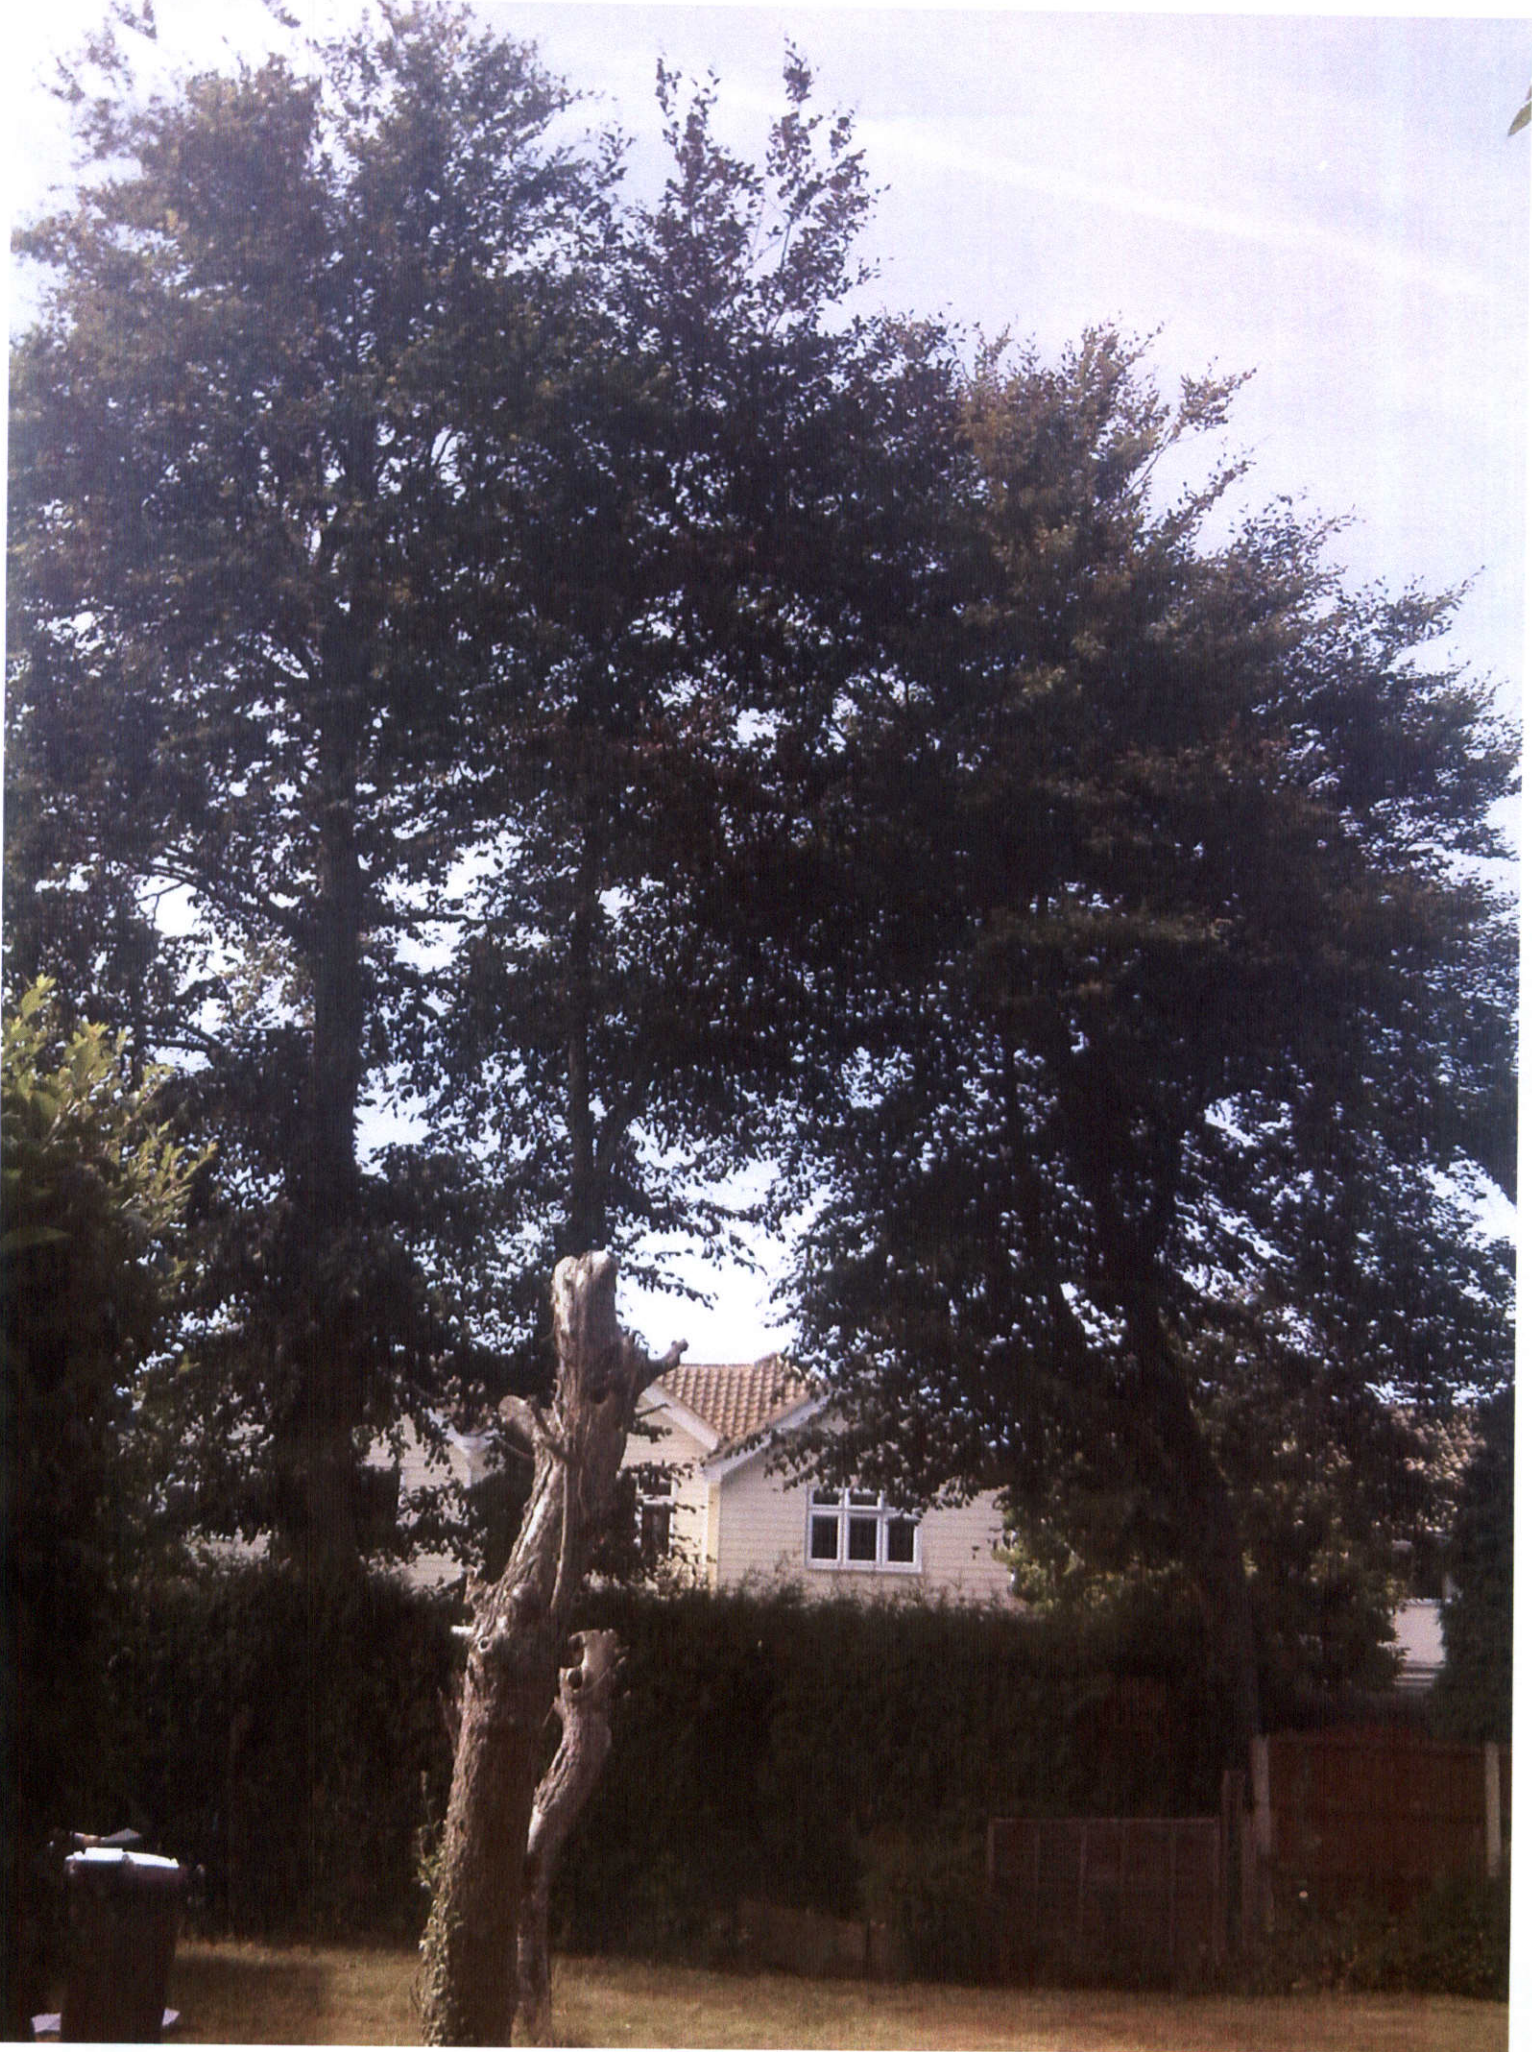
4.2. Appendix 2: Site Photographs.

T1. (Beech) is a mature tree with good form, amenity value and life potential. Minor ivy encroachment on stem, no obvious faults or defects following VTA (Visual Tree Assessment), lower branches on northern side have been removed.

T2. (Beech) suppressed between T1 +T3, minor ivy encroachment on stem, no obvious faults or defects following v.t.a, lower branches on northern side have been removed.

T3. (Beech) is a mature tree with a co-dominant leader on north side. The tree is growing in a southerly direction, low limb removed on the northern side.

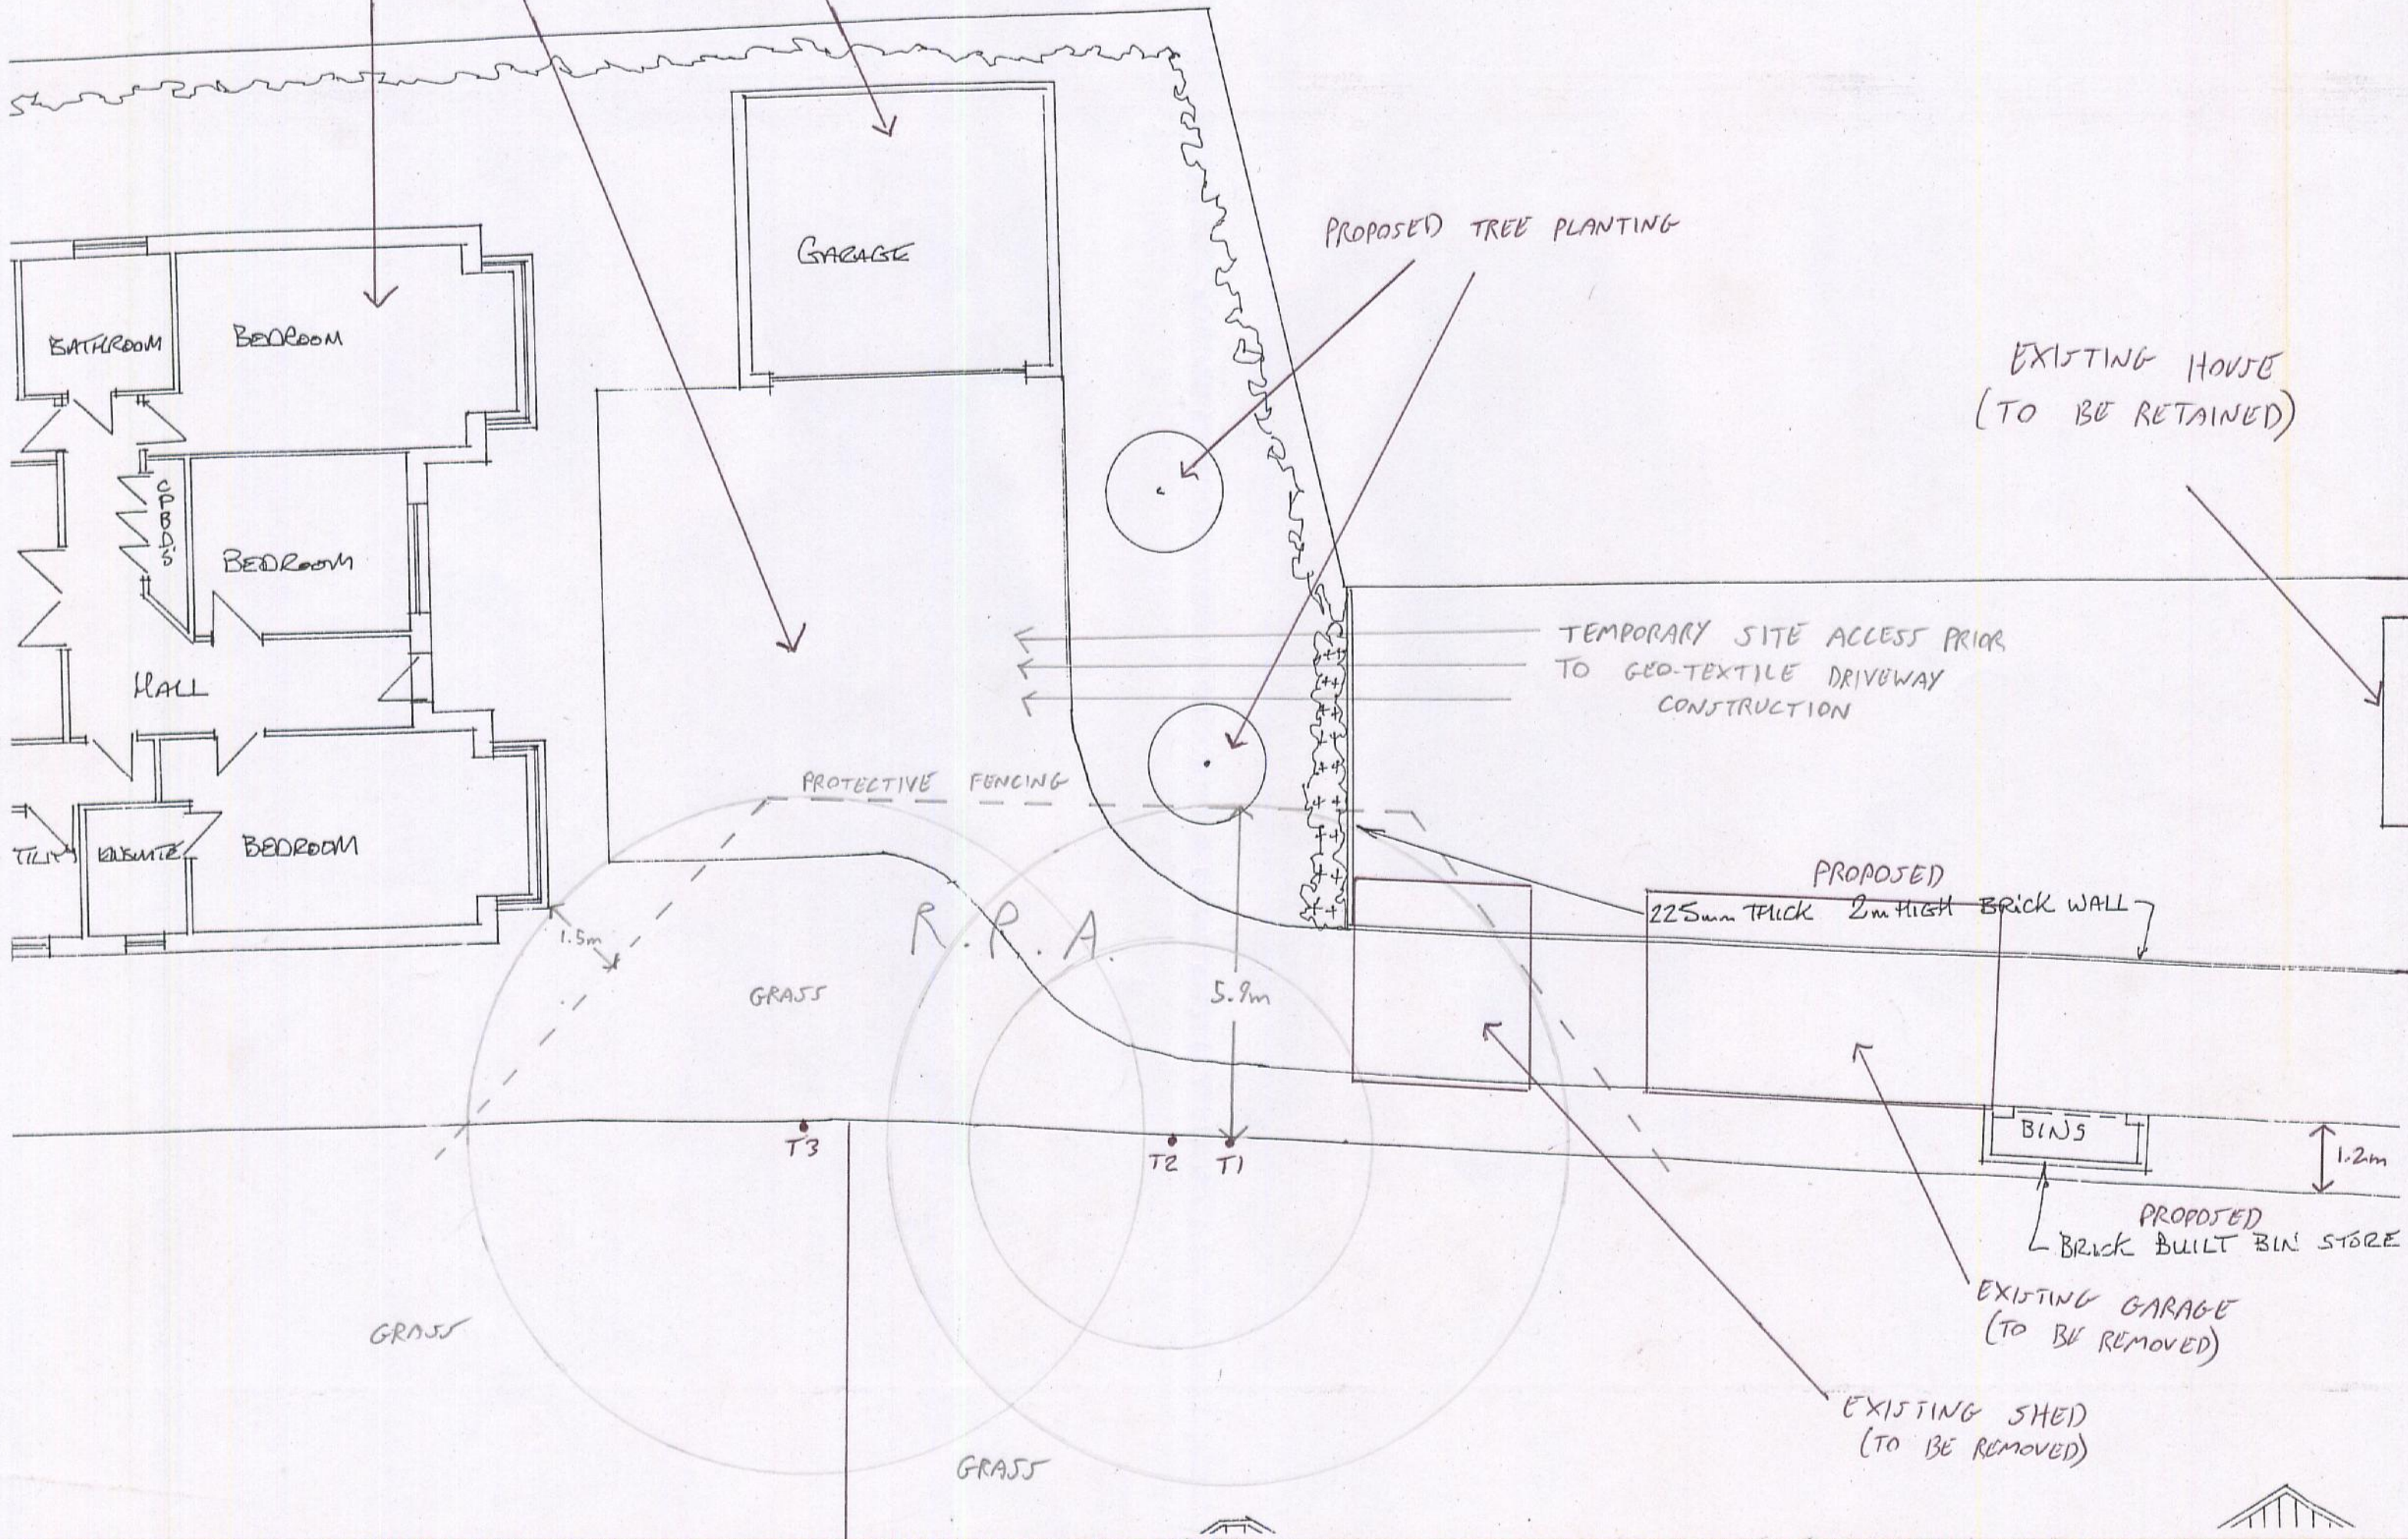
PROPOSED NEW BUILDS, HOUSE, GARAGE AND DRIVEWAY ACCESS

There is a high risk of damage to the rooting zone by compaction of soil due to heavy construction machinery.

There is a risk of damage to the rooting zone during excavation for foundations and driveway.

Restricted rooting area due to existing garage and laying of hard surface for proposed new driveway.

Erection and maintenance of protective fencing to the RPA (Root Protection Area) as per BS5837 (2005). This protective fencing is to remain in place and unmoved for the duration of the works. No materials or machinery are to be stored in this area for the duration of the works.

A no dig method is to be adopted during the construction of the driveway access, employing the use of an air spade/lance to ensure roots are not damaged in this process.

It is not recommended that the proposed 2m high brick wall is constructed as the footing will encroach into the r.p.a. Fence post and panels should be used as a less invasive alternative (this has been agreed with the builder and architect, and will be implemented instead of the brick wall currently shown on the enclosed plan.)
