Former Brickworks, Star Lane, Great Wakering

Ground Conditions and Contamination Assessment

E11997/1 - December 2006

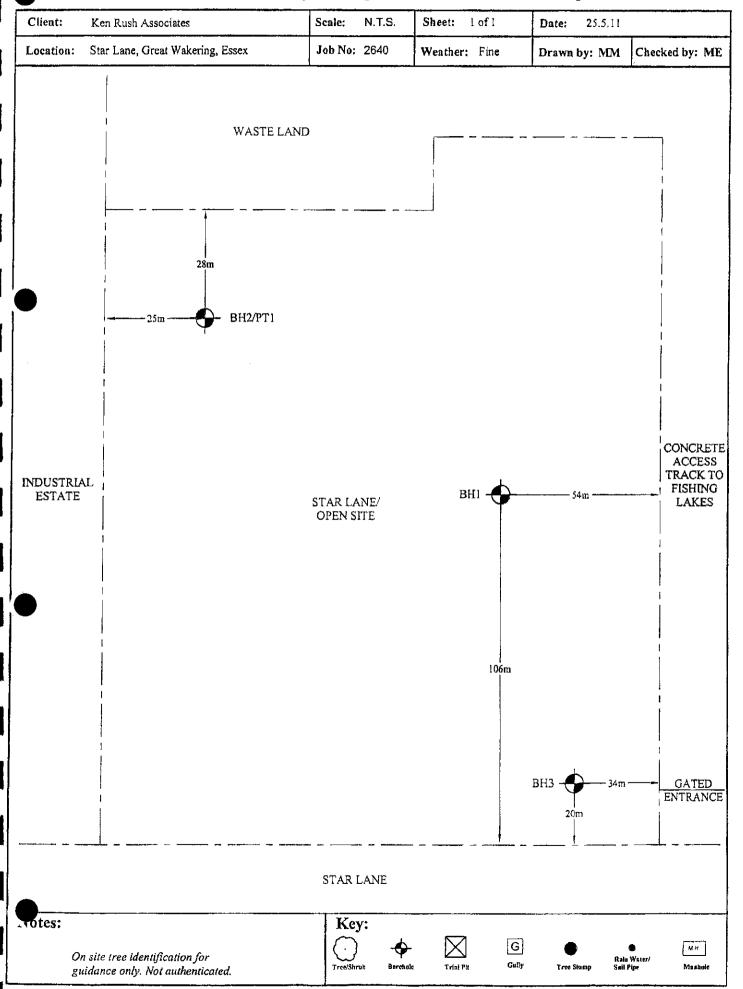
Client		Scale:	N.T.S.	Sheet No		Weather	· Fine	Date: 2'	
Site:	Star Lane, Great Wakering, Essex	Job No		Borehold		Boring m		<u> </u>	
Depth Mtrs.	Description of Strata	Thick- ness		Sample	Test Type Re	<u> </u>	Root Information	Depth to Water	Depth Mtrs
G.L.	MADE GROUND: medium compact mid brown silty clay with numerous brick fragments and gravel. (Tar/fluid present in samples).	1.2		D			Hair and fibrous roots to 0.9m. No roots observed below 0.9m.	Water	0.5
	Stiff moist mid brown sandy very silty CLAY thickly laminated with brown silt and fine sand.	1.6	×	D D	150 SPT 05, 03, N = 16				2.0

2.8		-	×*	D					2.5
3.8	Medium dense moist mid brown clayey silty fine SAND.	1.0	× × × × × × × × × × × × × × × × × × ×	D D	150 CPT 11,05, N = 20	I		3.7	3.0
	Medium dense wet mid brown silty fine and medium SAND with numerous fine gravel.	1.0	X X X X X X X X X X X X X X X X X X X	D D					4.5

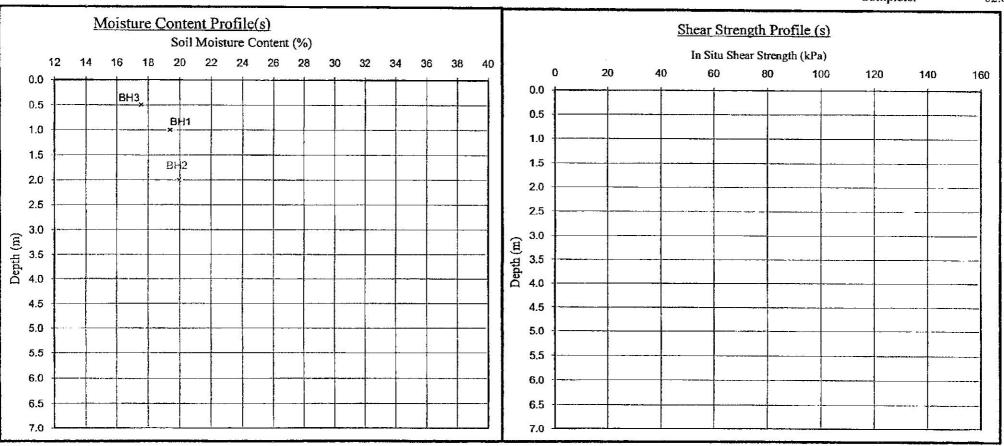
1. If the Soil Fraction > 0.425mm exceeds 5% the Equivalent Moisture Content of the remainder (calculated in accordance with BS 1377: Part 2: 1990, cl.3.2.4 note 1) is also plotted and the alternative profile additionally shown as an appropriately coloured broken line.

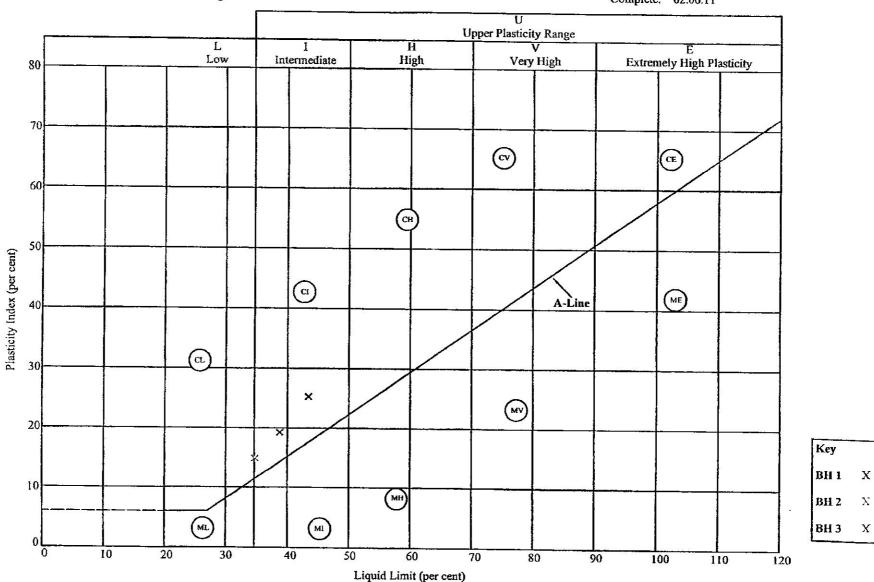
Plasticity Chart for the classification of fine soils and the finer part of coarse soils.

SILT (M-SOIL), M, plots below A-Line CLAY. C, plots above A-Line
