Former Brickworks, Star Lane, Great Wakering

Ground Conditions and Contamination Assessment

DTS RAEBURN Limited were commissioned by Stirling Maynard and Partners on behalf of JG Great Wakering LLP and Anglo Irish Asset Finance Plc, to carry out a geo-environmental desk study for a site at Star Lane, Great Wakering, Essex. It is understood that the site is to be redeveloped into residential houses. The desk study is required to provide information regarding the past usage of the site and likely ground conditions, and also to highlight any associated ground contamination and geotechnical risks.

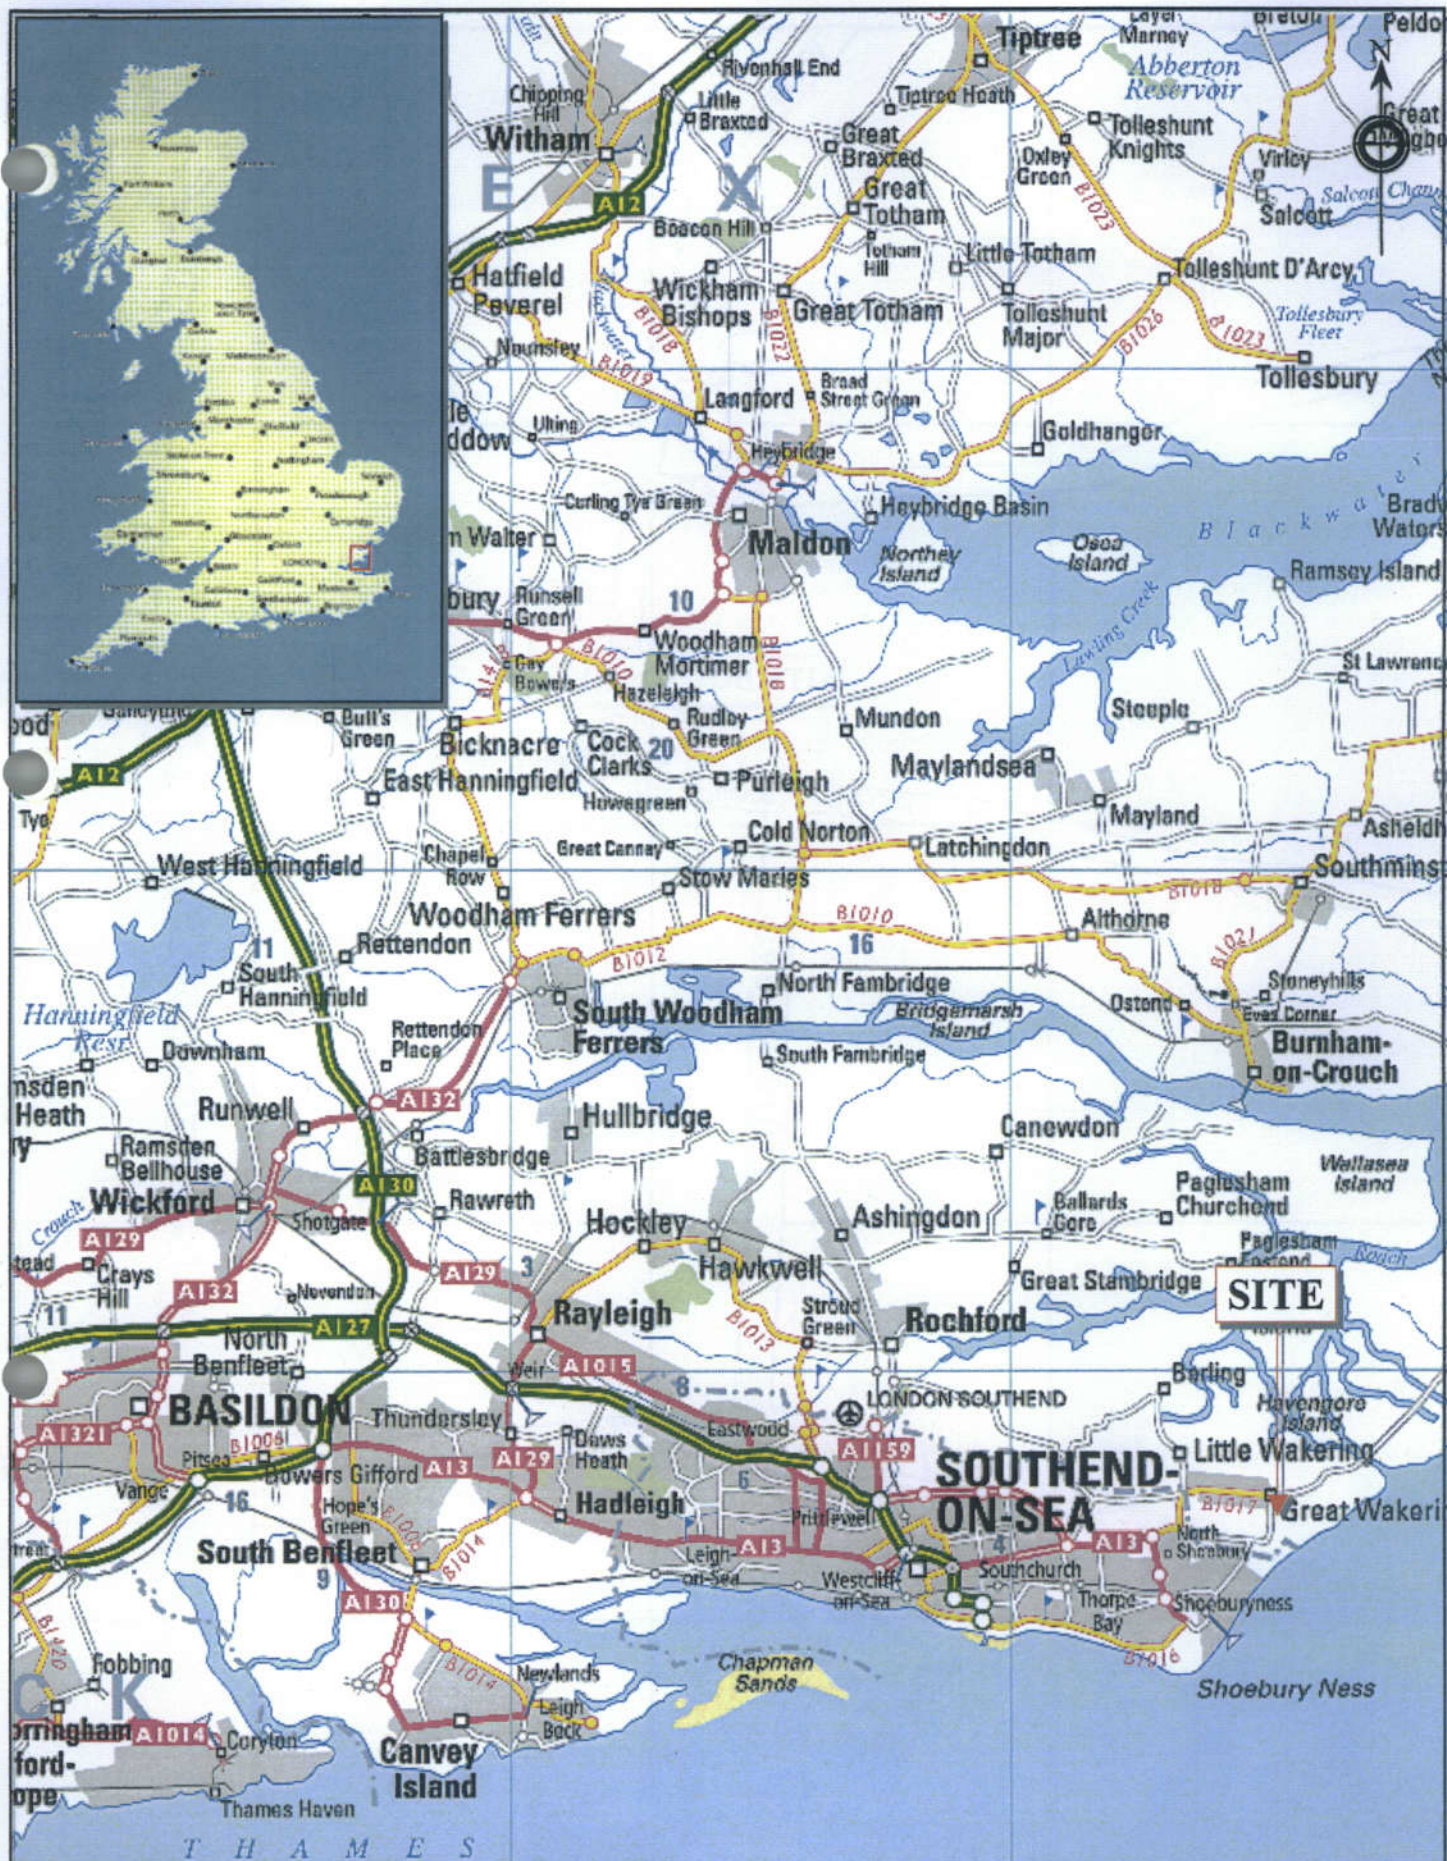
FIGURE 1

Site Location Plan
Scale 1:200,000
