Barrington's Cottages, Hockley Road, Rayleigh, Essex SS6 8BA
Description and analysis of the former cottages now shop. Surveyed 09 08 2014.

This report describes and analyses the buildings that comprise Barrington's Cottages, whose last use was as a shop called Eskimowear selling ski equipment. The purpose of the report is to provide an archaeological record of its present condition before conversion into a restaurant.

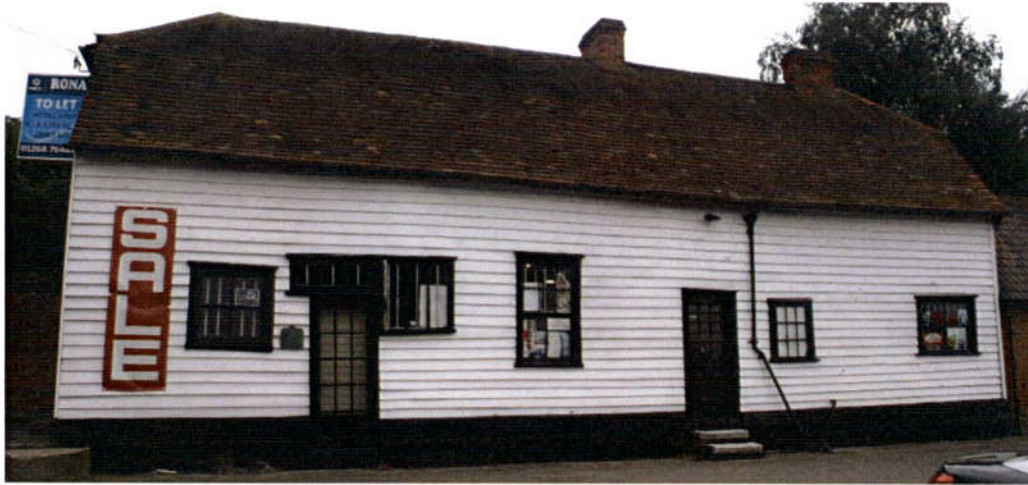
The southern elevation of the timber framed house.

The range of buildings comprises of a two storey timber-framed house divided into two dwellings and a conjoined brick built single storey stable building that has a clear division of C19th and LC20th brickwork under a continuous C20th single roman tiled roof.

The house has a plain clay roof; half hipped at each end with two C19th brick chimney stacks and a weather-boarded timber frame. Most of the boards appear to be C19th, circular sawn and are secured with lost head nails. The modern bandsawn replacements have French nails.

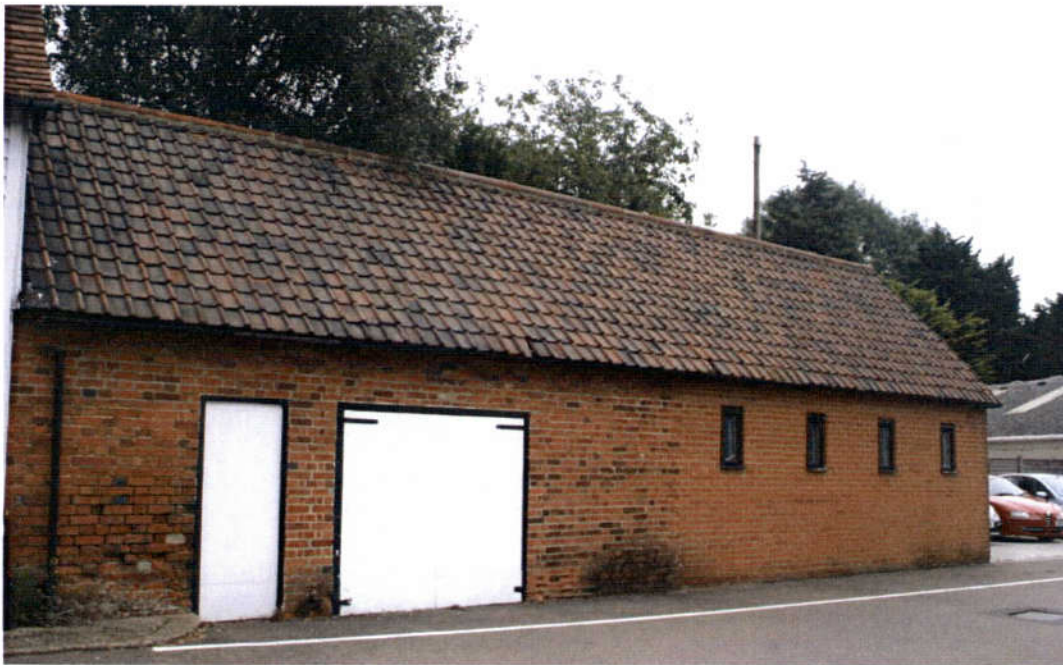
The southern elevation of the former stables and LC20th extension.

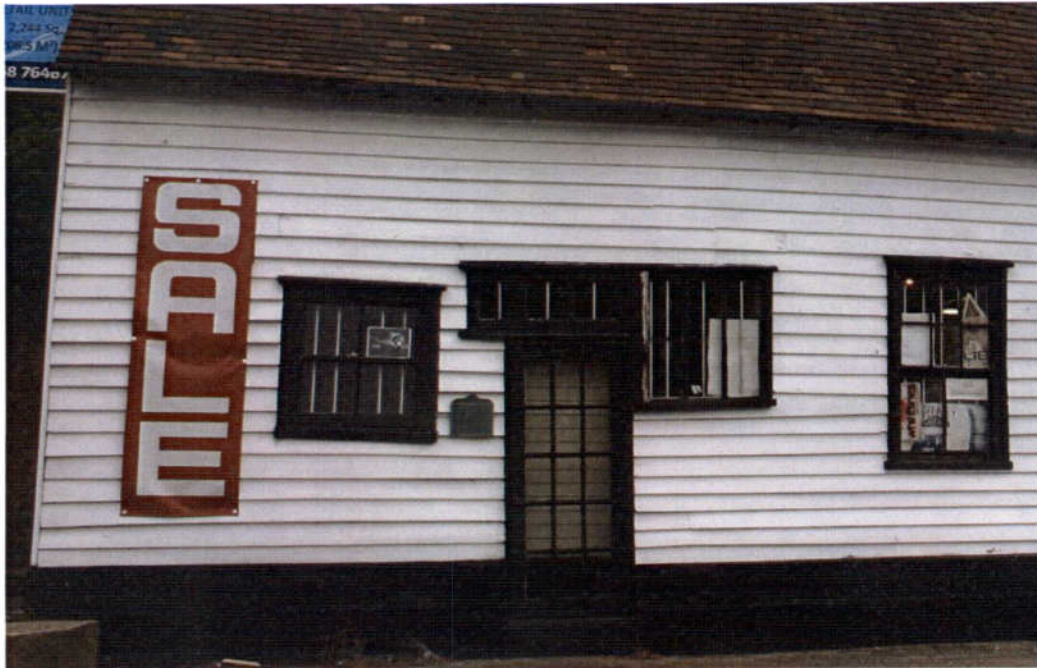
The awkward windows suggest an industrial use at some point.

The windows are awkwardly inserted without a thought to symmetry and appear to be LC19th. There is a 2/2 pane horned sash, a 6/6 pane horned sash, a 3 light fixed casement with butted glass (like greenhouse glass), a 9 pane casement and a sash window put on its side. Usually this implies that the cottages were used as workshops as well as accommodation and the randomly placed windows are to light machinery that used to be inside.

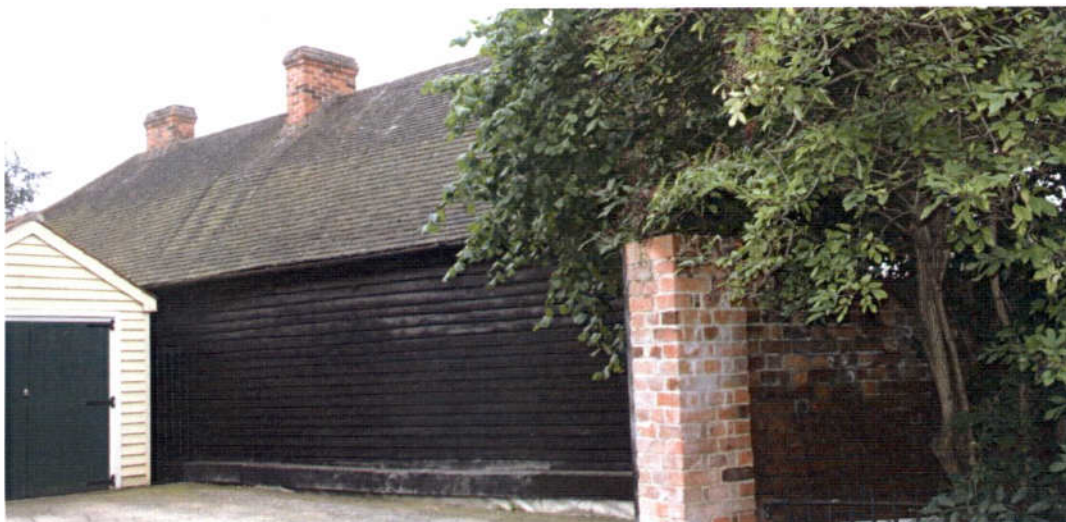
The northern elevation has been boarded over.

The northern elevation is largely inaccessible. The frame has been weather-boarded in the LC20th and inside there is membrane to confirm this period of works.

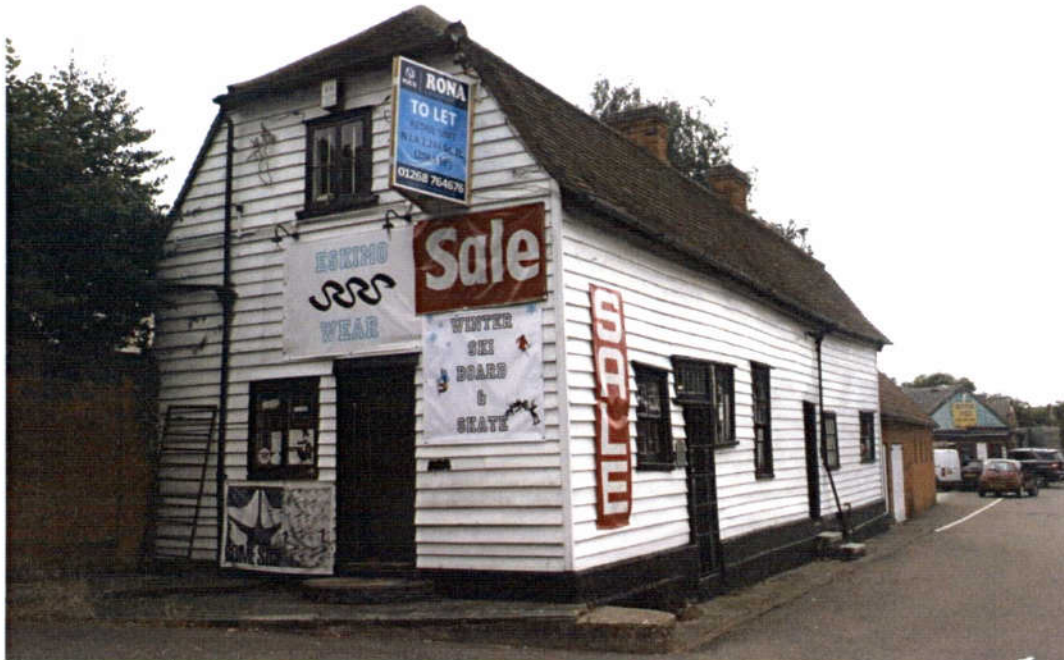
The western elevation is now the main entrance.

The western elevation is currently the main entrance, the other doors being bolted shut with security bars. All the doors are LC20th fully glazed shop doors. The windows are both C20th casements.

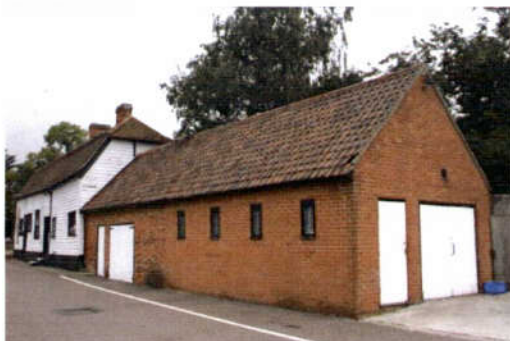
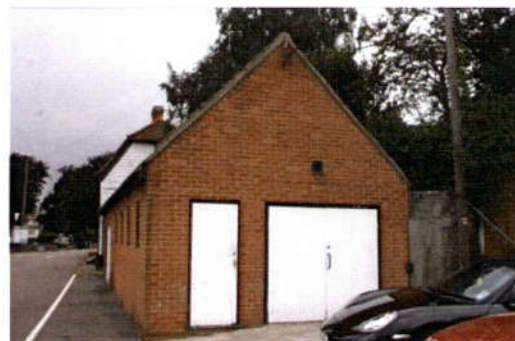
The brick range is clearly divided by the change in brickwork.

The eastern elevation has a modern brick gable of cement laid bricks. The two doorways have LC20th timber doors which match a similar pair on the southern elevation.

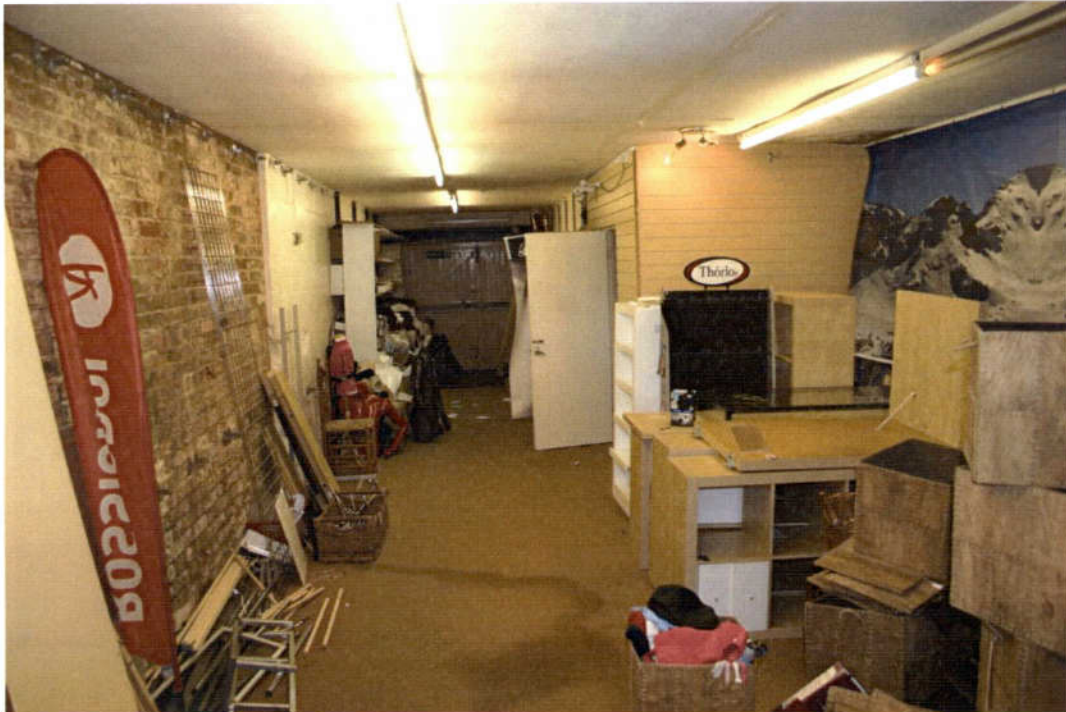
Looking E inside the brick range. Note the exposed brickwork.

The brick range opens into one room with a lightweight modern partition put in to form a small workshop for repairing and setting up skis. The modern extension is clearly demarcated with LC20th Celcon block cavity walls. The older walls are divided into two phases of brickwork.

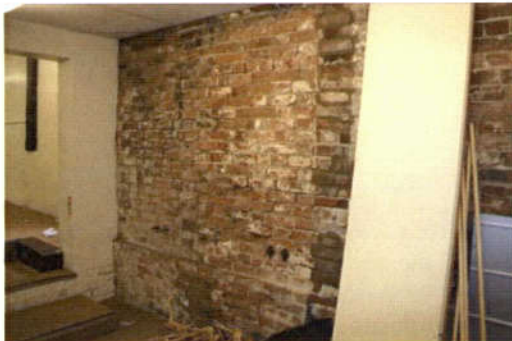
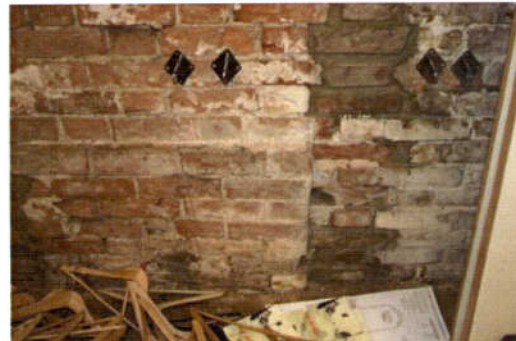
Two phases of brickwork in the north wall. Note the plinth and the wall scar.

The first build has orange 70x110x225-230mm handmade bricks set in lime mortar and laid in Flemish bond with a protruding plinth of at least 8 courses which terminates by a modern wall scar repointed in grey cement. The second build to the east has darker, larger bricks of 70x110x230-235mm with no plinth.

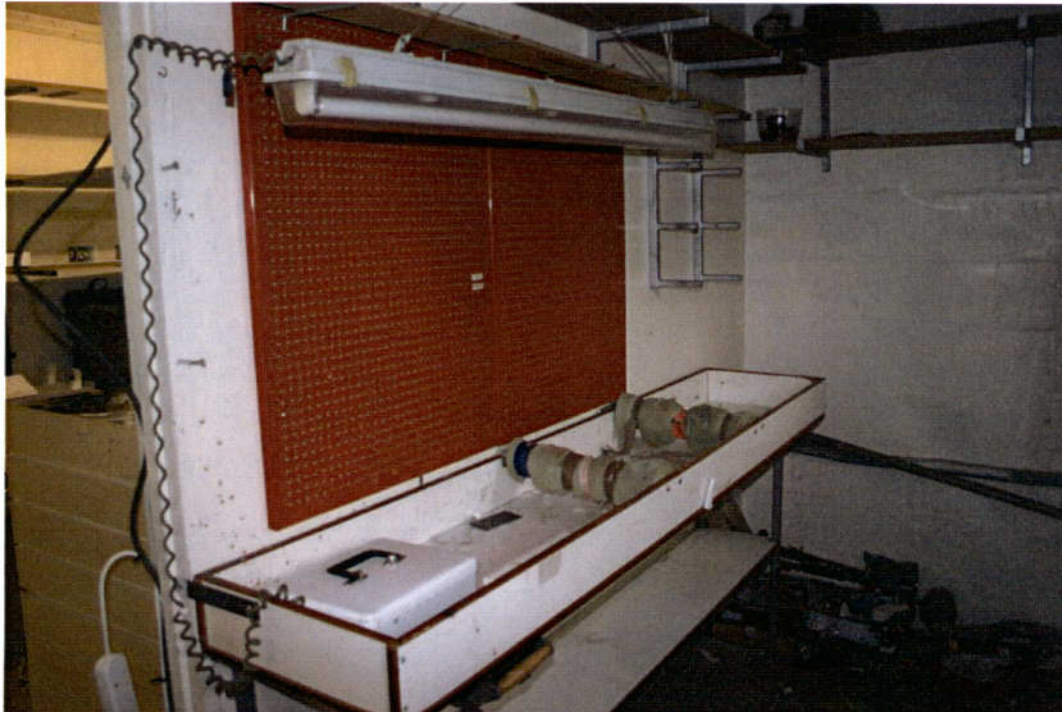
Looking NE inside the workshop. The bench was for waxing and repairing skis.

The brick range is outfitted with recent shop fittings, the floor is carpeted but feels like concrete. The ceiling is boarded and the walls covered, in part, with recent horizontal weight bearing display cladding.

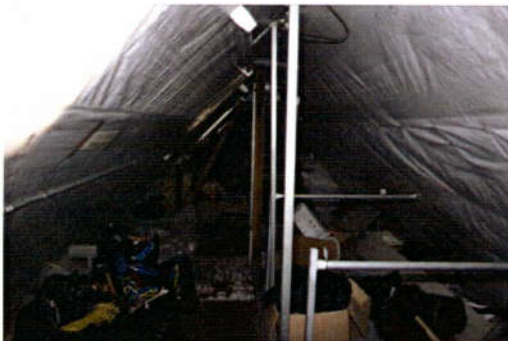
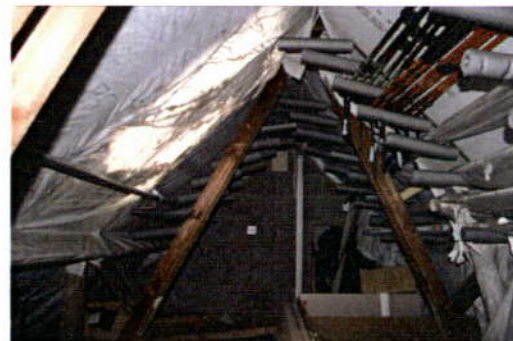
Looking E into the roofspace of the brick range.

The roof of the brick range is entirely LC20th and has composite lightweight softwood trusses, 2x4in softwood rafters with a membrane beneath the tiles. Inside has been lined for insulation and a large number of racks installed to store skis and clothing. The roof has four lights on the northern side which shows as bright spots in the photographs.

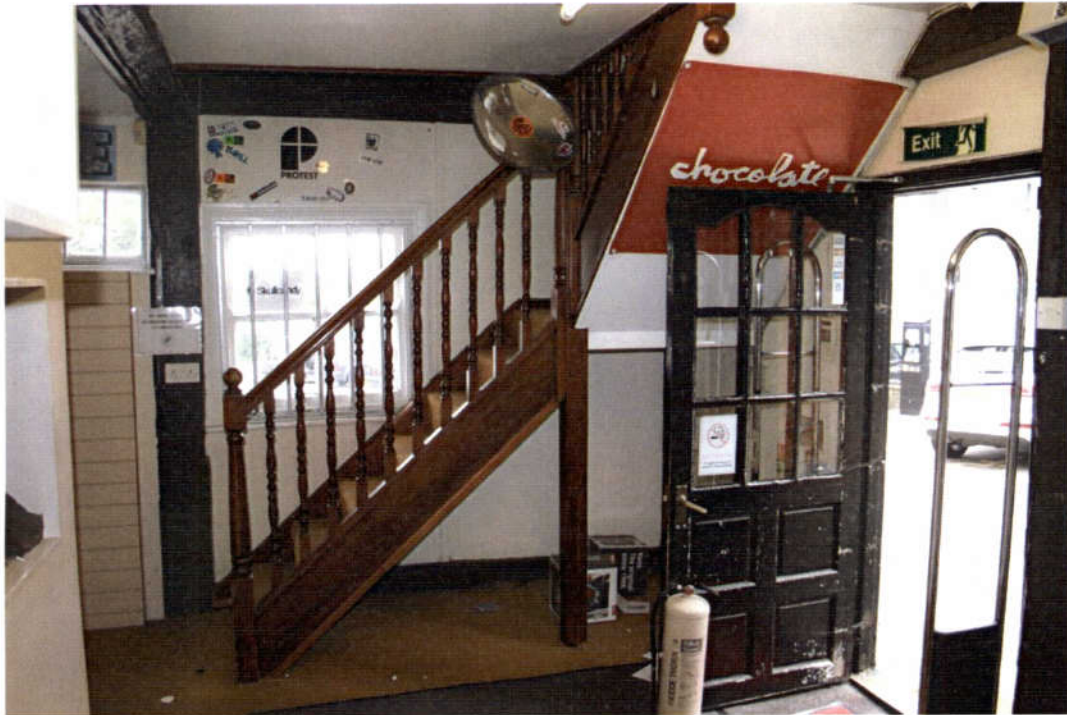
The main entrance to the shop. Looking S.

The shop is divided into bays by the storey posts and two of the earlier timber-framed partitions survive. In the reception room there is an ugly LC20th timber staircase with Victorian style turned from square newel posts and spindles.

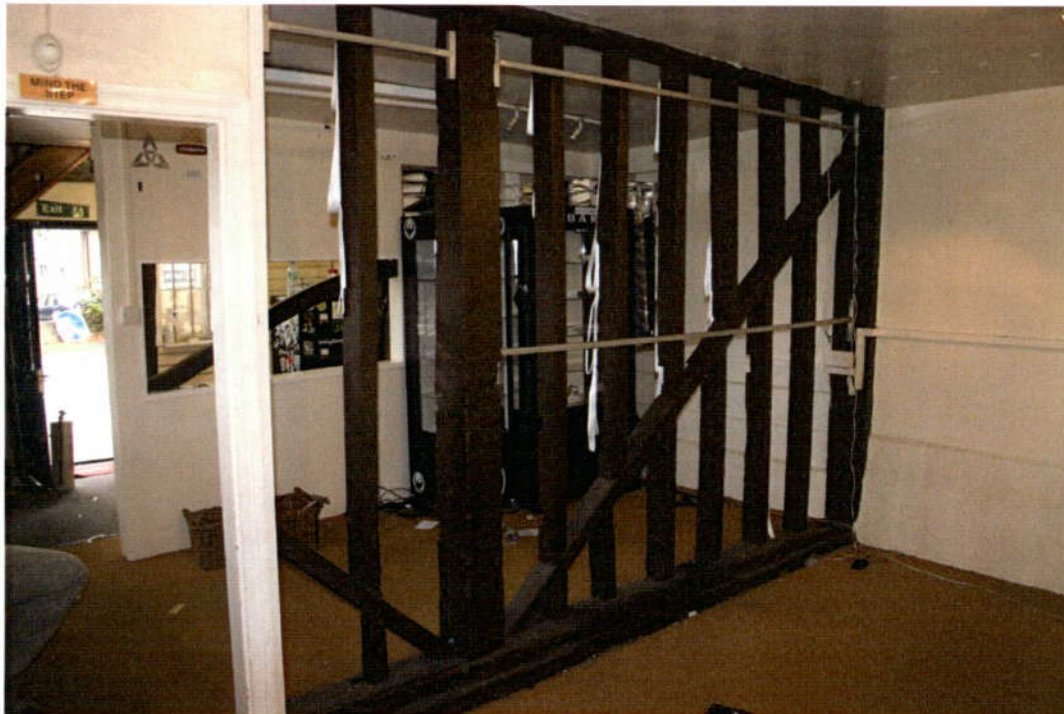
C19th partition of pitsawn timber.

There is one fully exposed partition assembly of the C18th or EC19th. The structure has primary braces with nailed interrupted studwork. The timbers are pitsawn and the nails are rose headed wrought iron nails. The joints have assembly marks cut with a race knife and there is also a rebate that passes across four studs for a later fitment. The studs are 2.5x4.25in in section and the central post is 7x7in.

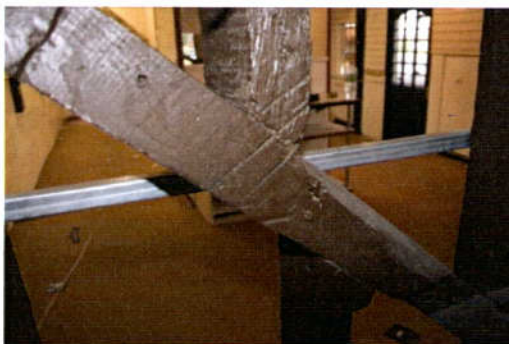
Carpenters assembly marks.

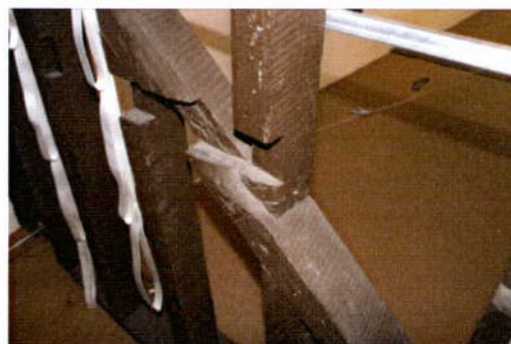
Pitsaw marks on the surfaces of the timbers.

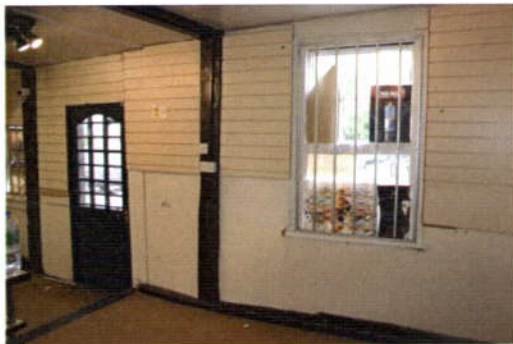
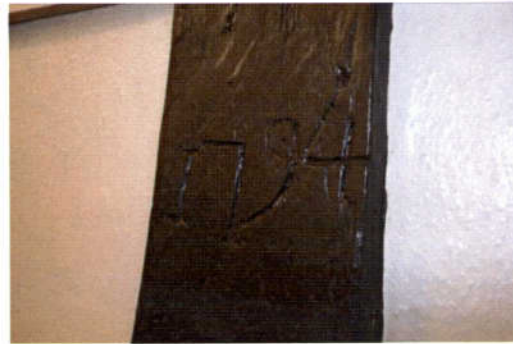
There is a date of 1794 carved in the storey post between the southern doors.

Dates have to be treated with caution but in this case the style of typography and the date itself fit well with a phase of alterations in that period. The storey posts and mid-rails appear much older than the C18th and it is likely they were reused in a refit in 1794. There are other details upstairs that support this date.

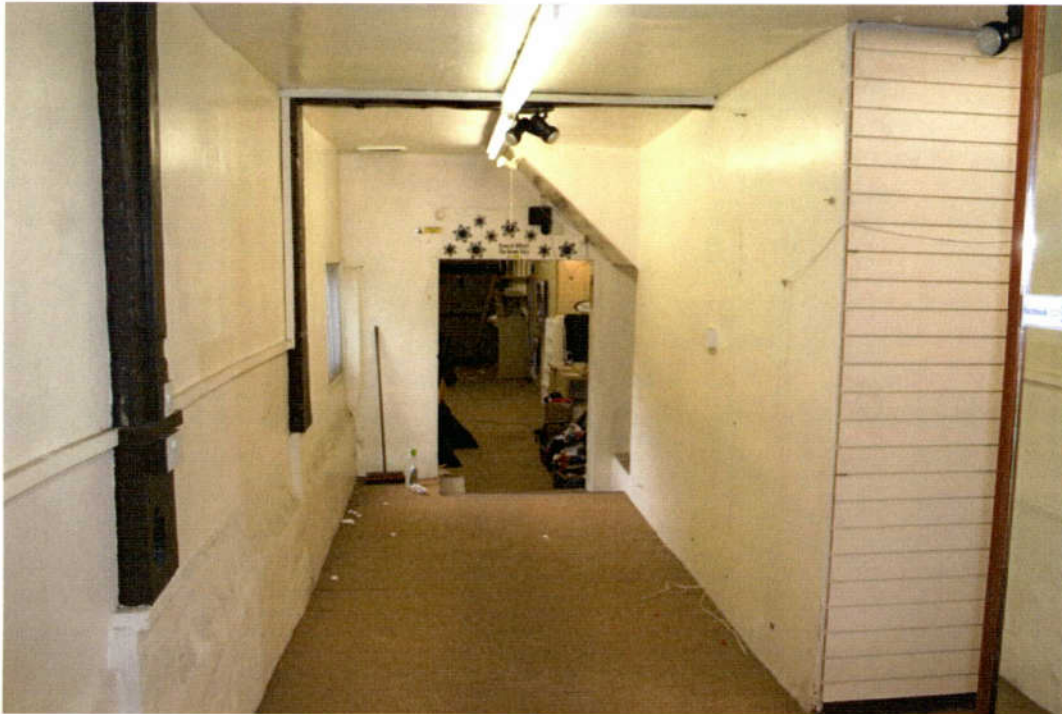
Looking E inside the house. The staircase and shop fittings are recent.

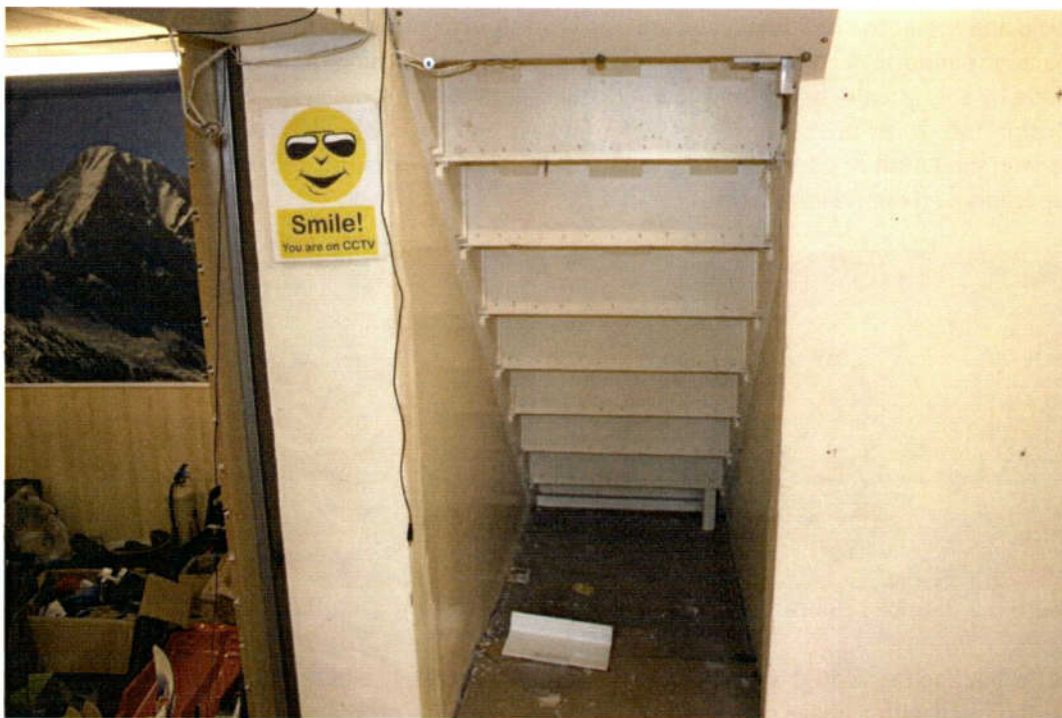
The underside of the second staircase.

There is a second staircase at the eastern end of the house that gives access to the upper floor and the roofspace above the brick range. This is LC20th and can be attributed to the 1980's period of renovation.

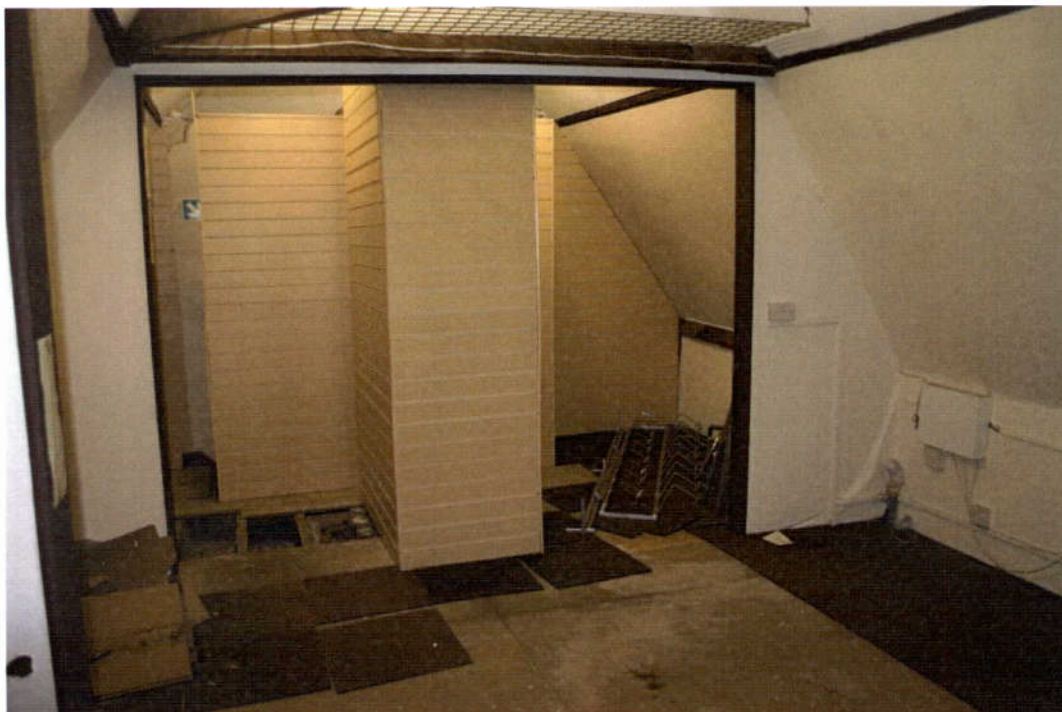
Upstairs looking towards the eastern staircase and chimney stack.

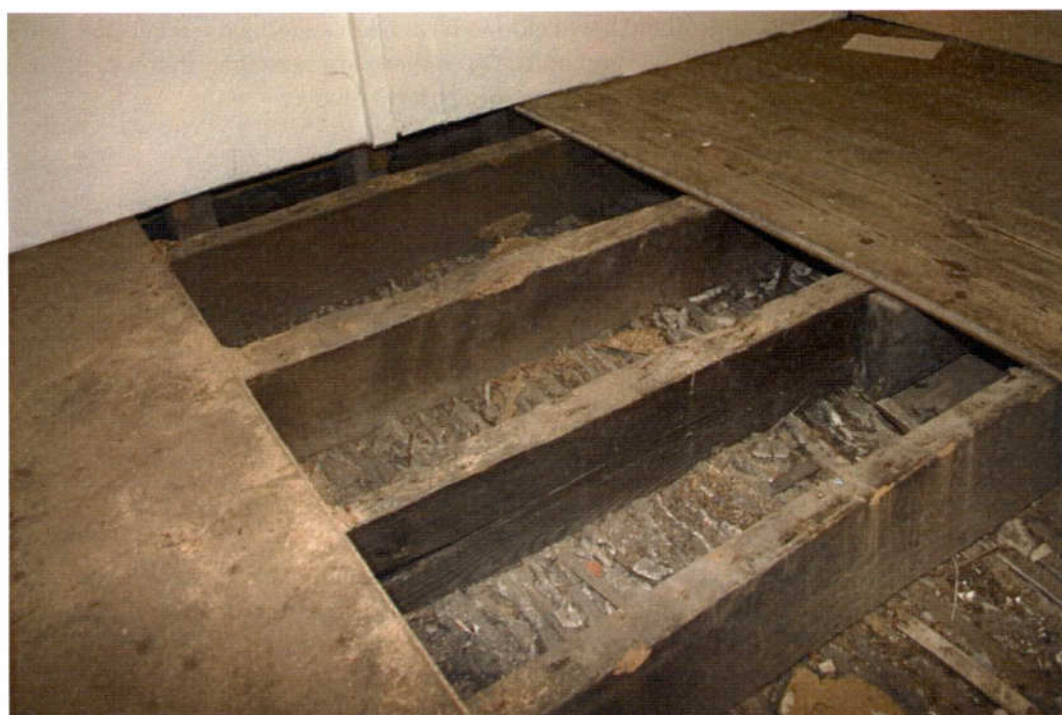
A section of exposed flooring at the top of the eastern staircase.

Upstairs the floorboards were lifted showing that the floor was made of 2.5, 2.0 and 3.0 in wide joists all 6in deep. There is a combination of machine sawn and pitsawn elm and softwood timbers set at 11in to 15in centres. Also here the external wall frame can be seen to be made of 3x5in machined studs.

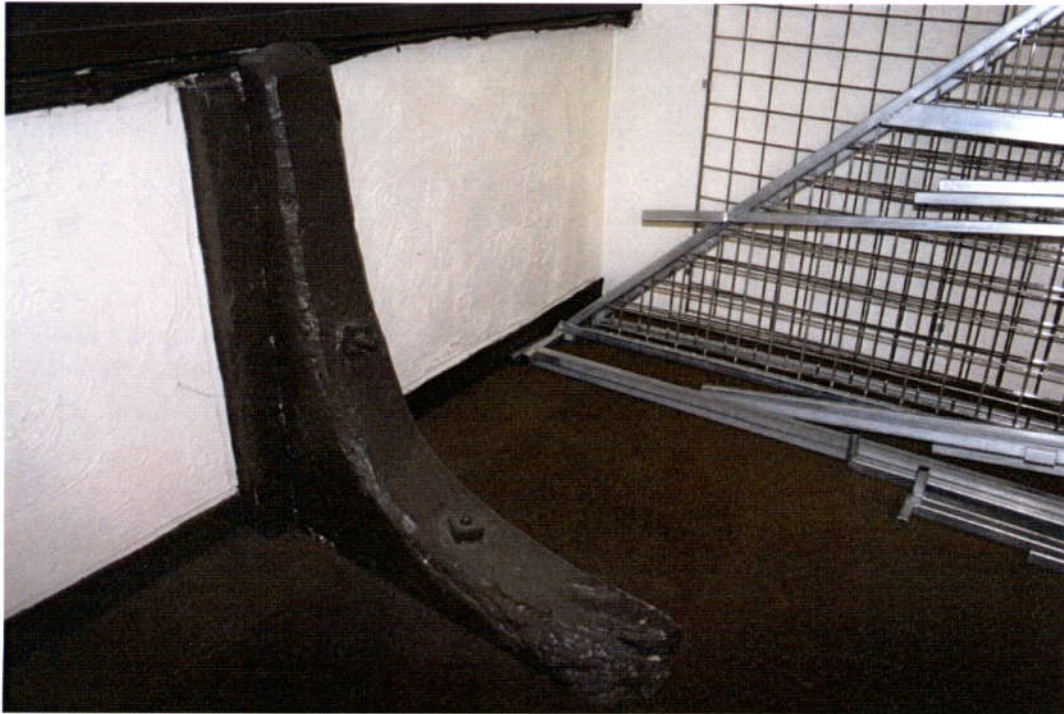
Bolted in elbows were used to strengthen the frame.

On some of the storey posts large, hand hewn elbows have been added, bolted in place with large wrought iron, square headed nuts and bolts. Often these are seen the other way up, as hanging knees. It is a feature of haylofts and granaries to have elbows.

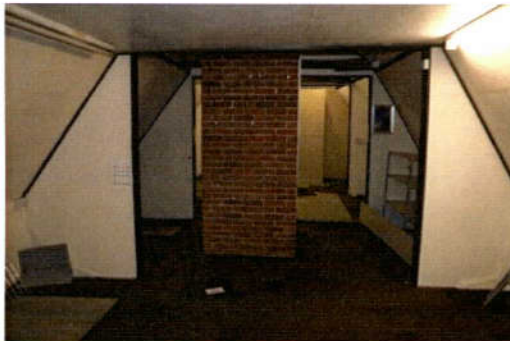
The central firestack looking E.

There are two chimney stacks in the house and both can be seen upstairs. The centrally placed one is built from 65x105x225mm red bricks with creased but smooth faces, softish arrises and horizontal pressure lines. They are set in a hard white mortar. The chimney is corbelled near the apex and this may have been done to avoid a large timber in the roof or more likely to improve the draw on the stack. It is a common feature in C19th chimney stacks. An X has been carved on one of the bricks but it is unlikely to be an apotropaic mark.

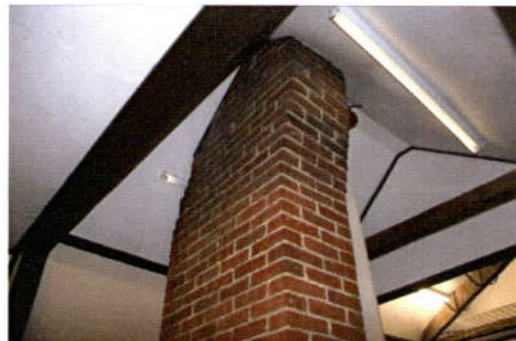
The chimney stack curves near the apex.

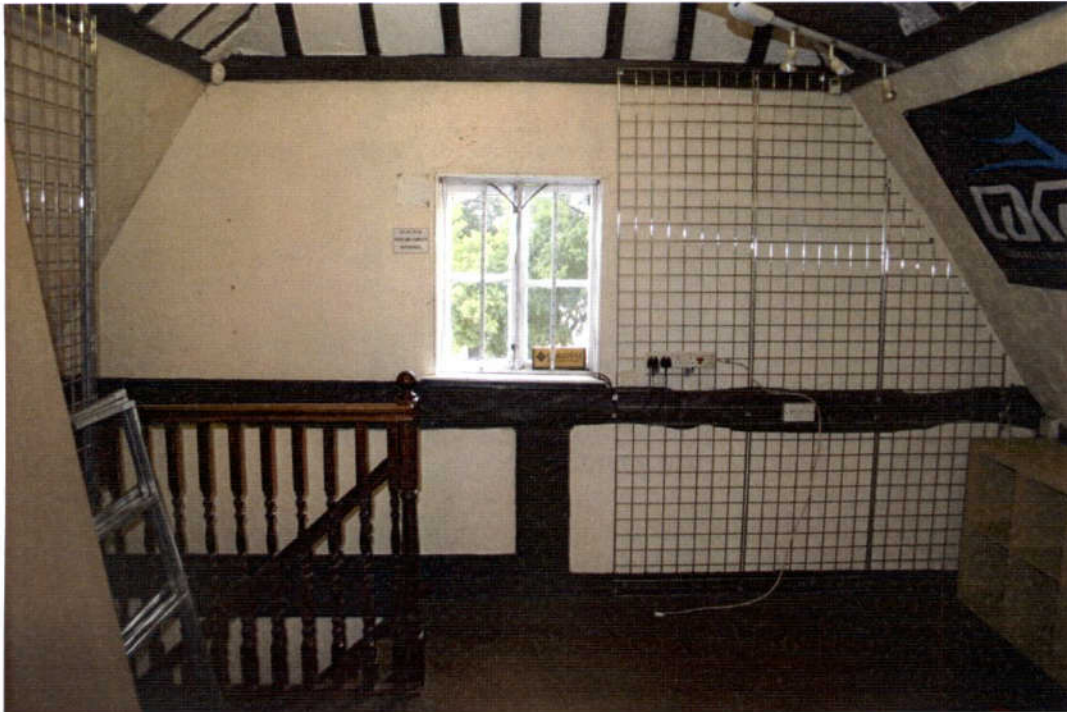
The timber frame in the western wall of the house.

The corner posts, storey posts and tie-beams come from a much older frame than the rest of the house and have been dressed with adzes to their current shapes. The tie-beam in the western wall has a slight upwards camber and remains of a chamfer. The other main timbers are also chamfered. It is highly likely an older frame was re-used to build the house.

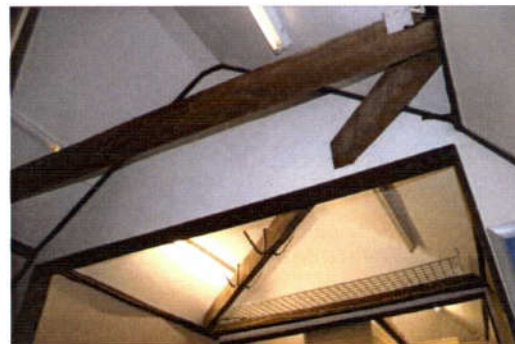
The hipped roof at the western end.

Modern roof bracing in the centre of the house.

All of the visible roof structure is LC20th, made from 2x4in sawn softwood. Some appear distressed but all have bandsaw marks. There are added diagonal braces that are essentially bandsawn softwood planks.

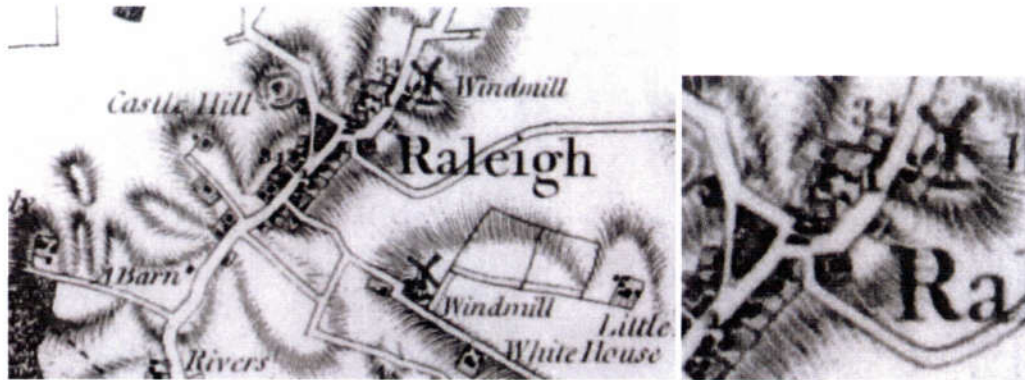
1777 Map of Essex by Chapman and Andre.

The map of Chapman and Andre does not appear to show the cottages as they are today. Rayleigh House (Barrington's predecessor) is next to the R of Raleigh.

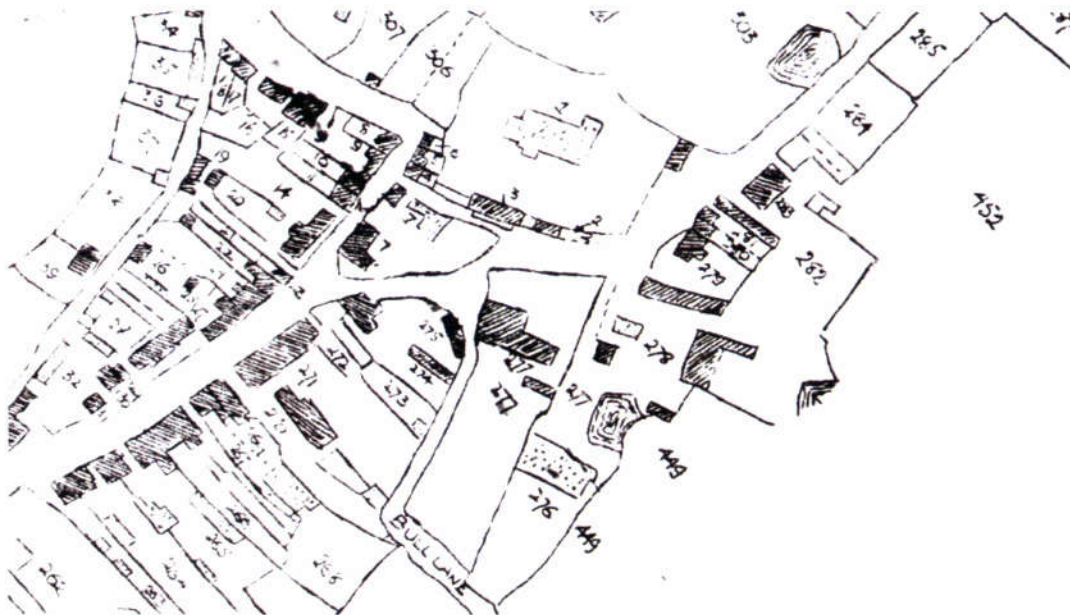
1840 Tithe Award Map. ERO D/CT 285B. Scaled up transcription, reoriented to N.

By comparing the 1777 map of Chapman and Andre to that of the 1840 Tithe Award it can be seen that there was a house on the plot 277 of Barringtons but not in the same place. In the Tithe Award the plot is referred to as Rayleigh Place belonging to Henry Cook and occupied by Jonas Asplin. Plot 276 is a House and Garden' belonging also to Henry Cook and occupied by John Byford. Henry Cook himself owns and occupied Plot 272 and he also owned Plot 274. Plot 278 which contains Barrington Cottages is described as 'House, Yards etc' owned and occupied by Daniel Watts. Plot 279 is a 'House and Garden' belonging to Mary Ford and occupied by herself and Frederick Boston.

At this point in time the site cannot be seen as an estate but rather a collection of disparate buildings under one ownership of which Barrington's Cottages is not a part.

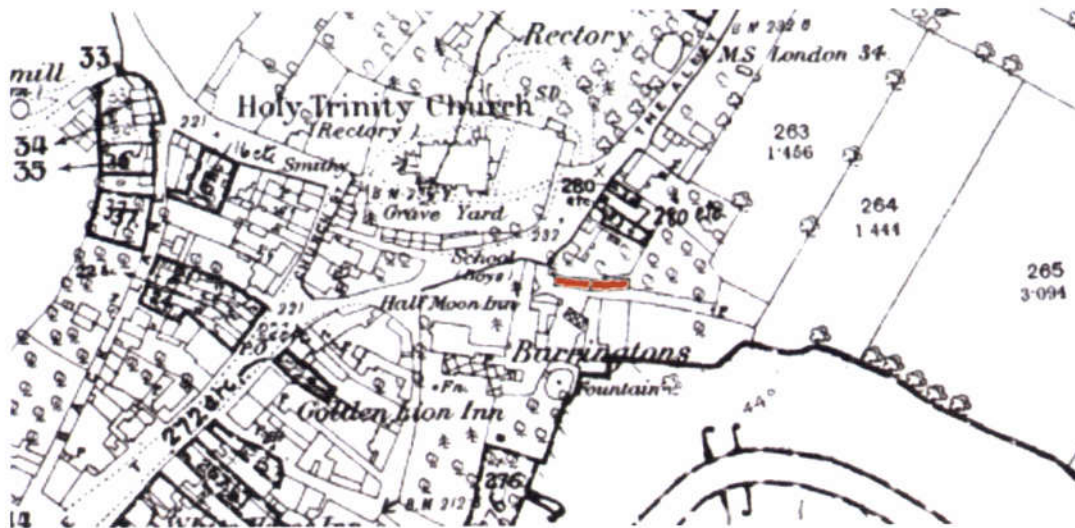
1874 First Edition Ordnance Survey.

By 1874 Barringtons has replaced Rayleigh House and is noted as a considerable estate with gardens, glasshouses and fountains. It is difficult to tell whether Barrington's Cottages are part of the estate.

In 1874 and 1897 Barrington's Cottages are shown as two buildings as they are today.

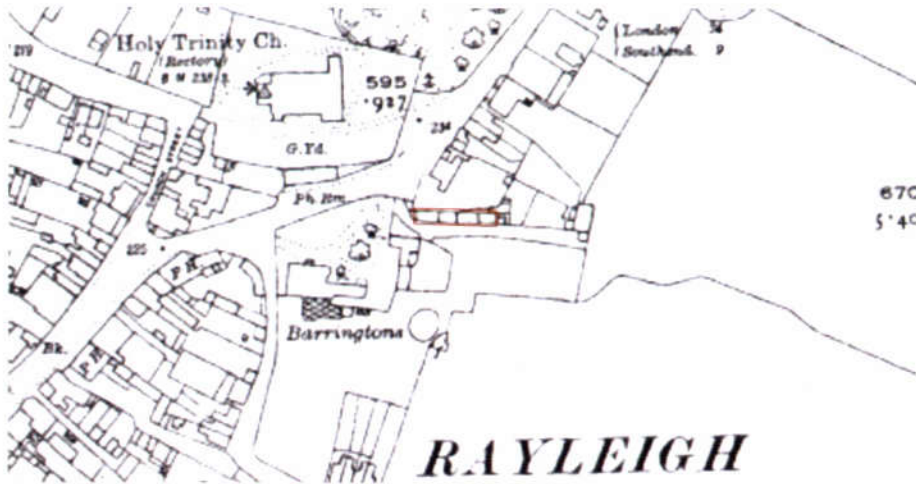
1923 Ordnance Survey

By 1923 Barrington's Cottages are shown divided into 4 units with additions to the eastern end. This subdivision remains at least in to the 1960's.
