**FAIRWAYS GARDEN CENTRE
HULLBRIDGE ROAD
RAYLEIGH
ESSEX SS6**

Photographic Record - Fairways Garden Centre, Hullbridge Road, Hullbridge

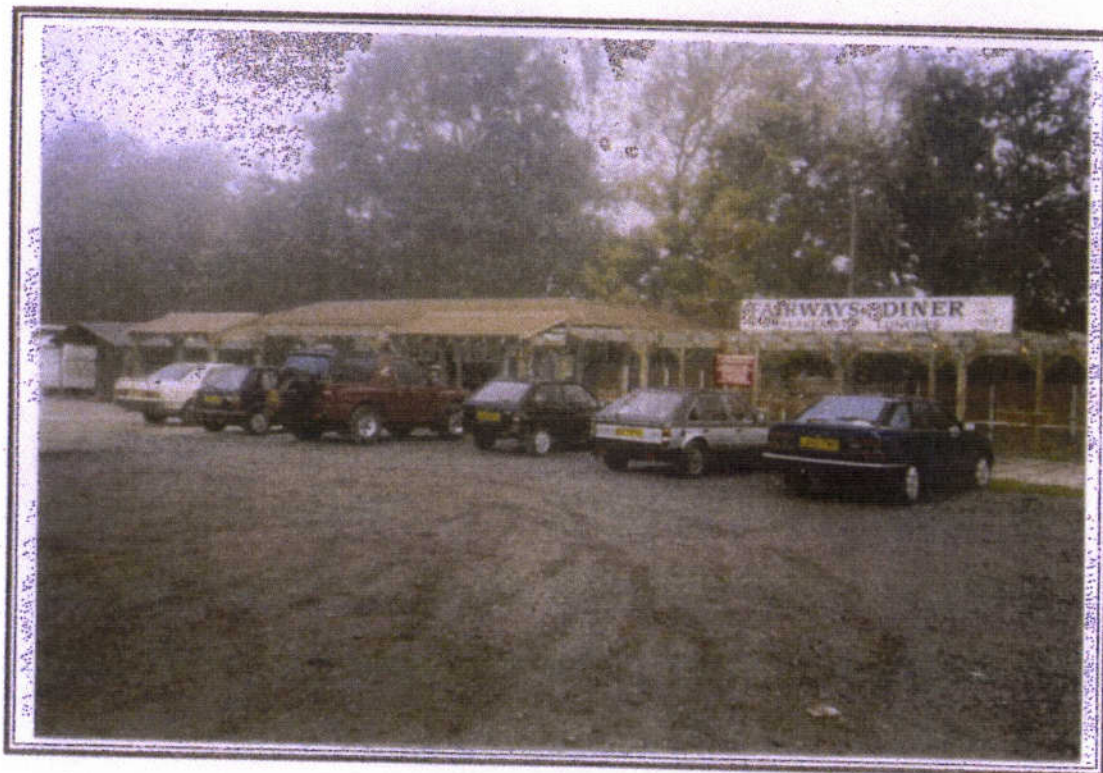
Diner

The cafe building has a pitched tiled roof upon a timber framework and is a timber framed structure clad with ply which has been rendered and incorporating exposed timber reliefs. The roofs to the building containing Units 2, 3 and 4 are part mono-pitched and covered with corrugated asbestos sheet and part cover with corrugated metal sheet. There are mono-pitched tiled front roofs. The external walls are partly of rendered block construction, part brick and part boarded. There is a mono-pitched tiled roof to the walkway running along the western elevation to the building. There is a timber framed display frontage to the retail unit.

The cafe building appears to have been in generally good order and has recently been improved by the addition of a canopied walkway.

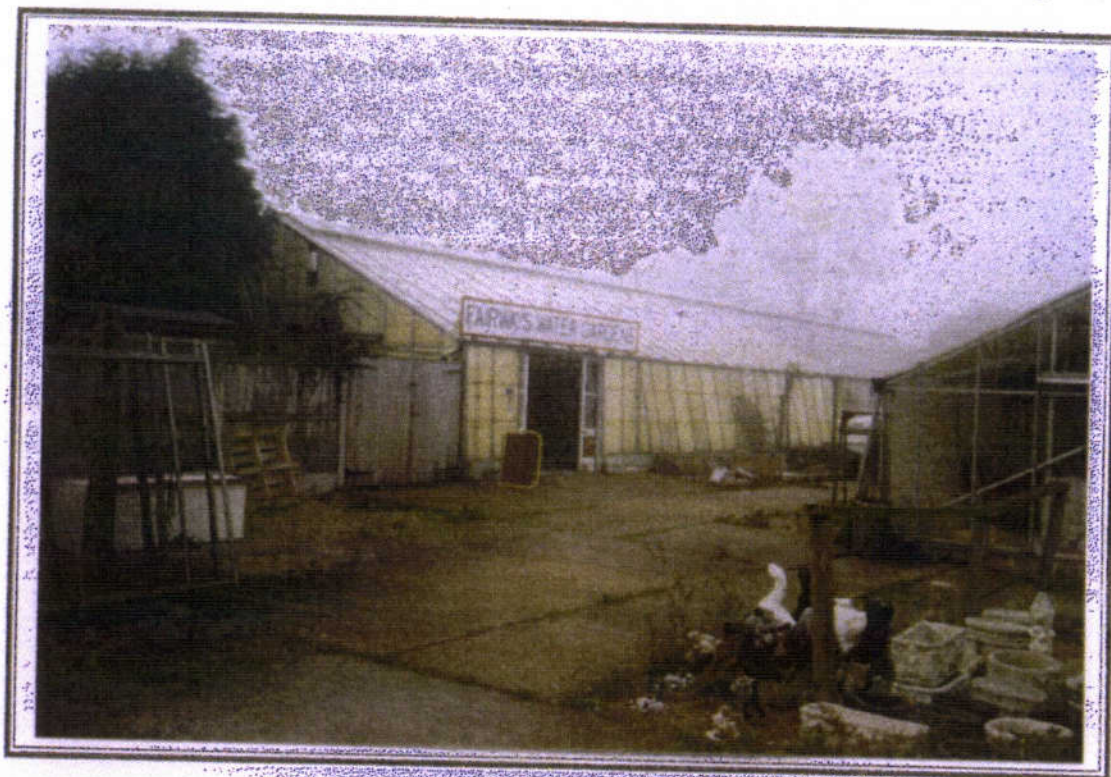
Aquatics Centre

Double greenhouse. The gross internal floor area is 562.12 sq m (6050 sq ft)

The greenhouses are aluminium framed and glazed.

The greenhouses appear to be in fair order although some maintenance is required where there is cracked, damaged and missing glazing.

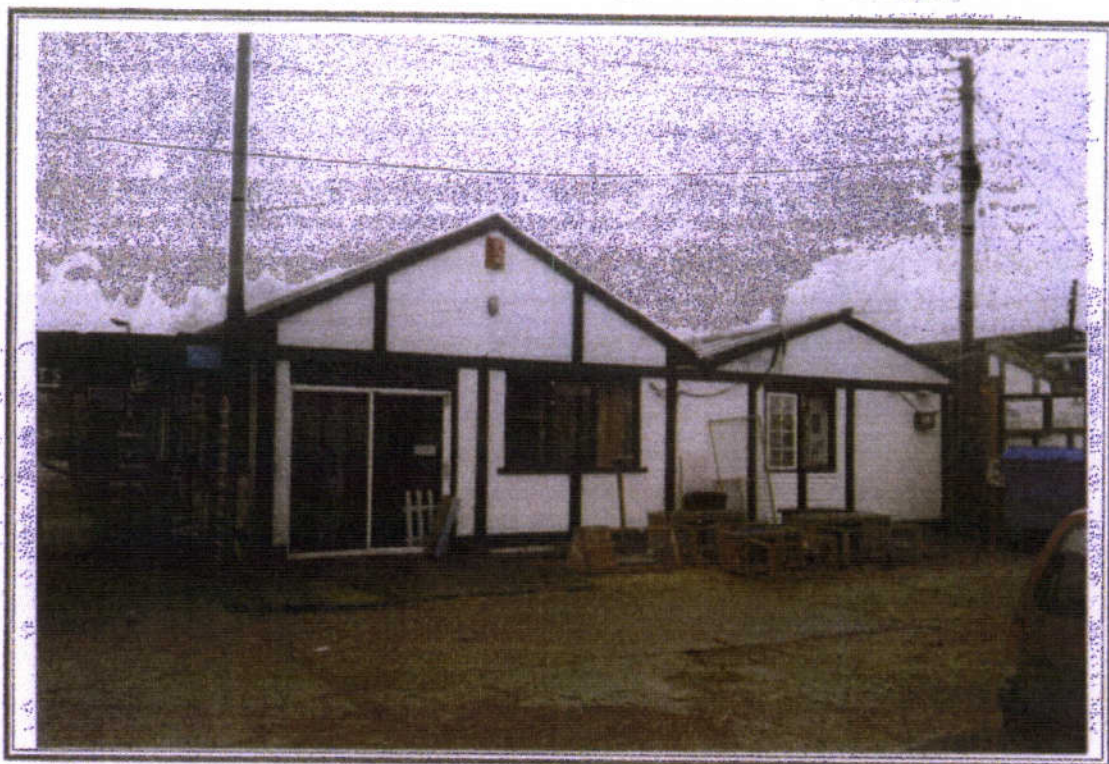
A retail unit at the front of a terrace of buildings. The gross internal floor area is 153.75 sq m (1655 sq ft). The demise includes garden land of approximately 1126 sq m (12,120 sq ft)

The roofs to Unit 5 are pitched and covered with felt laid on fibreboard and a timber framed structure. The external walls appear to be of part blockwork and part timber framed boarded cladding.

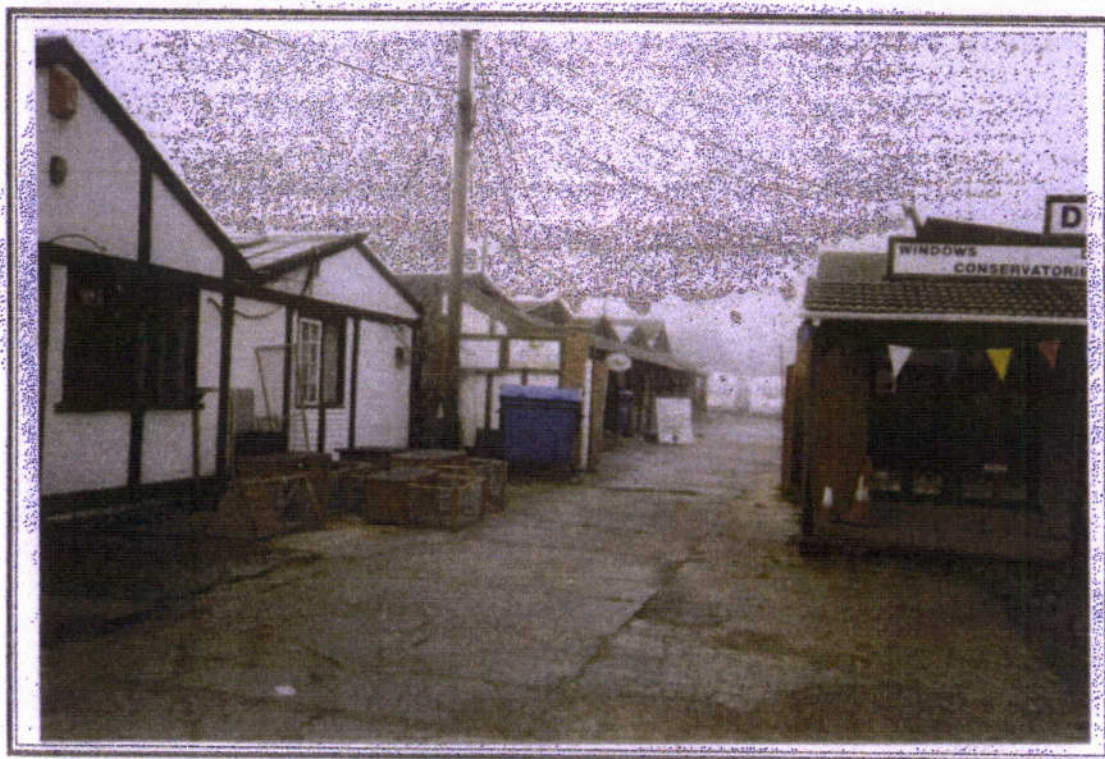
Units 6, 7, 8, 9 & 10

Multi let. Units 6/7/8 & 9 are terraced, Unit 10 is detached. The gross internal floor area is 448.50 sq m (4829 sq ft)

Unit 6, 7, 8 and 9 are of 'Belfast' design being clad with curved corrugated asbestos sheet with timber and blockwork front and rear elevations.

Unit 10 has a pitched ridged trafford tiled asbestos roof and the flank wall thereof is clad with corrugated asbestos sheet.
