# **Bat & Owl Survey of Apton Hall Rochford**

**e & m design partnership  
26/28 The Square  
West Street  
Rochford  
Essex  
SS4 1AJ**

**John Dobson B.Sc  
Essex Mammal Surveys**

**May 2015**

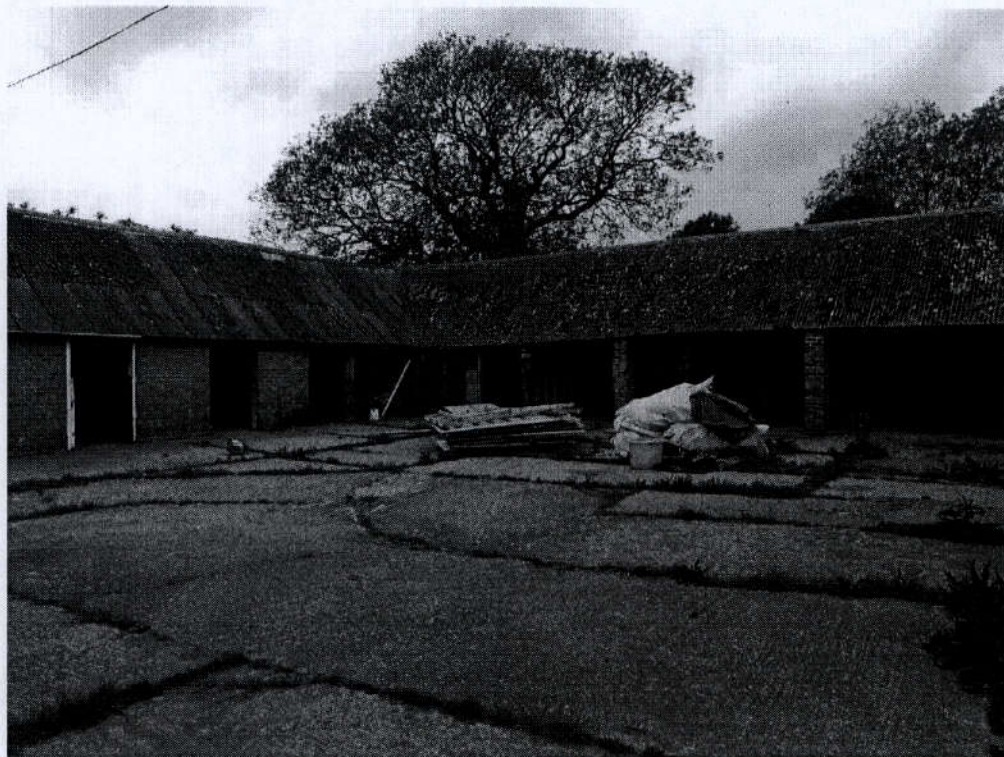
**Photo 1:** The buildings bordering the southern and western sides of the farm courtyard

These buildings border the northern, southern and western sides of the courtyard. Those to the south and west (see Photo 1) had a corrugated asbestos roof slope facing the courtyard, and metal sheeting on the other slope. Both buildings received daylight illumination via missing doors (the building to the west was a 3-bay cart lodge with brick pillars) and both had a covering of cobwebs in parts of the roof. Some stud work had been erected in the south-western corner, and the external southern wall was covered by ivy that was growing into the building. There was a lack of crevices in the brickwork and cut timber rafters, and no evidence of bats was found on the walls and floor of the buildings.

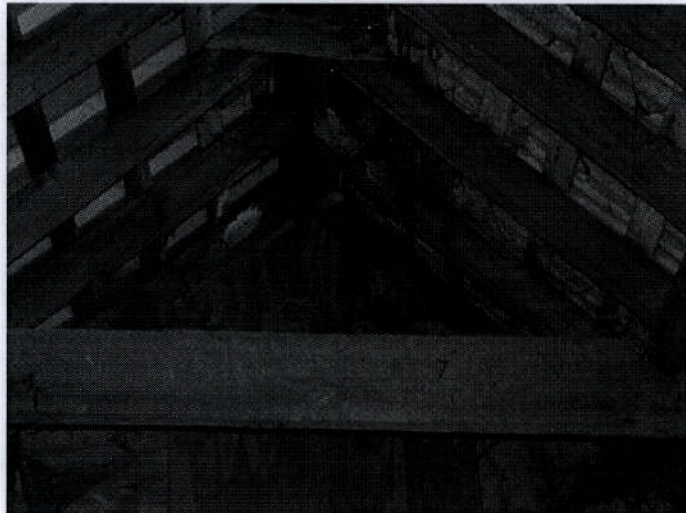
**Photo 3:** Showing cobwebs along the ridge

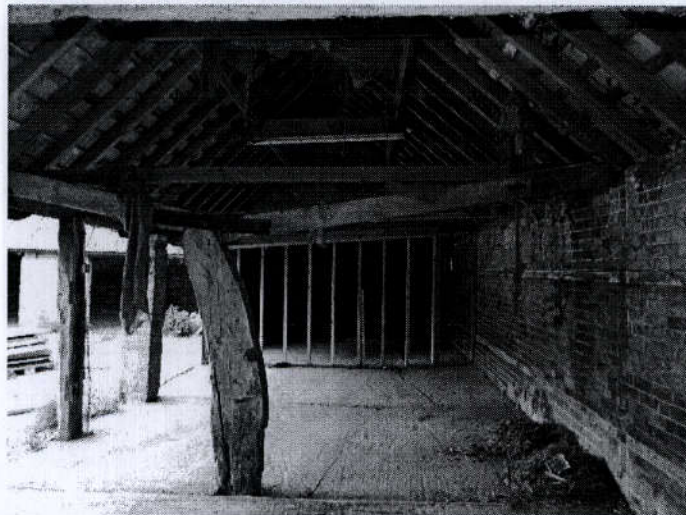
**Photo 4:** Interior of western building

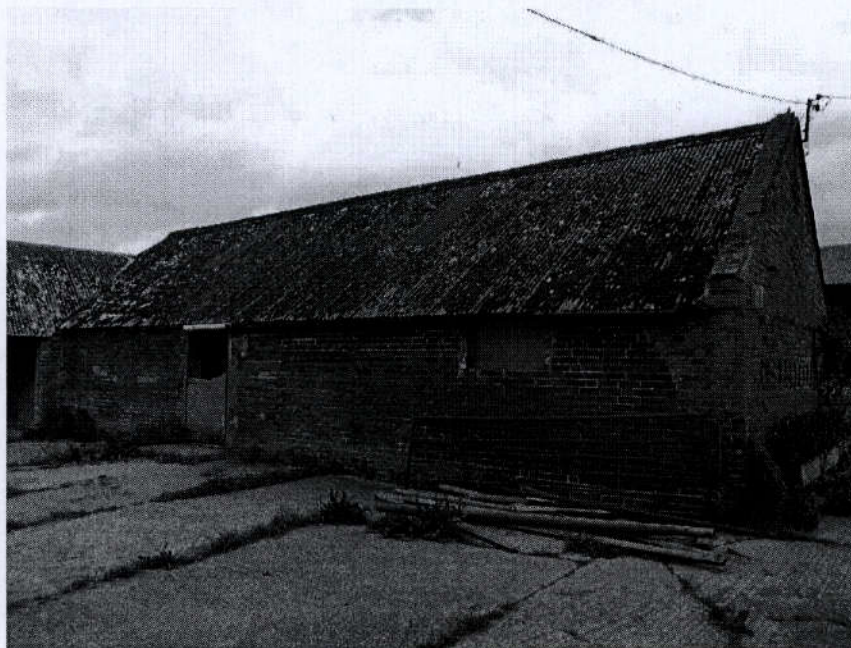
A former livestock shed is located on the northern side of the courtyard. The building is of brick construction with a corrugated asbestos roof. The interior receives daylight illumination via two windows in the northern wall, one to the west and two corrugated, transparent panels in the roof. There was a lack of crevices in the brickwork and cut timber rafters, and no evidence of bats was found on the walls and floor of this building.

**Photo 5:** Former livestock shed on northern side of courtyard

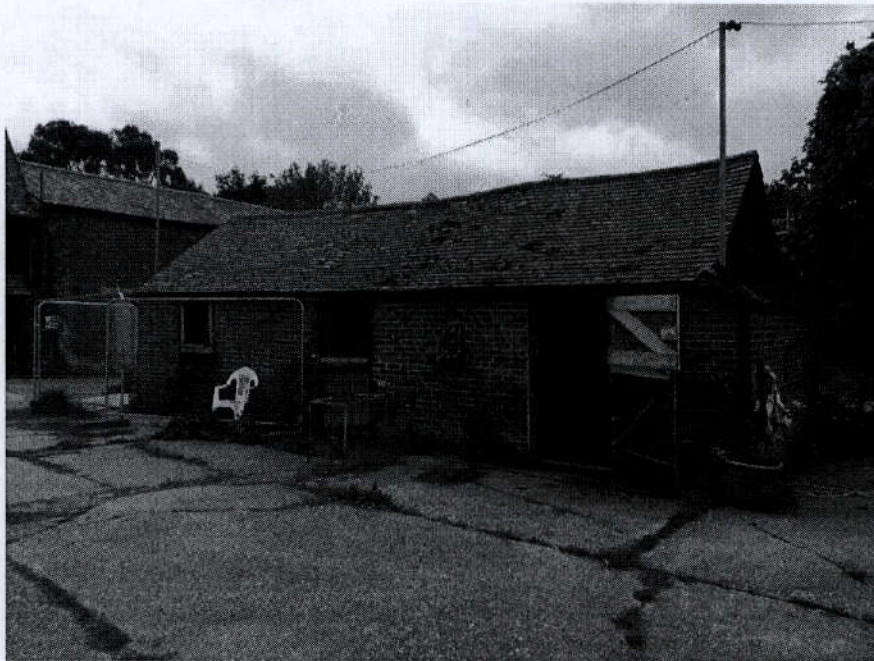
This small, brick building with an unlined, tiled roof is located in the central part of the site. The interior is divided into three sections, all with approximate dimensions of 4m x 3.5m. There was an abundance of cobwebs on the walls and ceilings, conditions that would be unsuitable as a roosting place for bats. No evidence of their presence was found to be associated with this building.

**Photo 7:** Stables due for demolition

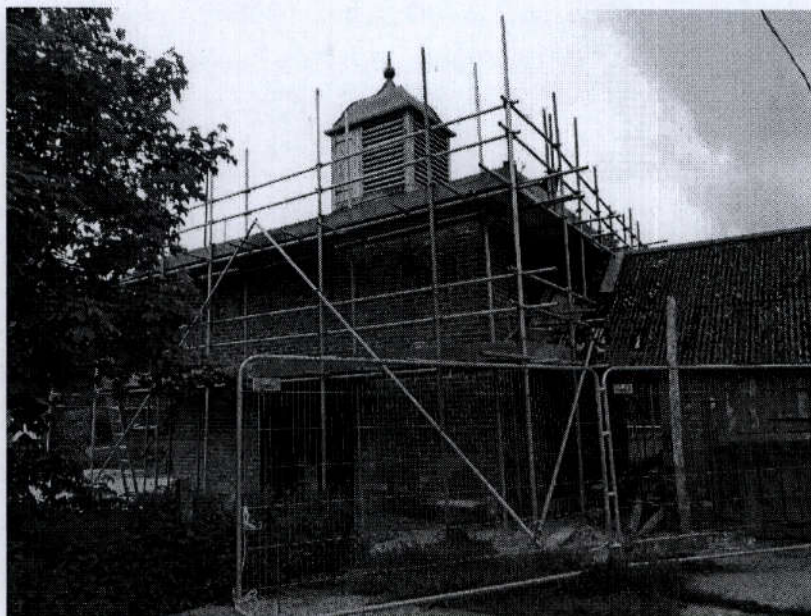
This is a brick building in the south-east corner of the courtyard. The building is covered by a scaffold and is the subject of a major refurbishment, with the roof having been replaced and the walls rebuilt. The interior is open to the wind and receives daily disturbance as the work progresses. No evidence of bats was found in this building.

**Photo 9:** Dove cote building

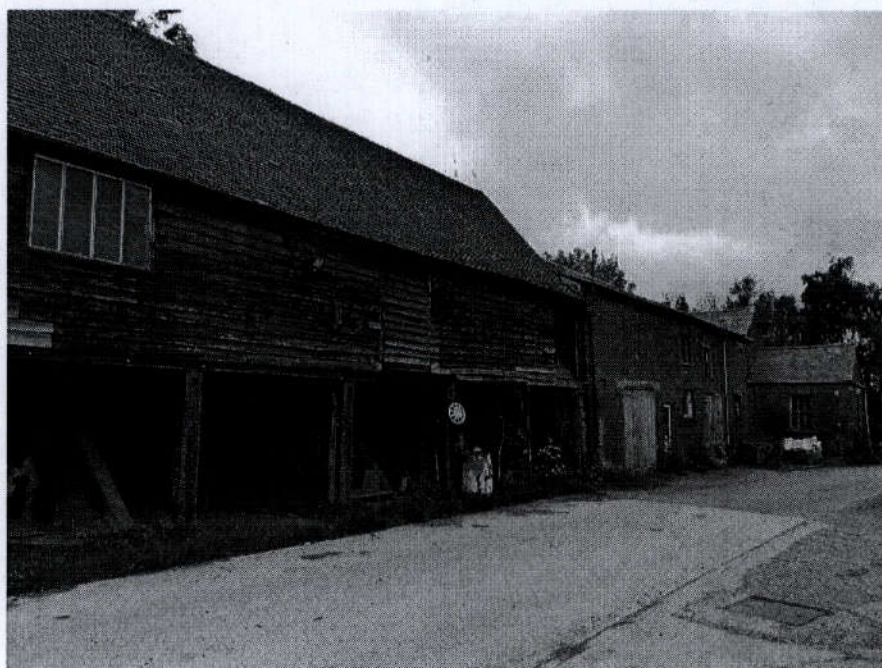
**Photo 10:** The cart lodge (with upper floor) and brick building

Of the buildings along the eastern side, the single-storey lock-ups were secure buildings and had no evidence of the presence of bats. The ground floor of the cart lodge was open to the west and had a ceiling formed from the joists and floor boards of the upper floor. There was a lack of crevices in this part of the building that was exposed to wind and rain from the west.

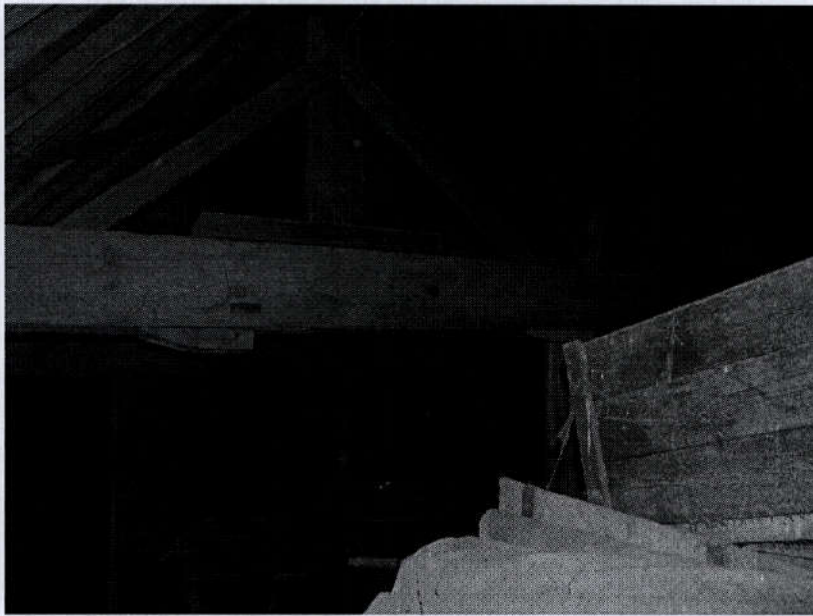
The upper floor had been used for storage and there was a covering of dust on the former farm machinery stored on this floor. The building had several butterfly wings on the floor beneath the ridge beam, the evidence indicating that the upper floor is occasionally used as a feeding perch, probably by a single brown long-eared bat. However, such perches are part of a bat's foraging rather than roosting behaviour and are not protected. A two-storey brick building attached to the southern end of the cart lodge was in a derelict condition with missing windows and roof slates. The interior was exposed to damp and draughts and was unsuitable as a roosting place for bats.

**Photo 11:** Upper floor of cart lodge

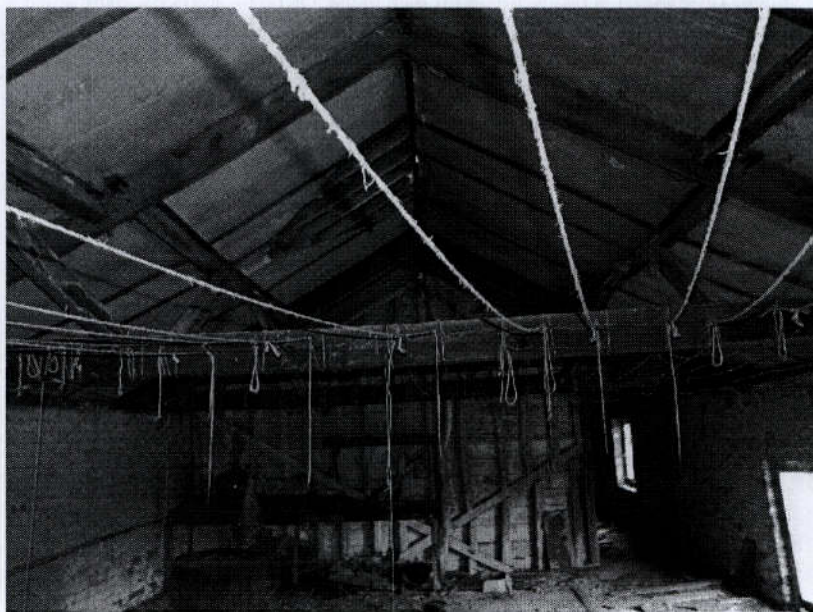
**Photo 12:** Upper floor of brick building – the roof is lined with plasterboard

The upper floor of the brick building was open to the roof part of which was lined with plasterboard. The floor received daylight illumination via missing windows and lacked crevices that might offer potential roosting places for bats.

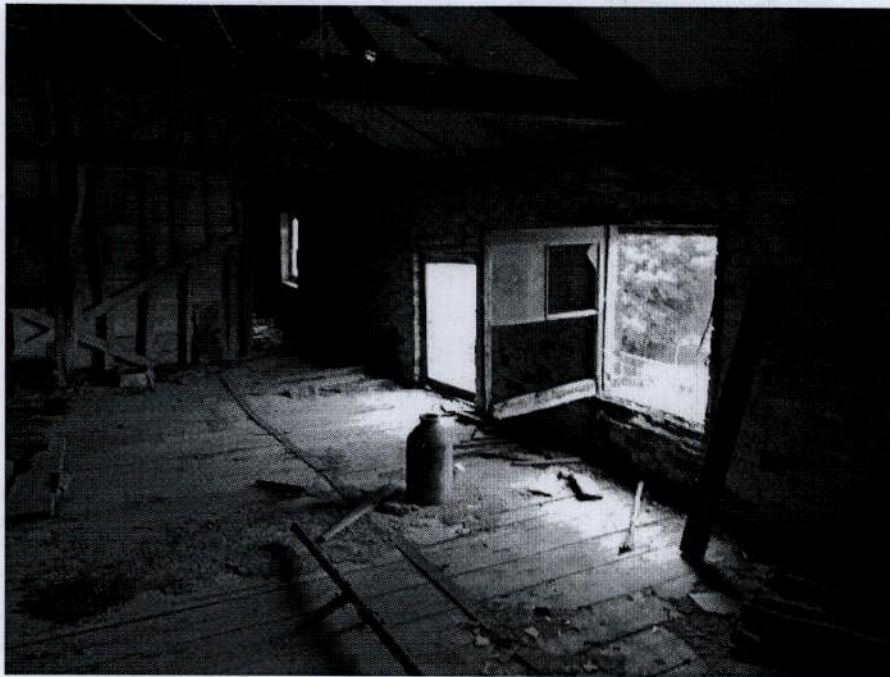
**Photo 12:** Upper floor showing missing windows
