A desk-based assessment of the former brickworks at Star Lane, Great Wakering, Essex

CAT project ref.: 14/10f
NGR: TQ 934 872 (centre)

CAT Report 809
February 2015

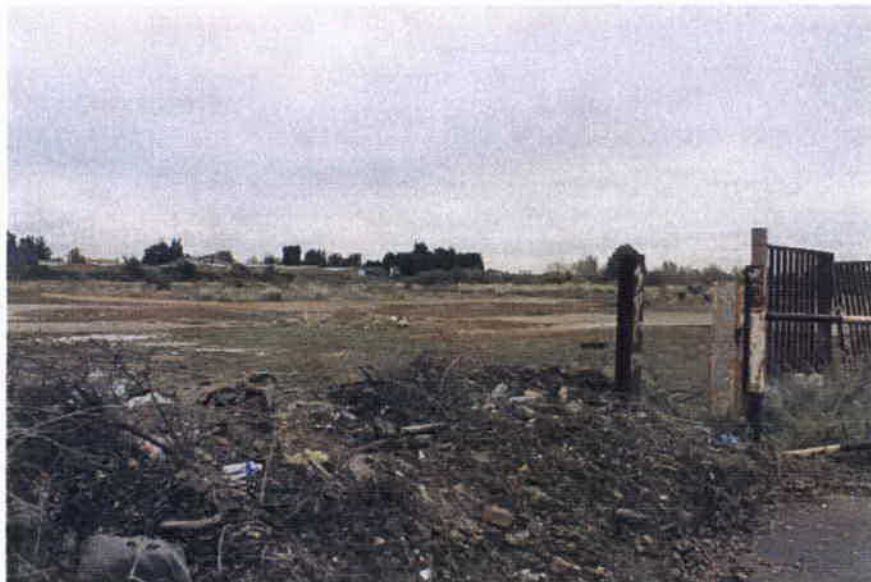
Illustration 1: view north-east across site, showing extensive concrete hard standing, all that remains of the former brickworks.

- 2.3 Current land use: the site is currently derelict with large areas of concrete hard standing and a few small areas of grass (Illustration 1). To the east of the former brickworks the area associated with quarrying of the brickearth is an overgrown wilderness of small man-made hillocks and fishing lakes (Illustration 2).

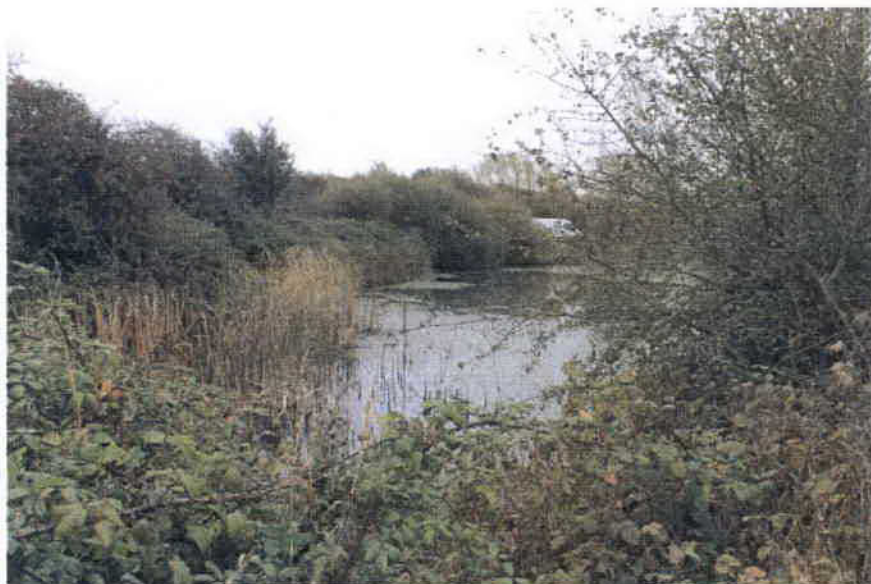
Illustration 2: view north-east across wilderness and fishing lake created from former quarry areas.

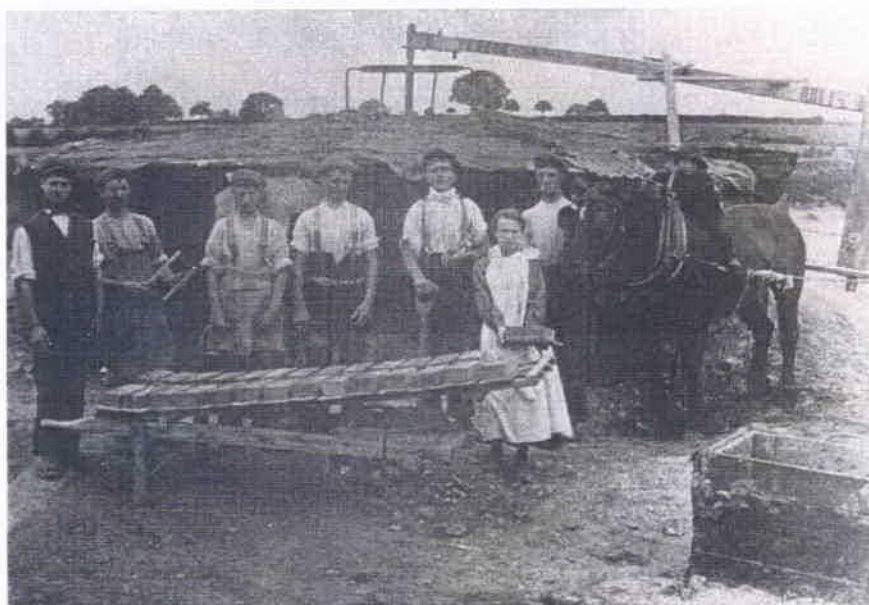
Illustration 3: a late Victorian brick yard in Chelmsford, with young workers (possibly related family members) standing in front of a horse-driven pug mill and with a barrow of hand-made bricks in the foreground. Similar scenes would have been found around the brick fields of Wakering.

Prior to the 1860s Wakering had a few small, family-owned brick yards. These usually had a horse-driven pug mill where the brickearth was mixed with water and lime and a small bench where the bricks were moulded (Illustration 3).

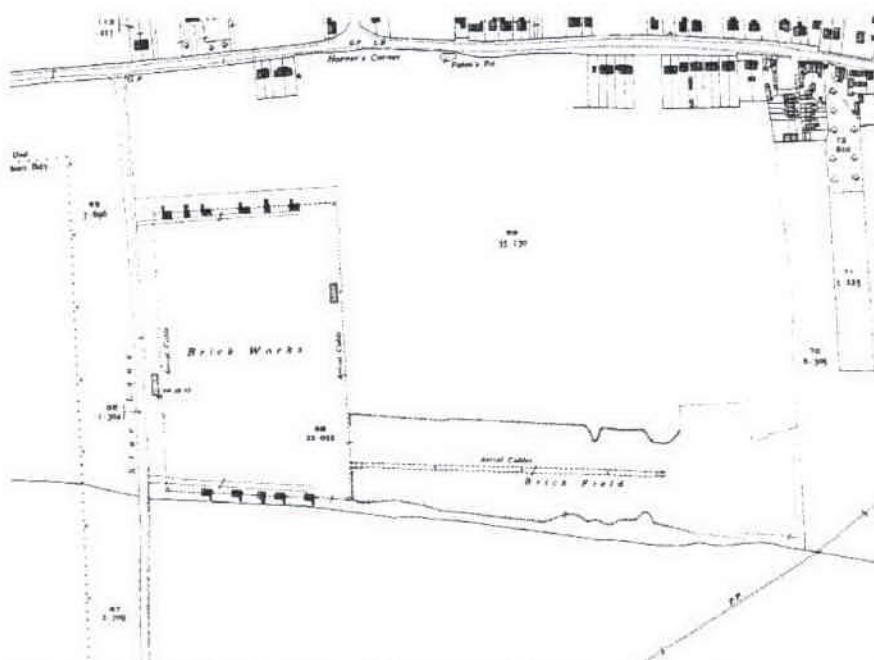
The earliest cartographic evidence for the Star Lane brickworks is the 1939 edition of the Ordnance Survey (Illustration 4). This shows the brickworks on the east side of Star Lane as a rectangular site with two rows of buildings, one at the north end of the site, comprising six structures, and one at the south end of the site, comprising five structures, each accessed by a drive leading from Star Lane. Two additional structures are shown, one to the east of the site, one to the west. These may have a connection to the aerial cables that run around the perimeter of the site and extend eastwards into the brick field. These aerial cables were supported on pylons and conveyed clay in buckets from the quarry sites in the brick field. As the aerial cables pass above each of the eleven structures at the brickworks it is logical to assume that each structure represents a brick-making shed, presumably with a kiln attached.

Illustration 4: 1939 edition Ordnance Survey, showing the two rows of structures at the brickworks and the brick field to the east.

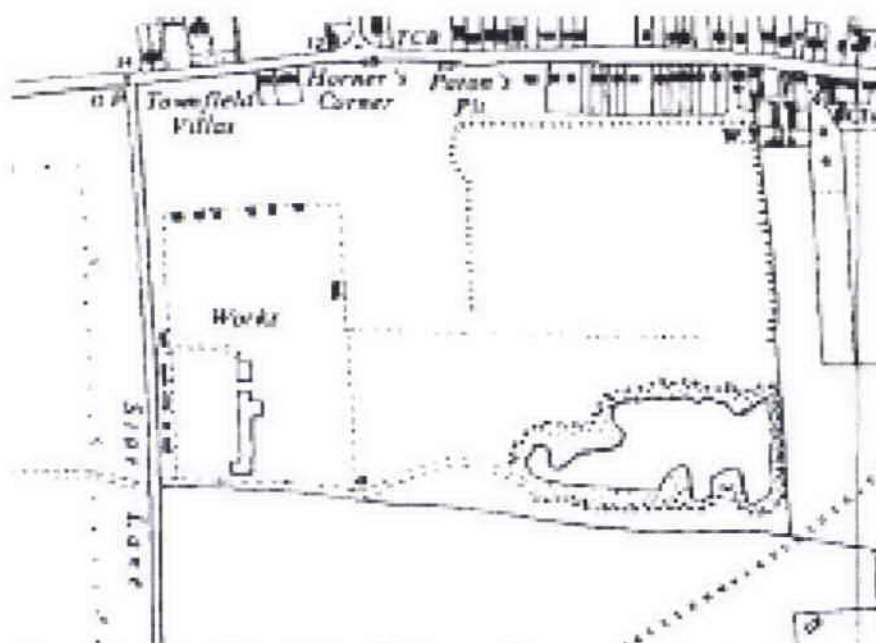
The 1939 layout represents the earliest phase of the brickworks. The next available mapping is the Ordnance Survey of 1961 (Illustration 5). By this time the southern row of structures has been replaced by a large, north-south aligned building and there are additional structures along the west perimeter fence. The brick field to the east has expanded to the north somewhat and the aerial cable system appears to have been scrapped, although one of the pylons adjacent to Star lane is reputed to have survived until the site was levelled.

Illustration 5: 1961 edition Ordnance Survey, showing the large north-south aligned structure in the south part of the site and the expanded brick field to the east.

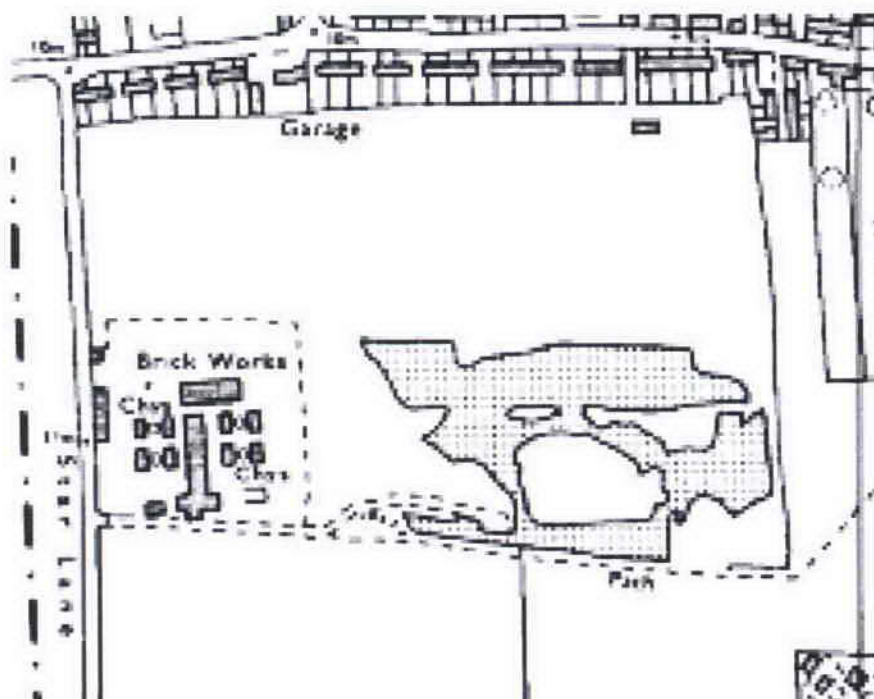
The most significant amount of change appears to have taken place between 1961 and 1971. The Ordnance Survey mapping for 1971 (Illustration 6) shows no trace of the 1939 layout and the northern part of the site has been disposed of, reducing the area of the brickworks by approximately one quarter. New buildings have been erected and the eight downdraught kilns installed. The quarrying of the brick field to the east has expanded and reflects the increased output of the modern brick-making machines.

Illustration 6: 1971 edition Ordnance Survey, showing the new layout of the brickworks and the increasing quarrying activity in the brick field to the east.

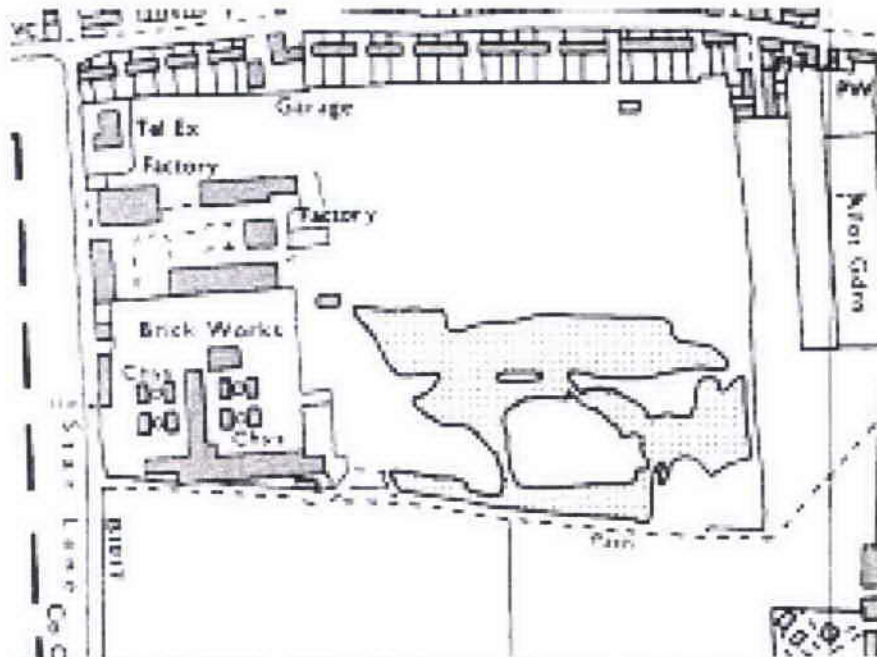
The final mapping consulted was the 1989 Ordnance Survey (Illustration 7). The only significant change is the addition of a large east-west aligned structure on the southern edge of the site. Star Lane Industrial Estate is shown built up against the northern boundary of the brickworks. This has been constructed over the site of the northern row of brick sheds identified from the 1939 mapping.

Illustration 7: 1989 edition Ordnance Survey, showing the final layout of the brickworks with Star Lane Industrial Estate to the north, constructed on the site of the 1939 brick sheds.

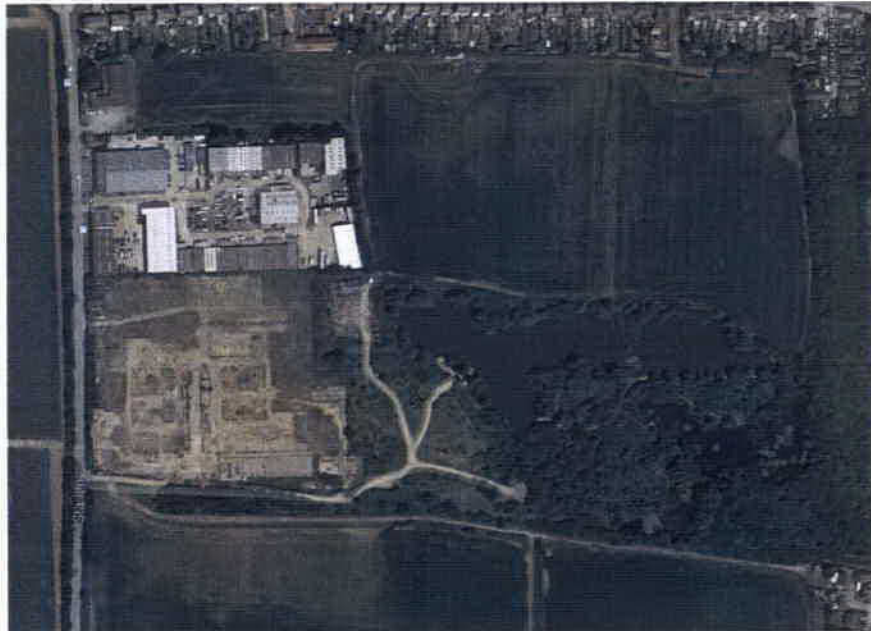
Illustration 8: Google Earth satellite image, showing the levelled brickworks surviving only as a concrete slab with the wilderness of the former brick field to the right.

Although the site has been levelled (Illustration 8), photographs taken by amateur enthusiasts of industrial archaeology give some indication of what the buildings at Star Lane brickworks would have looked like. Illustration 9 shows two of the chimneys standing between the massive downdraught kilns.

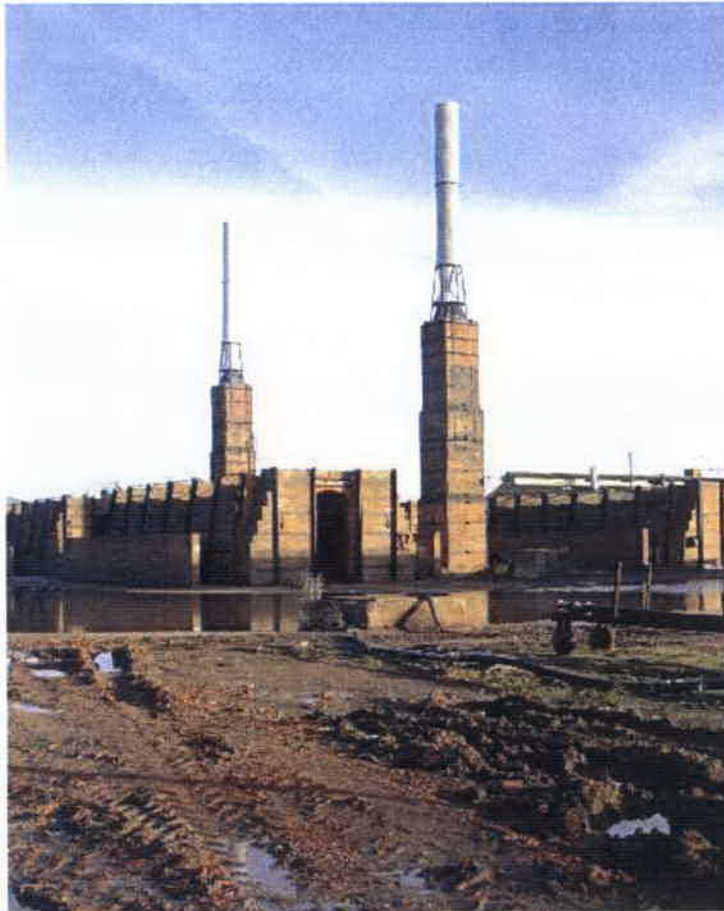
Illustration 9: chimney stacks between the pairs of downdraught kilns.

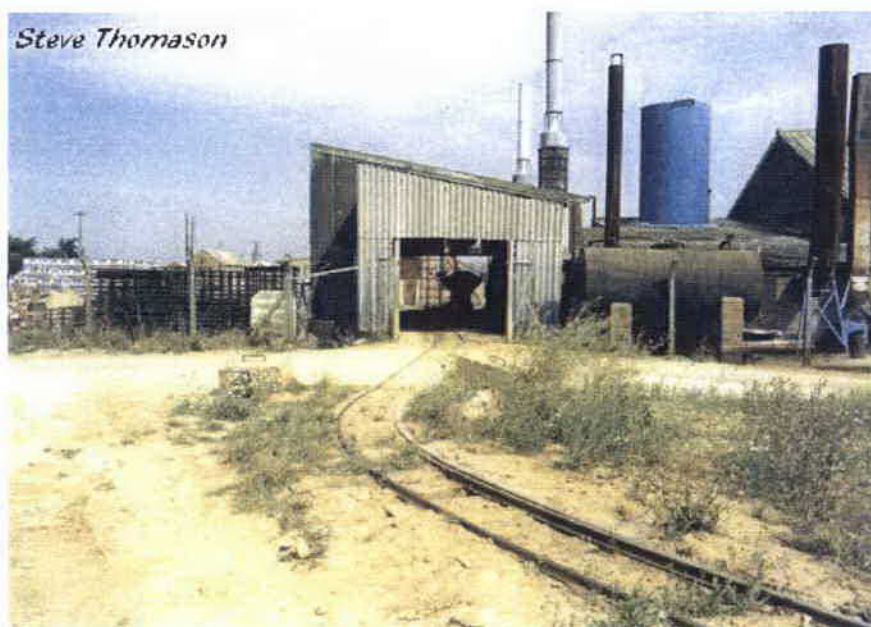
Amateur enthusiasts have also shed light on how the raw clay was transported from the brick field after the decommissioning of the aerial cable system. Star Lane brickworks was equipped with a 2-foot narrow gauge railway that linked the clay pits to the complex, running alongside the agricultural land to the south of the brickworks. This crossed the track separating the brickworks from the fields and entered a tipping shed located against the perimeter fence (Illustration 10). This was one of the last working railways serving a brickworks in England. Traces of the railway can still be seen in places, hidden beneath dense undergrowth (Illustration 11).

Illustration 10: narrow gauge railway bringing weathered clay to the tipping shed at the south side of the brickworks. The chimneys for the downdraught kilns can be seen in the background. © Steve Thomason <http://www.inqr.co.uk>

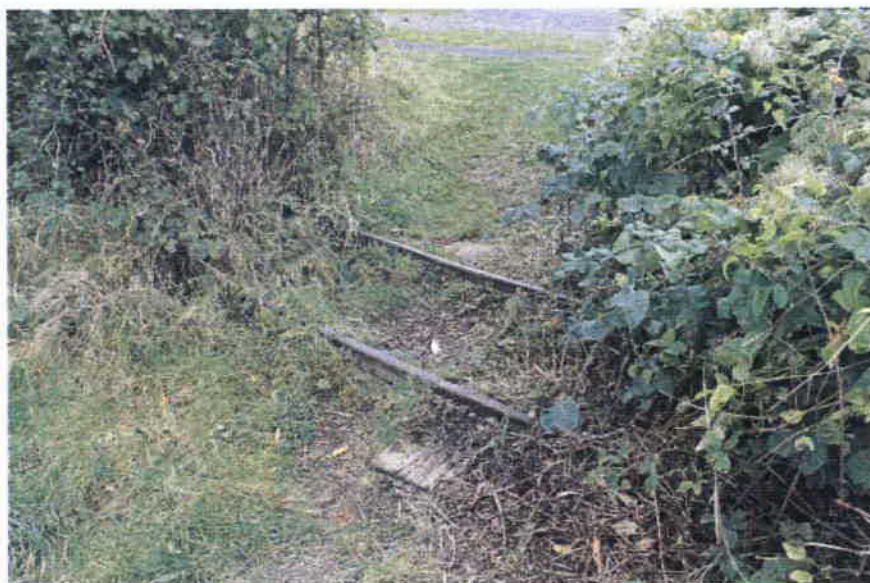
Illustration 11: remains of the narrow gauge railway running along the south side of the brickworks.

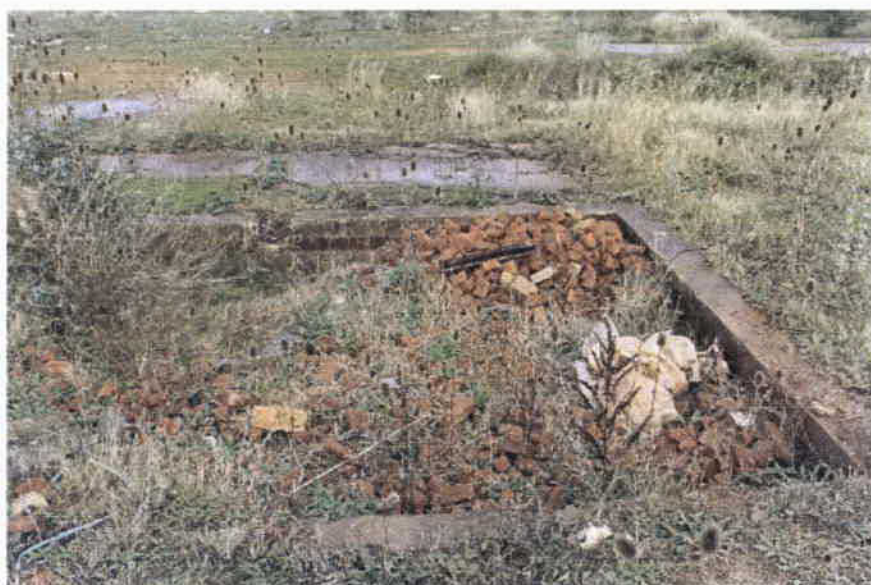
Although the site has been levelled of all upstanding remains, the reinforced concrete slabs that formed the bases of the buildings and the hard standing between them has been left in place. From these remains (combined with the map evidence) it is possible to locate individual buildings and deduce function. In particular, the flue pits for the kilns survive as rubble-filled pits (Illustration 12). At the south end of the brickworks, on the site of the large east-west aligned building, there are 30 pairs of iron rails set into the concrete, divided into 10 bays by brick walls (Illustration 13). These must represent a form of rolling floor, allowing pallets of bricks to be moved around the complex.

Illustration 12: rubble-filled flue pit, all that remains of the downdraught kilns.

With regard to the second point, archaeological excavation of the remains would surely be limited to the removal of the rubble from the flue pits of the downdraught kilns. It should be emphasised that the remains do not comprise demolished buildings sealed by later layers of archaeological stratigraphy, but are the *in situ* bases of buildings shown on the Ordnance Survey mapping. It is possible that stripping the site of accumulated soil/debris and vegetation where this has built up might provide a clearer picture of the brickworks and the mapping of features such as the iron rails may help explain the processes involved with brick manufacture in the mid-late 20th century better.

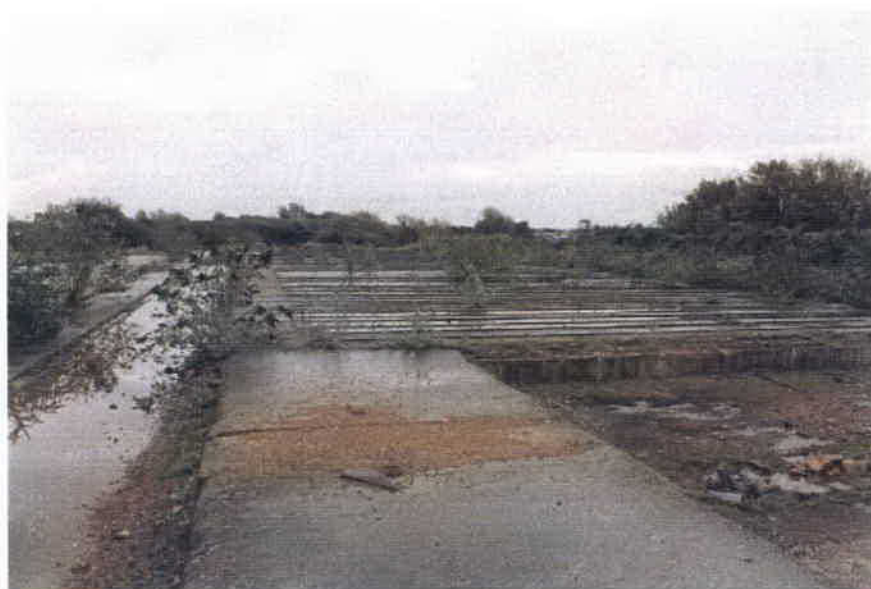
Illustration 13: iron rails set into the concrete floor of the east-west aligned building at the south end of the site.
