ARBORICULTURAL REPORT
(BS5837:2005 'Trees in relation to construction – Recommendations' Tree Report)

Rayleigh House
High Street
Rayleigh

On Behalf of
Autosecond Ltd

26th July 2007

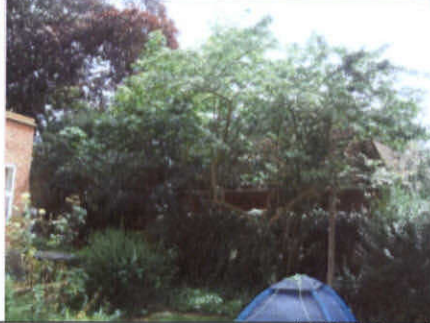
T7 Copper Beech and T8 Holly

T7 Copper Beech A1 and 2	Large tree in good health overhanging existing house. RP is largely in tarmac area and is 547 square metres	Retention essential Minor tree works recommended to remove small hazards and clear roof.
T8 Holly C2	Insignificant Holly in fair health. Small RPA. Provides a shade tolerant understory to beech.	Retention desirable
